Area Mining Impact Overview Report Resort Village Area Structure Plan_Rev2

Three Sisters Mountain Village
Canmore, AB
Wood File: CG09125

16-Nov-20

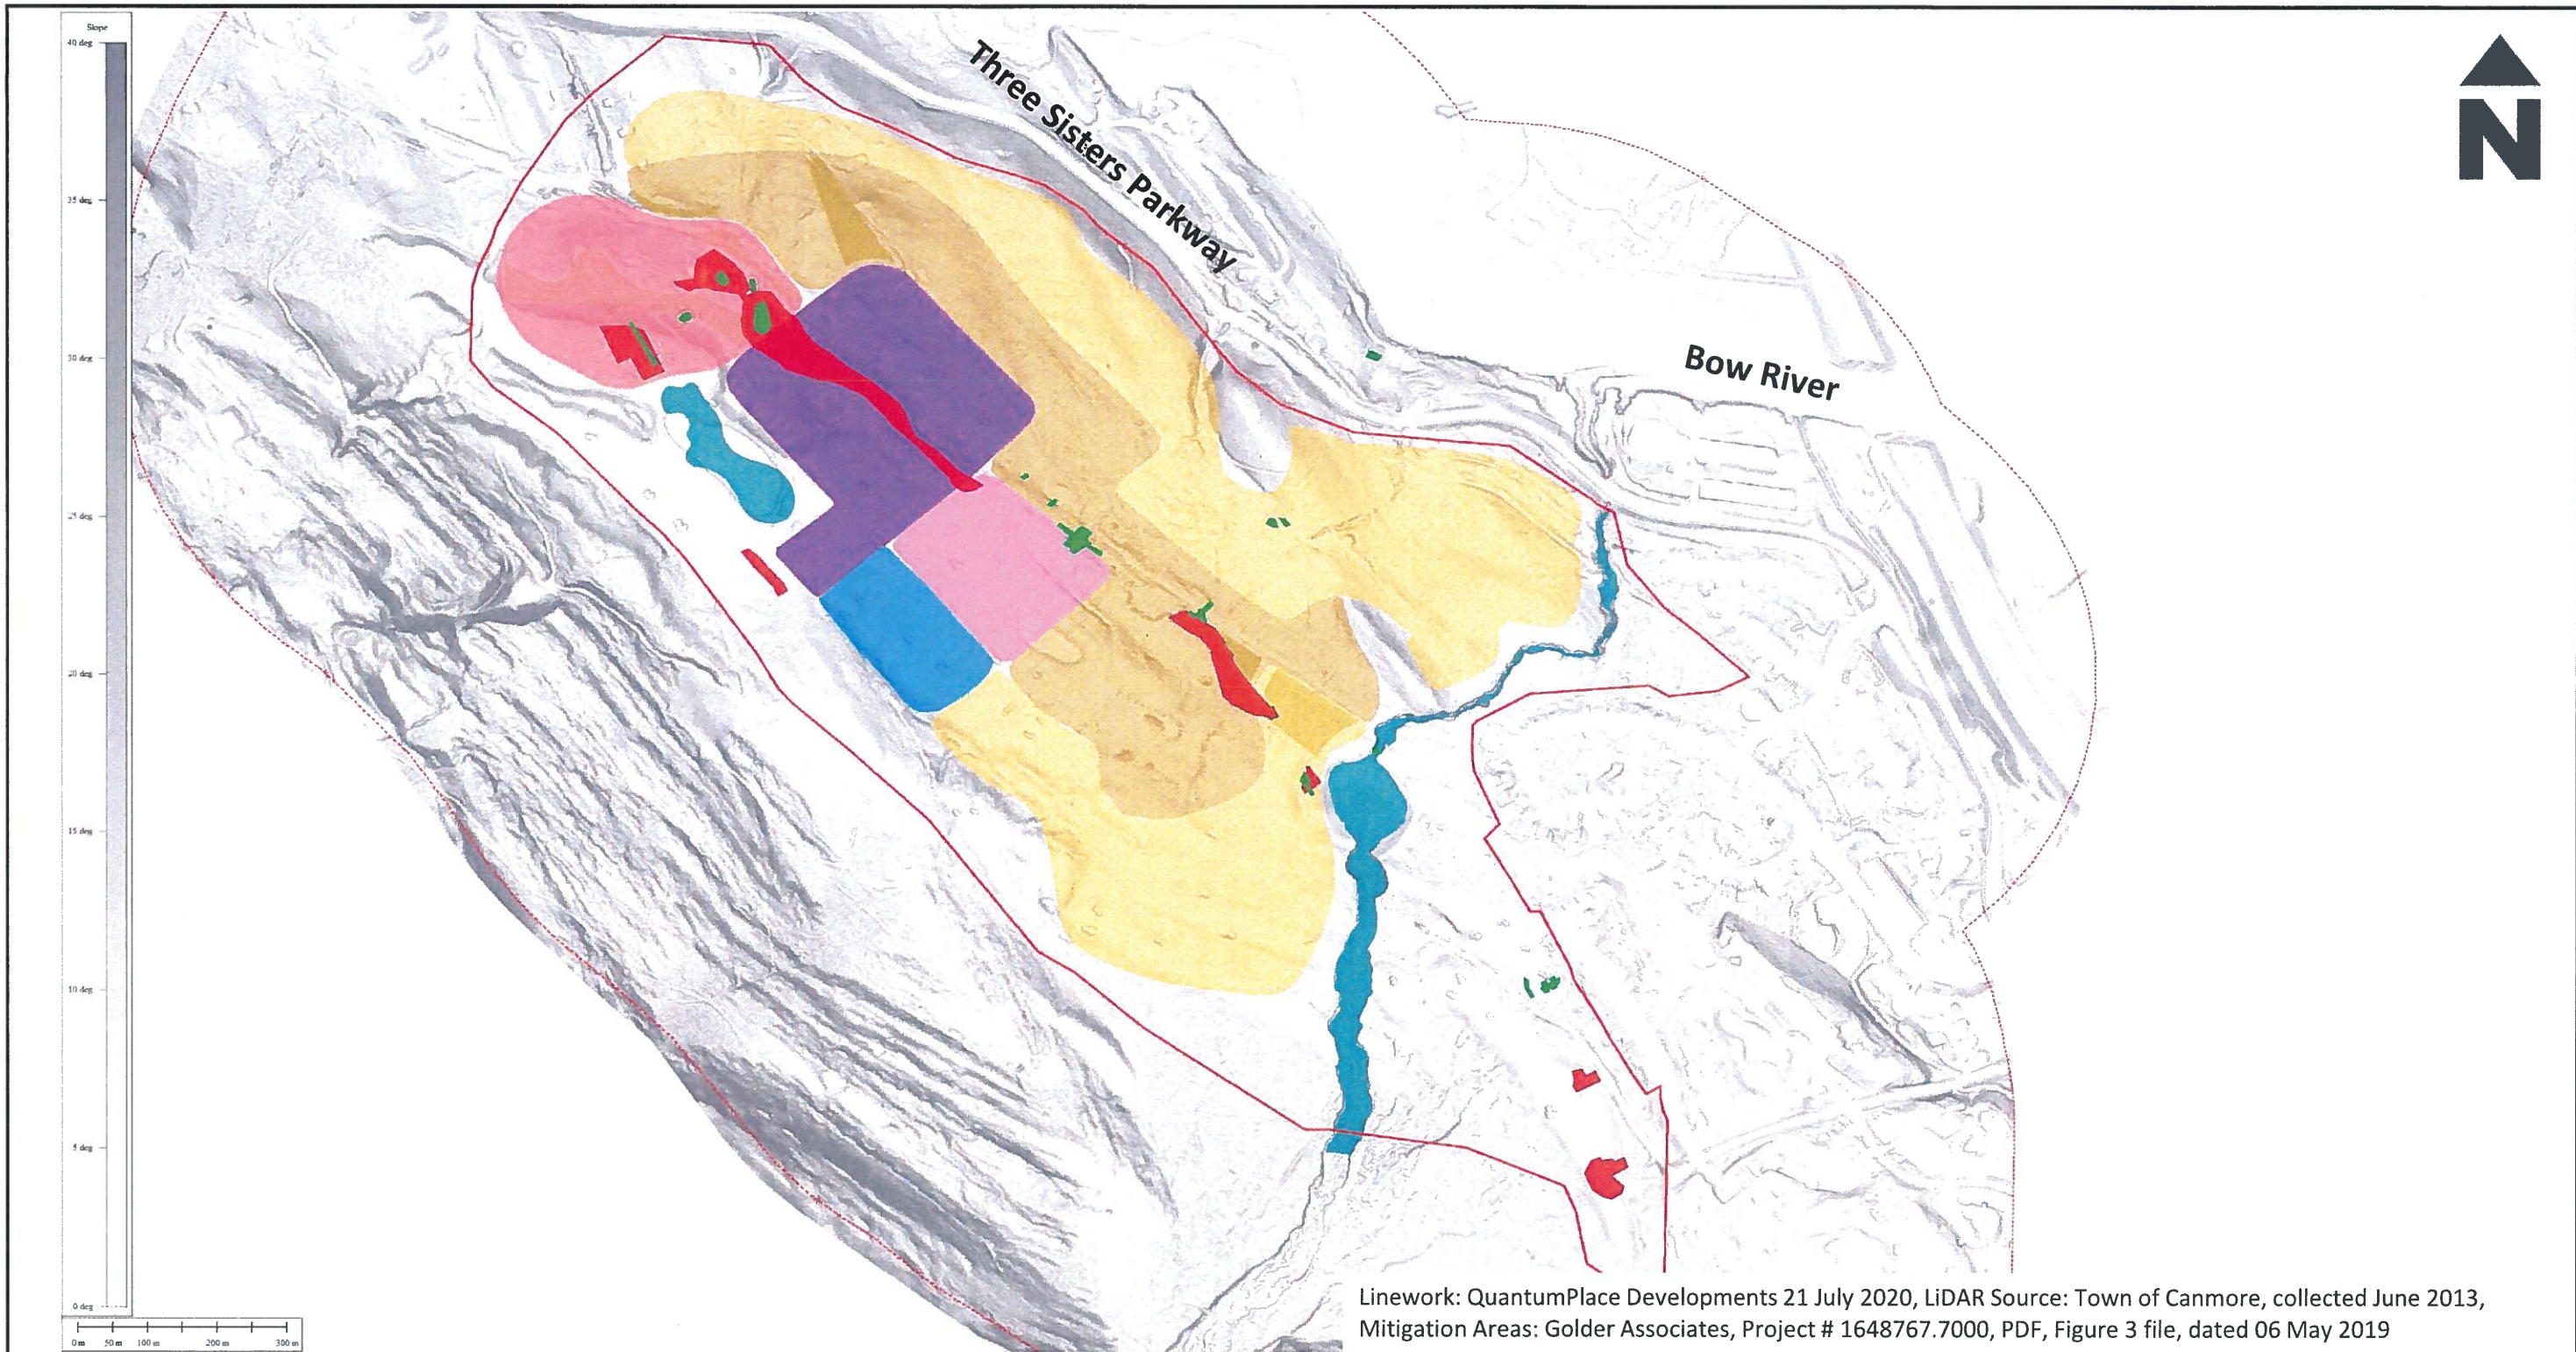
PROJECT NAME	PROJECT NUMBER
	Resort Village ASP	CG09125
	SHEET TITLE	FIGURE NUMBER
	Previously Mitigated Areas For Golf Course Use	16
		ISSUE/REVISION
		Rev2

Some hazards identified within the ASP area were mitigated using geogrid and paste backfill during construction of the unfinished golf course that currently occupies the site. The locations of the mitigation works are shown on **Figure 16** in relation to the proposed development. Most of the mitigation work focused on the subcrop areas of the Sedlock seam, as well as shafts and portals. The level of mitigation, which included excavation/backfilling with geogrid and local paste fill injection, was only undertaken to address public safety for recreational land use, and would need additional assessment, analysis, design, and mitigation for building construction.

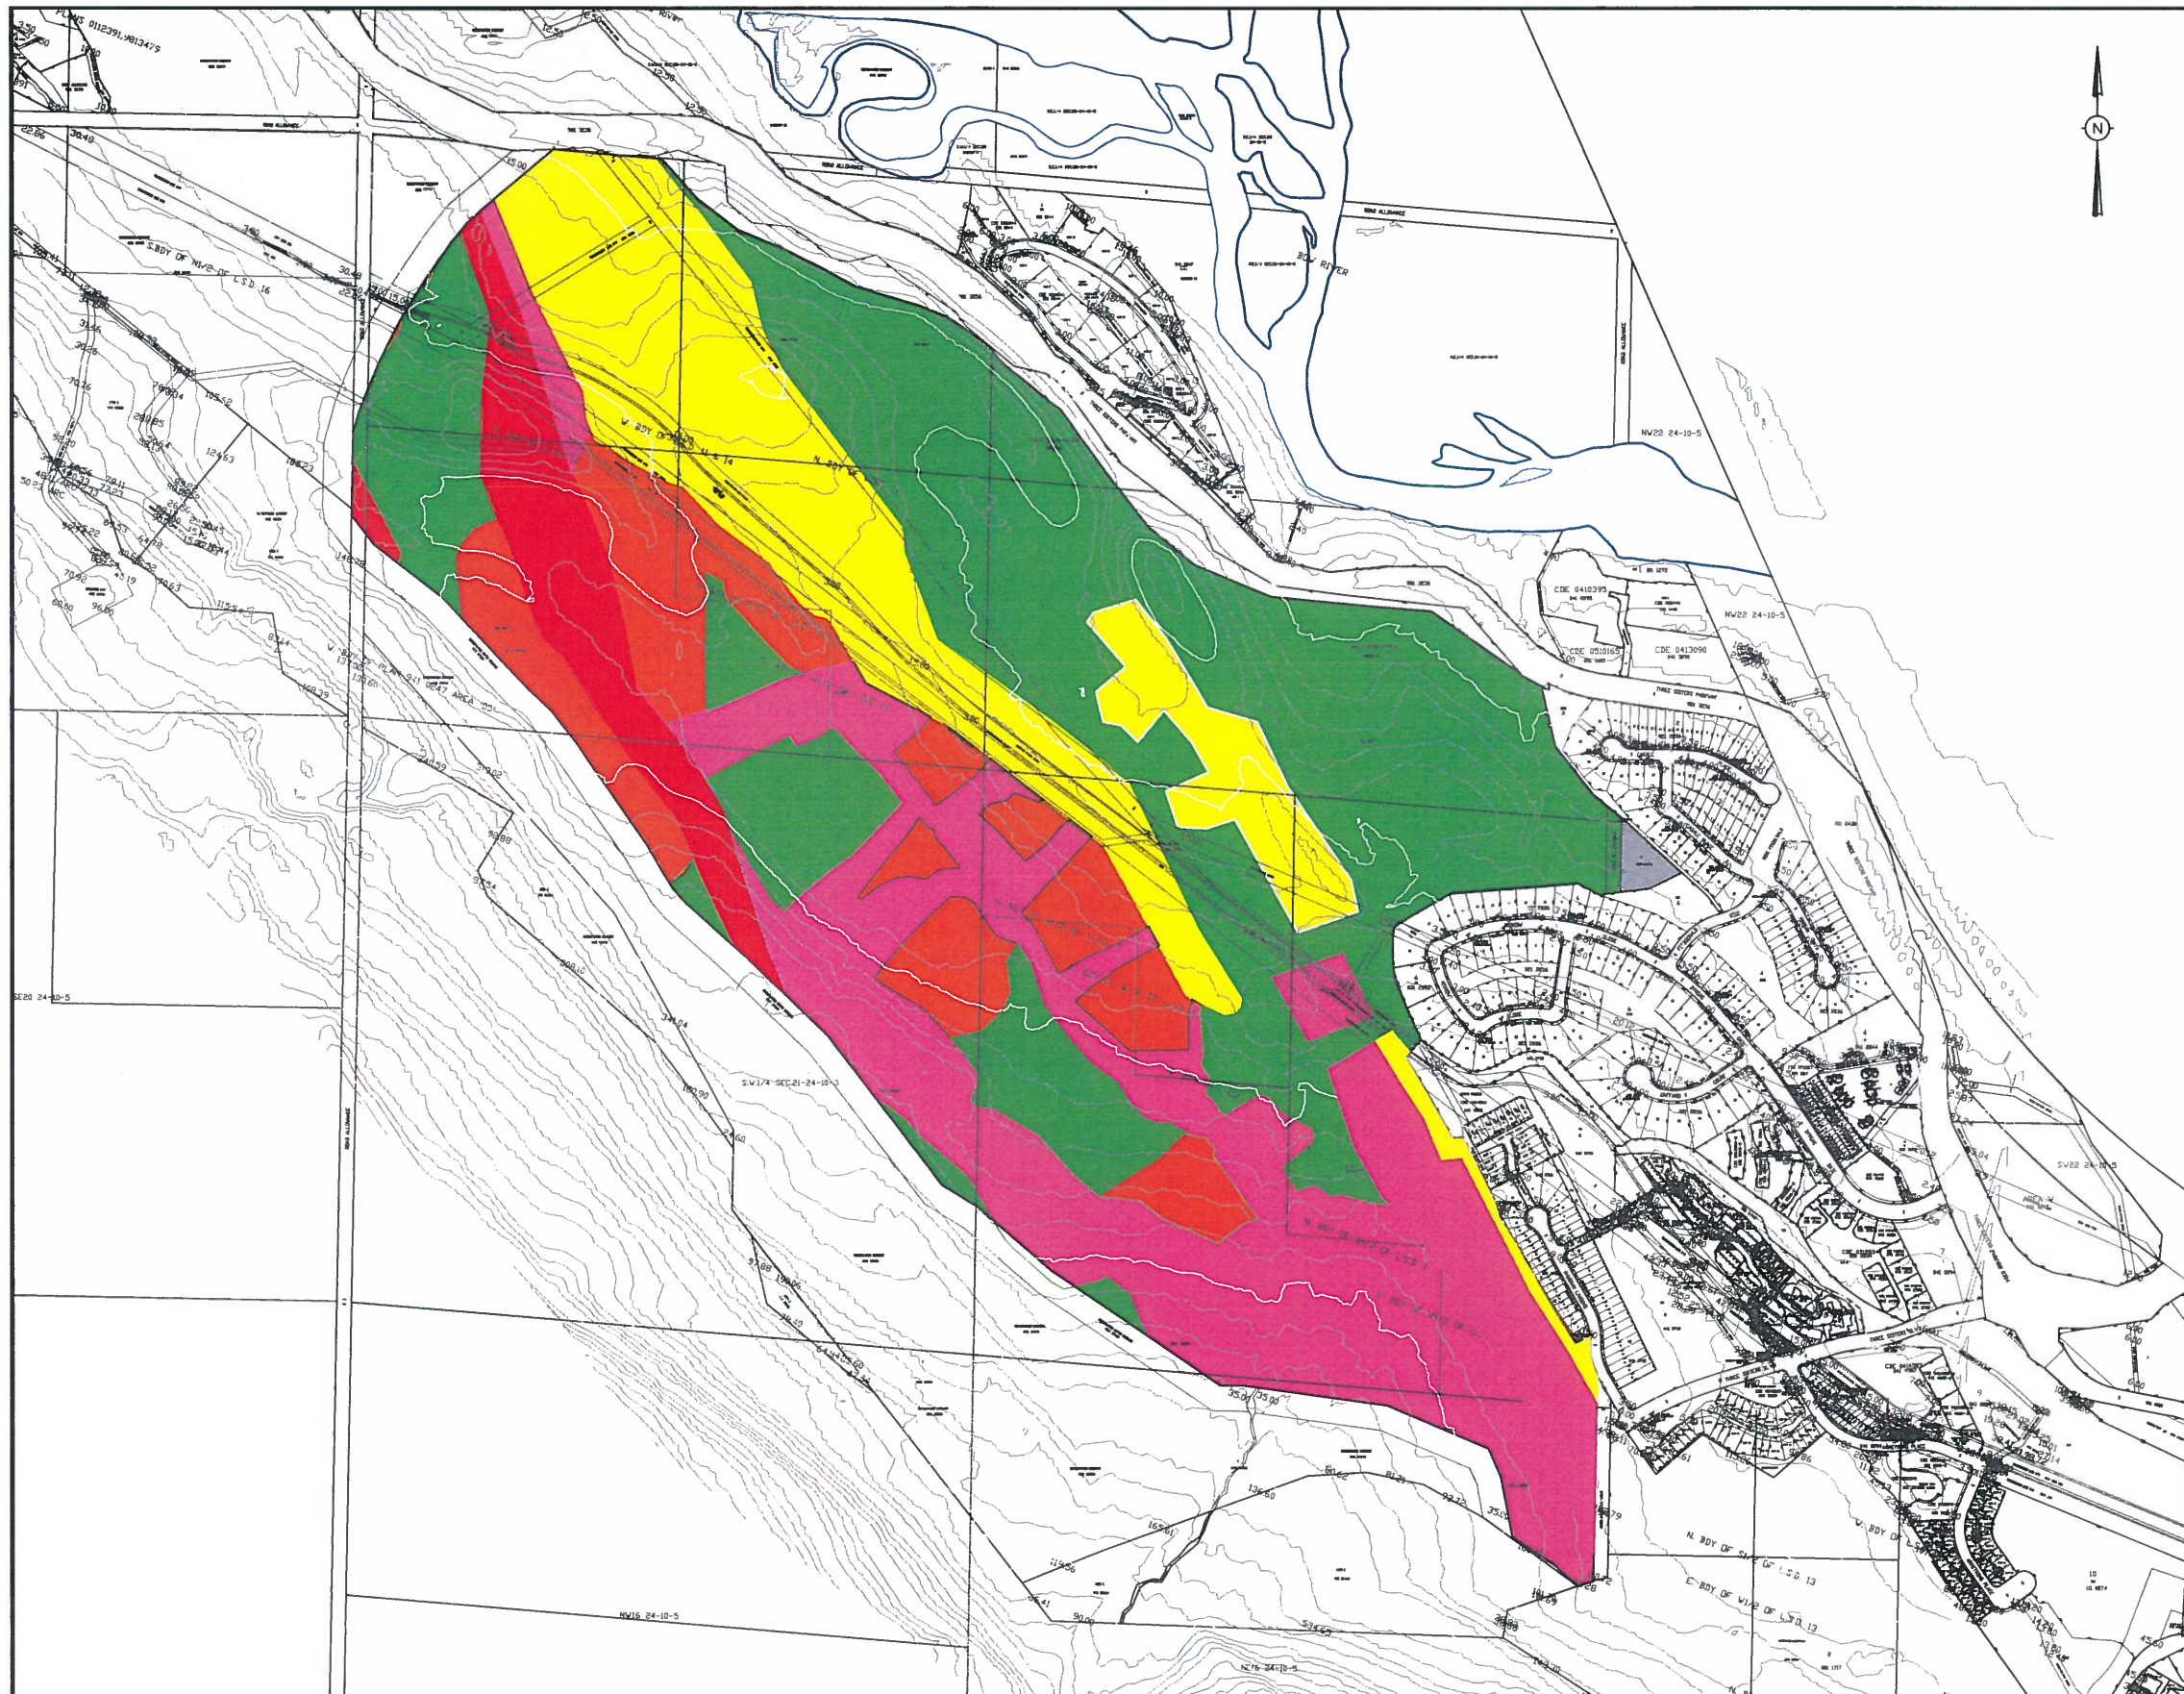
The ASP area has been divided into zones based on the potential for subsidence or sinkholes, and associated potential damage to structures. The breakdown of the zones is as follows:

- ZONE 1 (GREEN): NO STRUCTURAL OR GROUND MITIGATION REQUIRED FOR DEVELOPMENT. THESE ARE AREAS THAT HAVEN'T BEEN UNDERMINED, OR ARE LOCATED ABOVE THE MIDPOINT OF BROAD DE-PILLARED AREAS WITH EXPECTED UNIFORM SETTLEMENT.

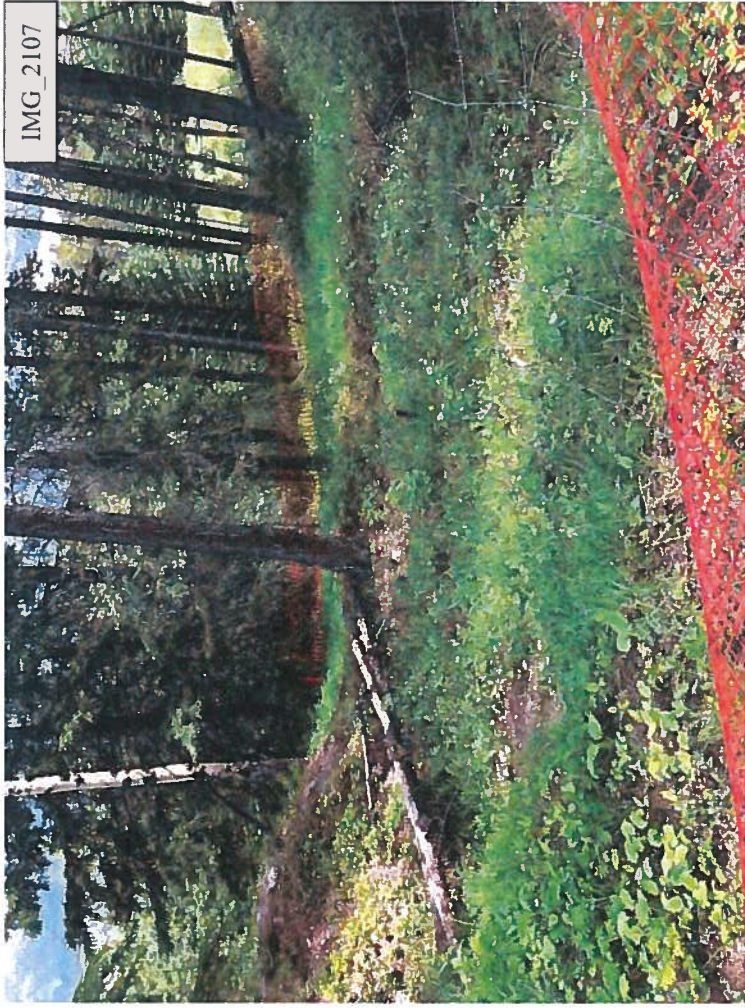
Photograph 1: Feature #74, June 2020

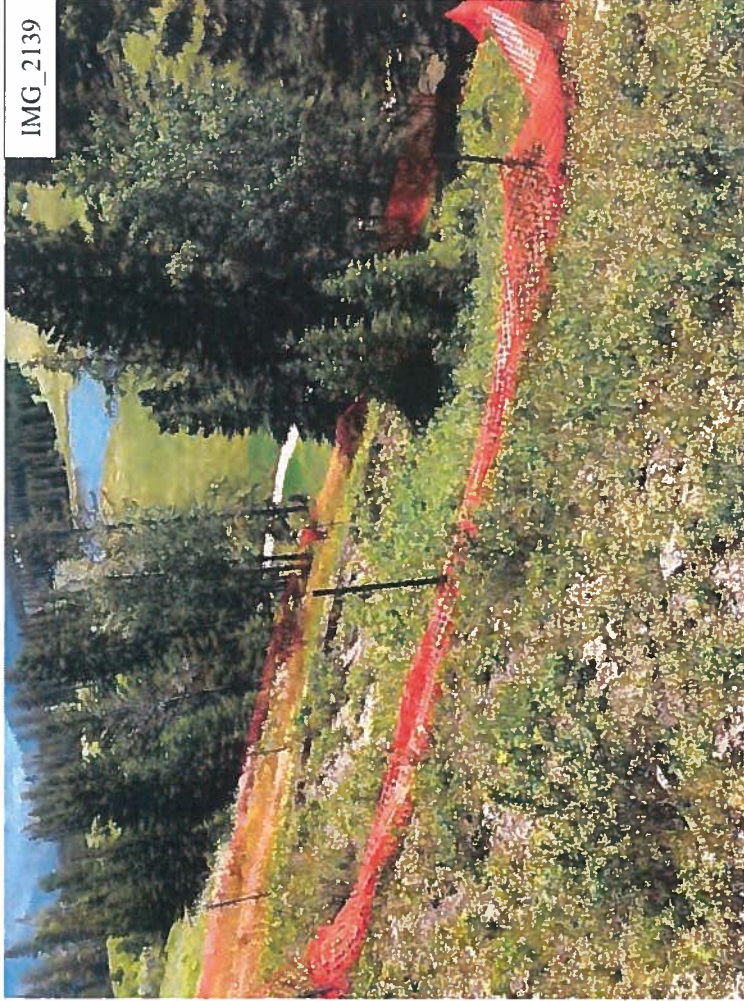
Photograph 2: Feature #73, June 2020

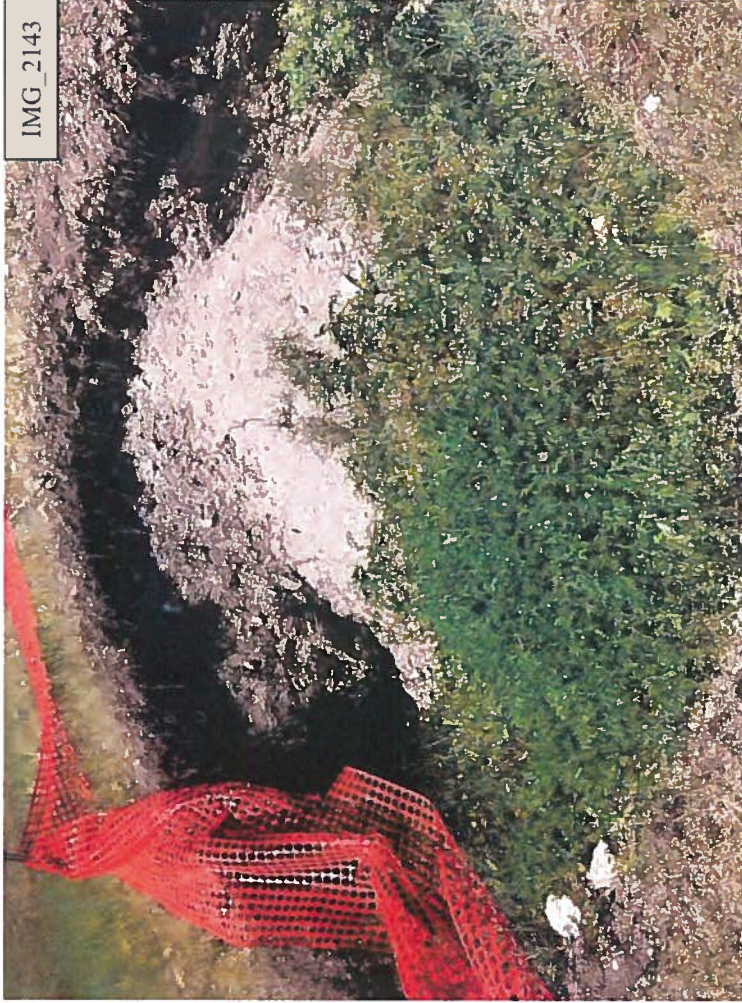
Photograph 3: Feature G404, June 2020

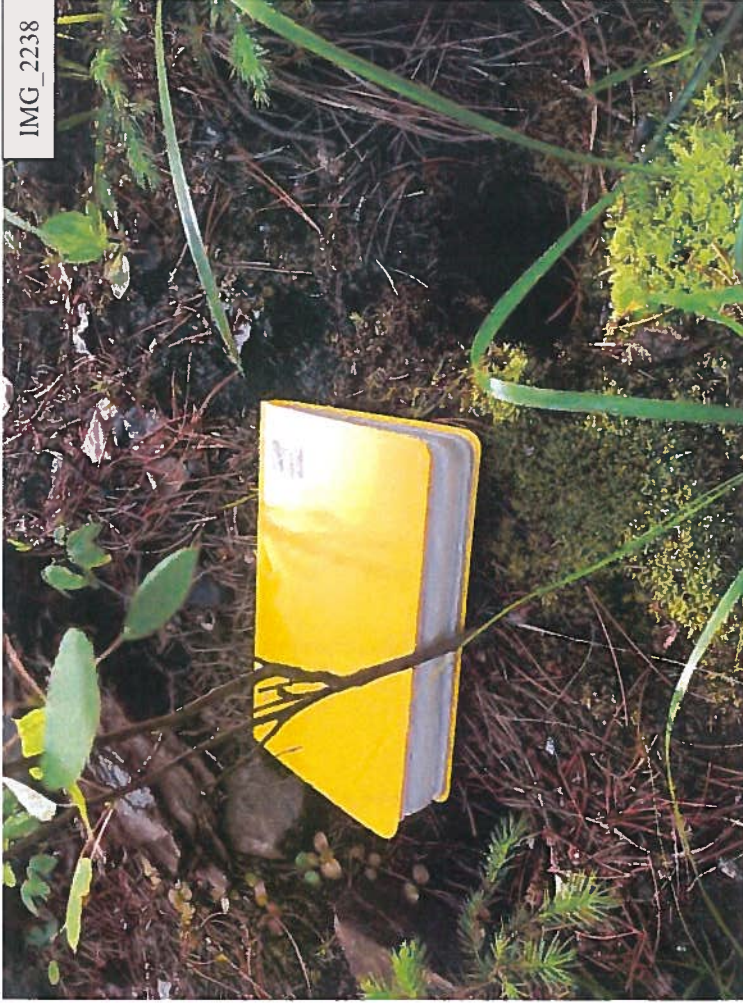
Photograph 4: Feature UMA9, July 2020

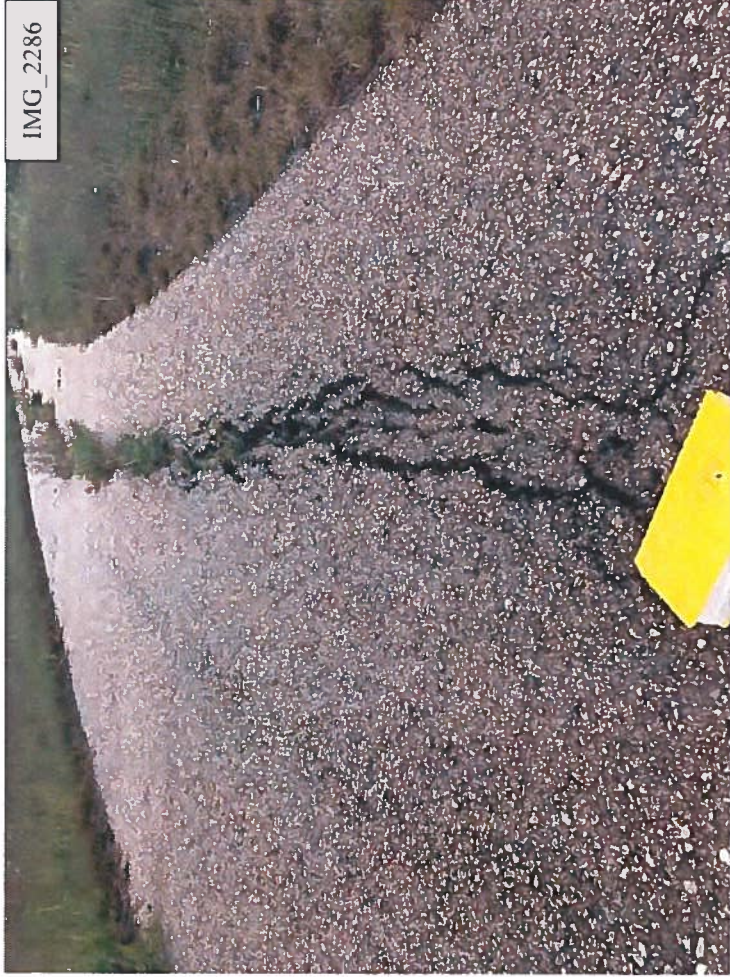
Photograph 5: Crack in pathway, Waypoint 092, July 2020

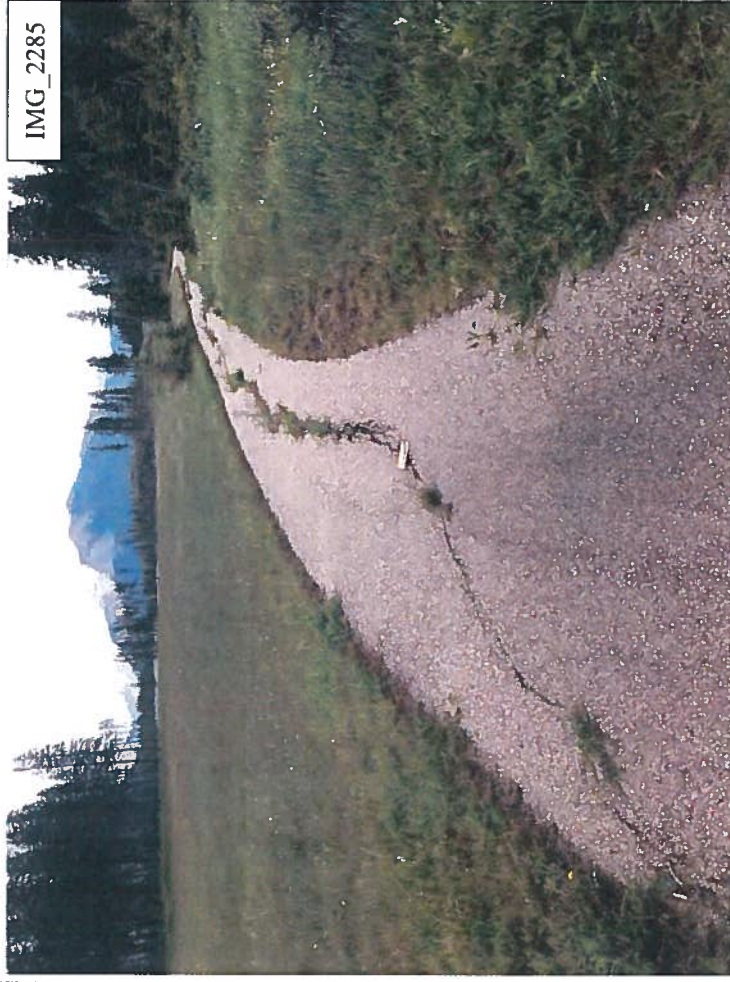
Photograph 6: Crack in pathway, Waypoint 092, July 2020

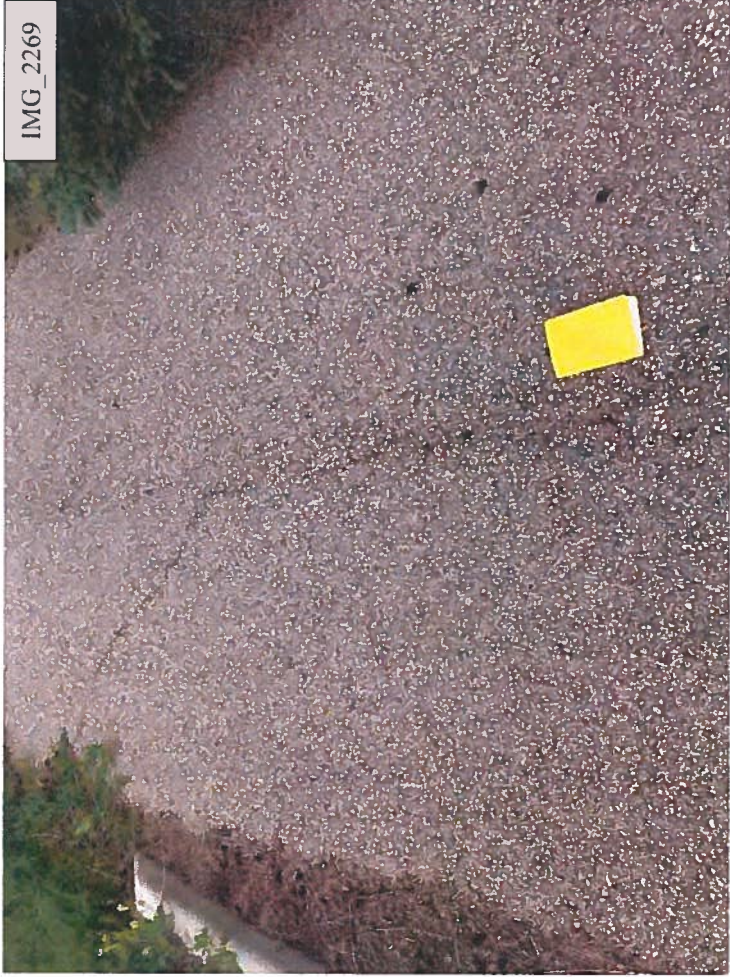
Photograph 7: Slight crack in pathway near feature G903 (waypoints 076 – 083), July 2020

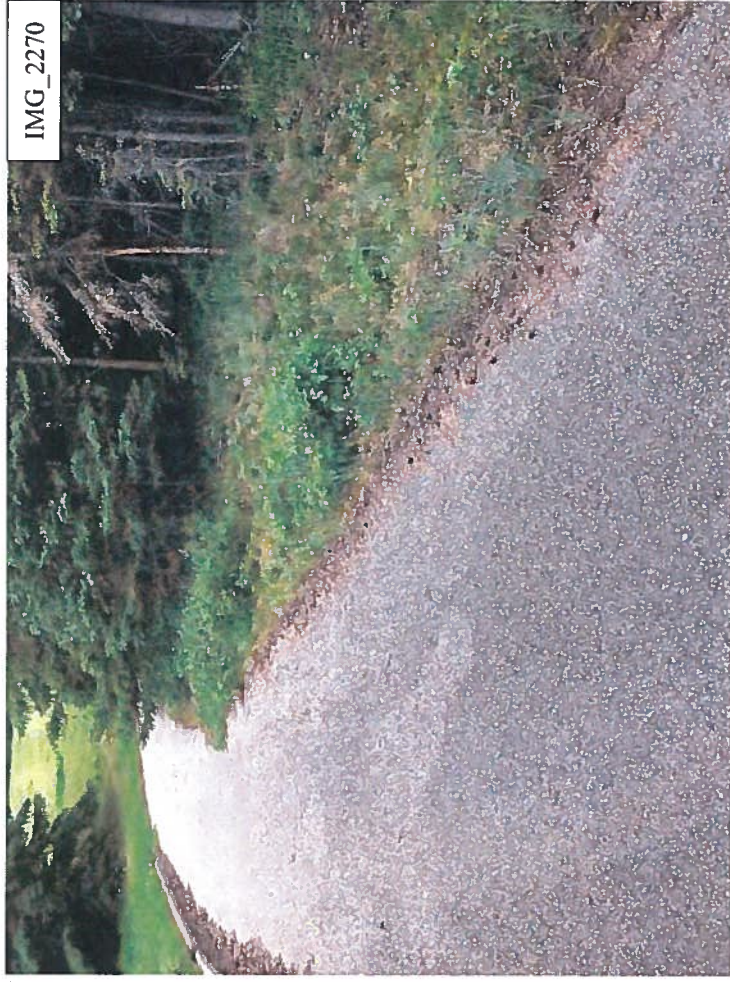
Photograph 8 : Slight crack in pathway near feature G903 (waypoints 076 – 083), July 2020

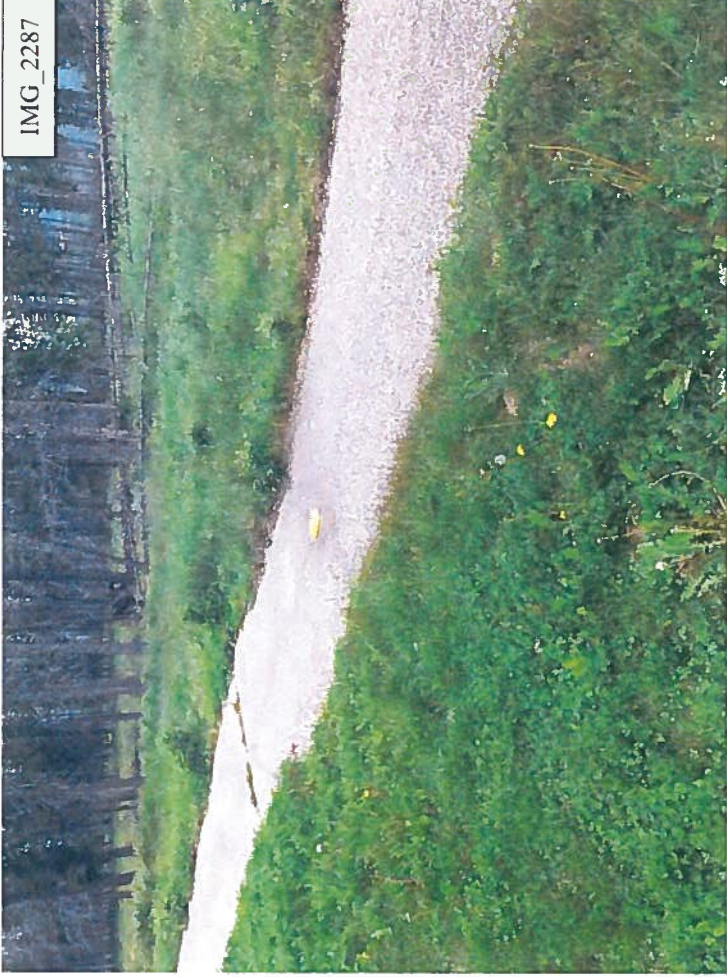
Photograph 9: Depression in area where G173 and G334 were observed in the past, Waypoint 093, July 2020

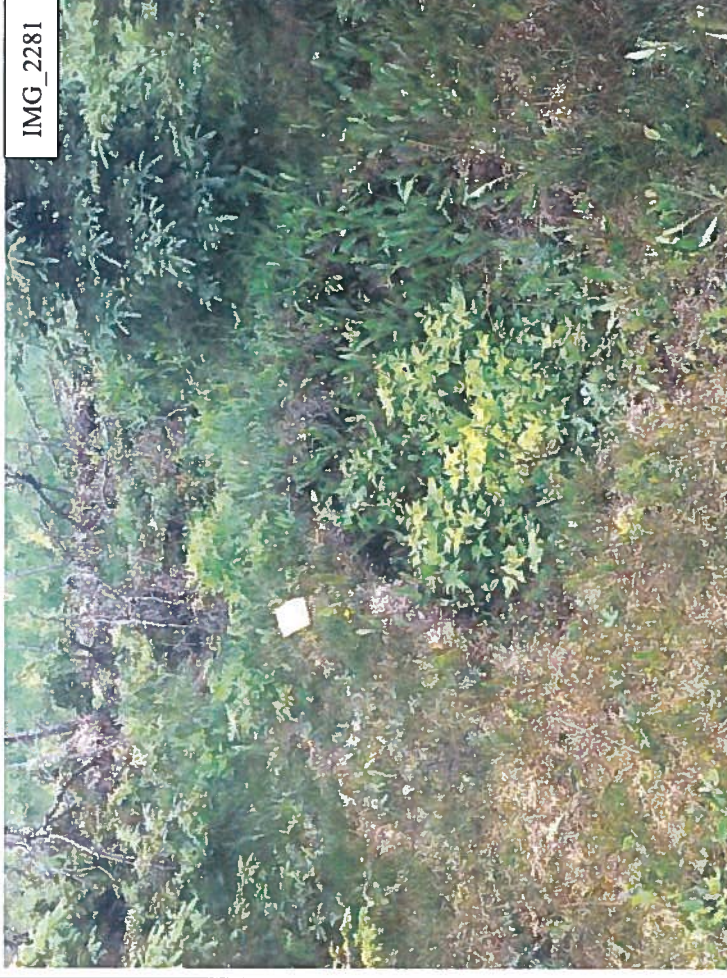
Photograph 10: 4 circular depressions, well vegetated, ~1.5 m in diameter, 0.6 m deep, Waypoints 088 - 091, July 2020

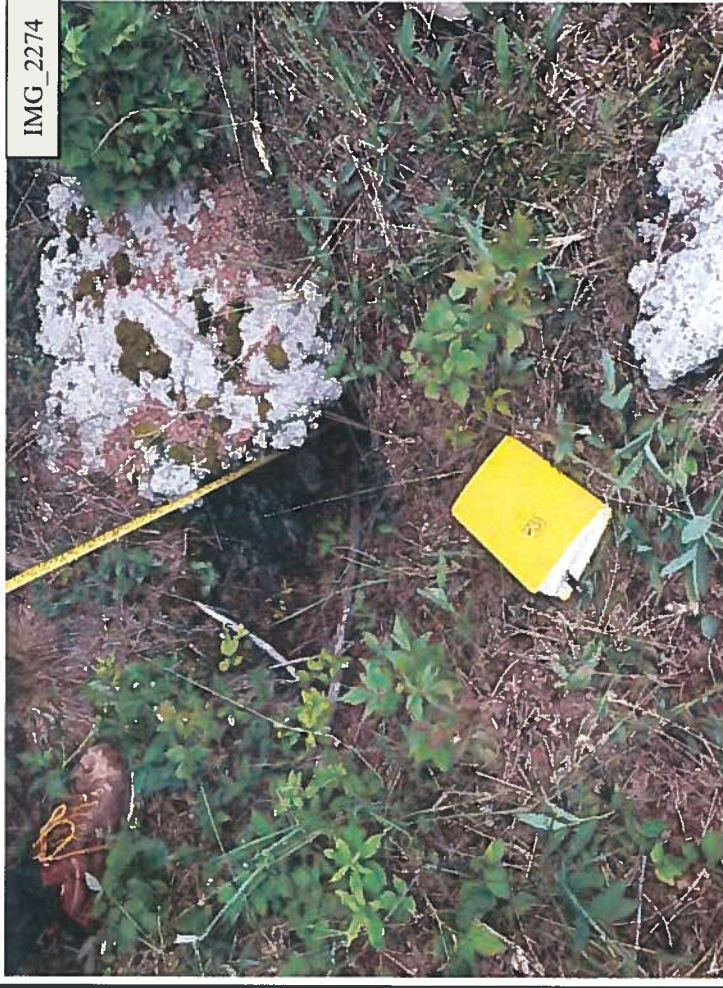
Photograph 12: Feature G902, Waypoint 083, July 2020

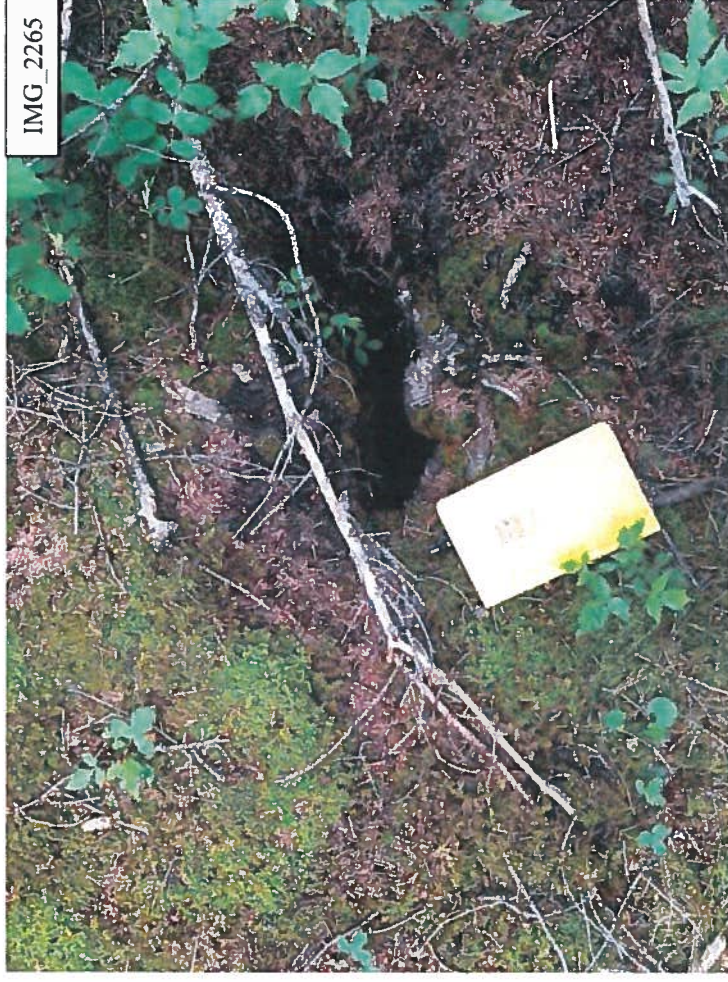
Photograph 14: Numerous small holes appear to be in line, Waypoints 076 - 081, near Features G165, G167, and G177, July 2020

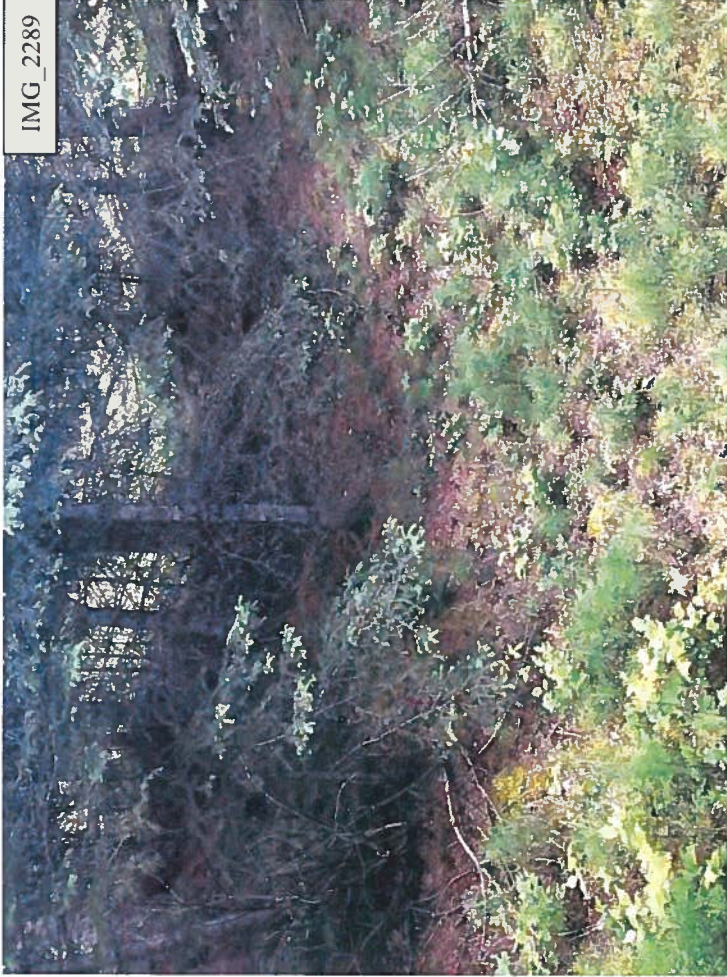
Photograph 15: Depression in area where G136 was observed in the past, Waypoint 094, July 2020

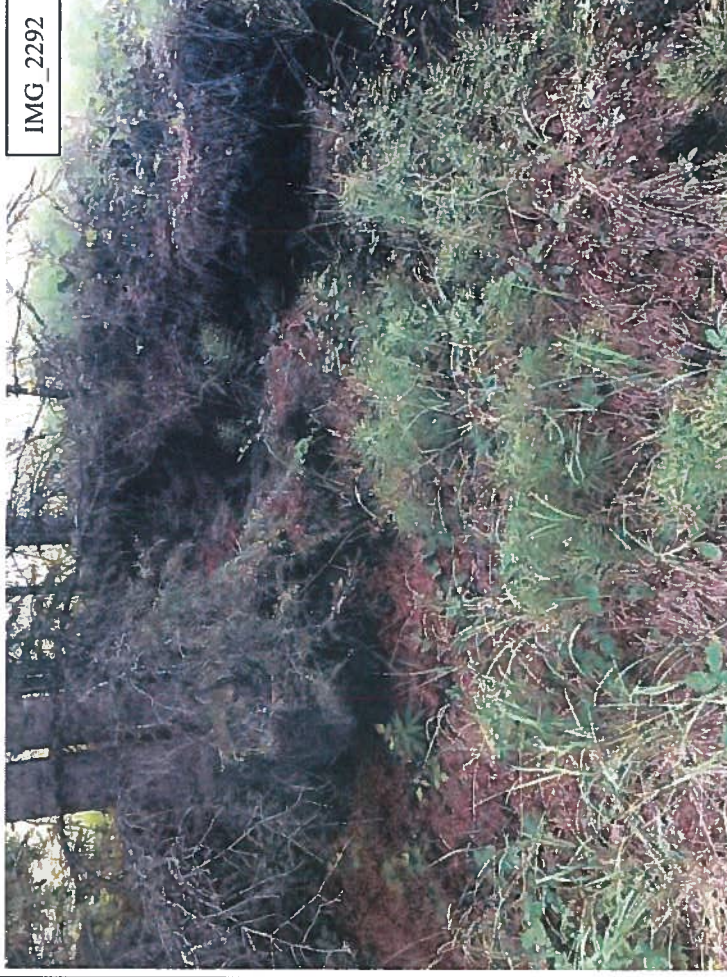
Photograph 16: Depression in area where G136 was observed in the past, Waypoint 094, July 2020

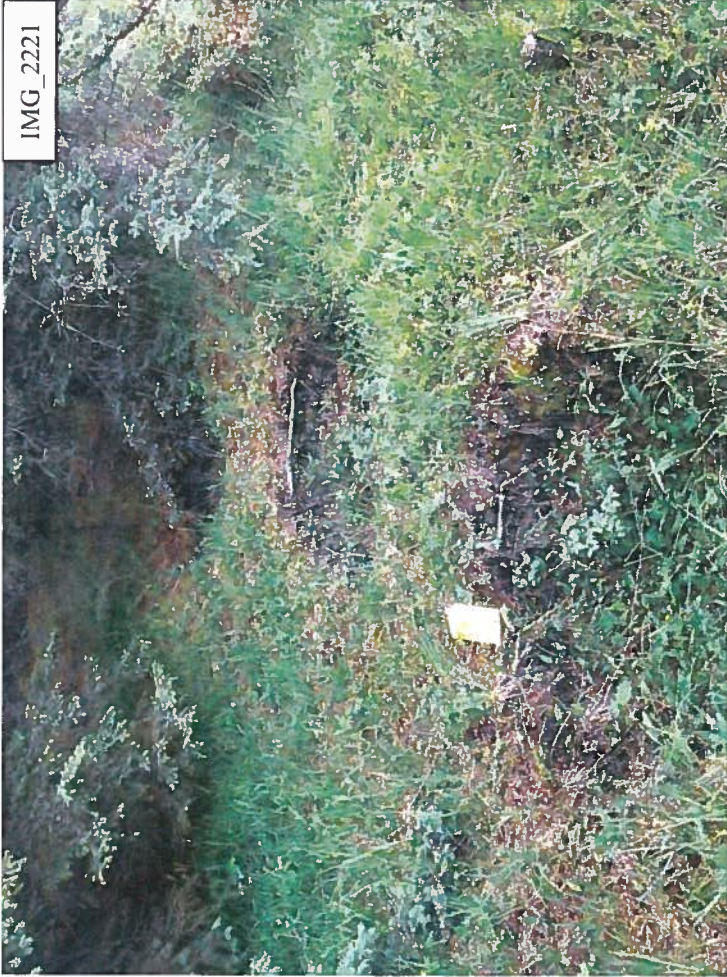
Photograph 19: 3 pit features observed, 1 m in diameter, 0.5 deep, Waypoint 054, July 2020

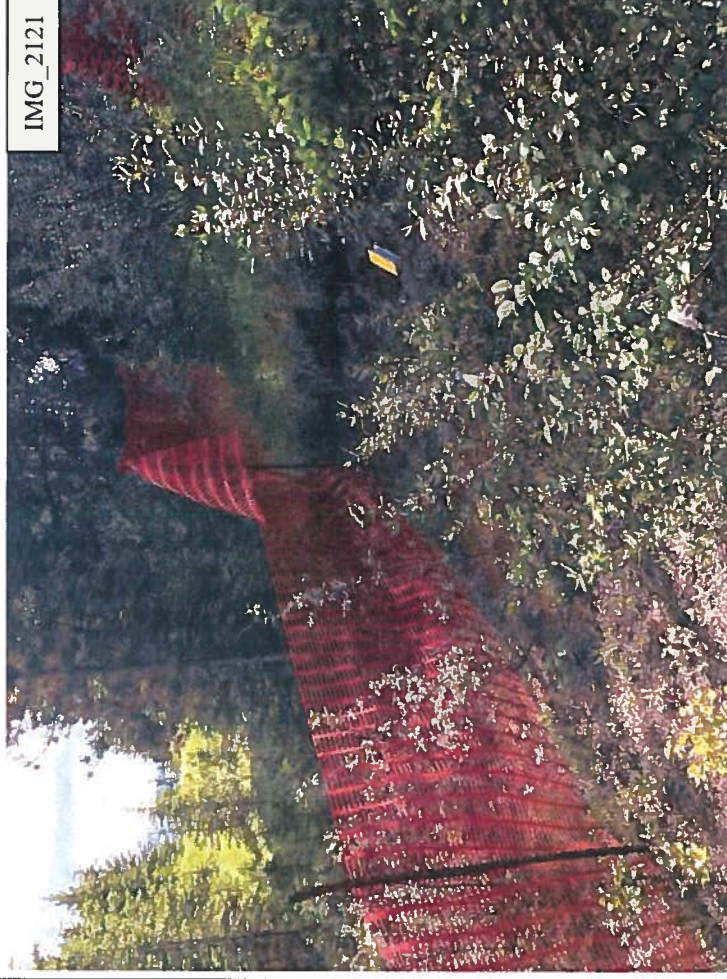
Photograph 26: Feature #75 in fenced off area, Waypoint 010, June 2020

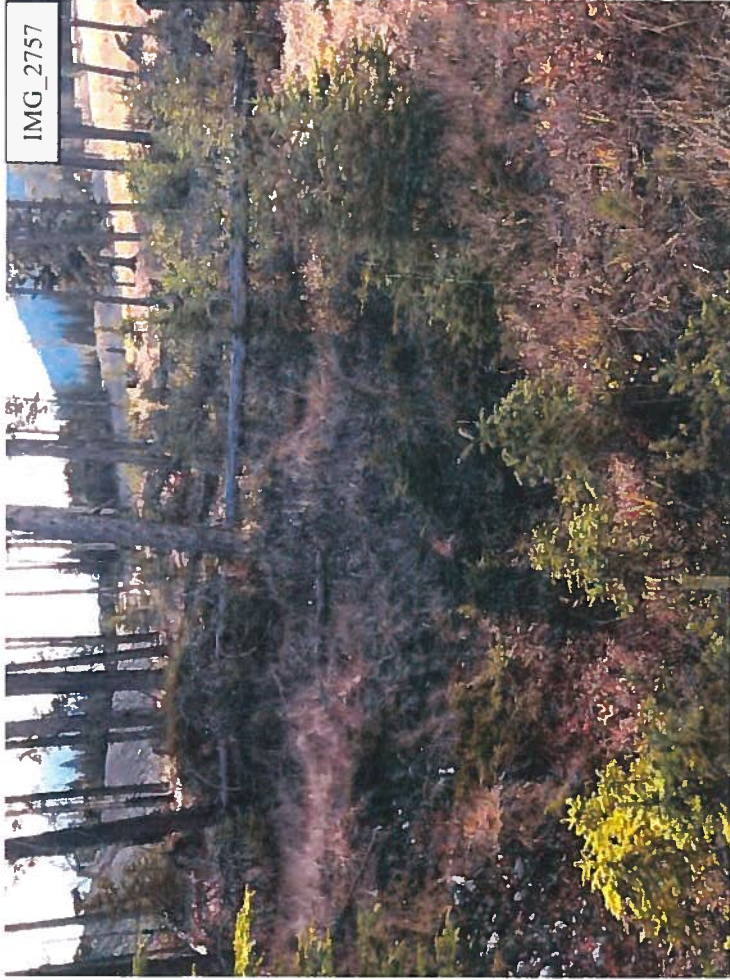
Photograph 29: Depression at Waypoint 133, September 2020

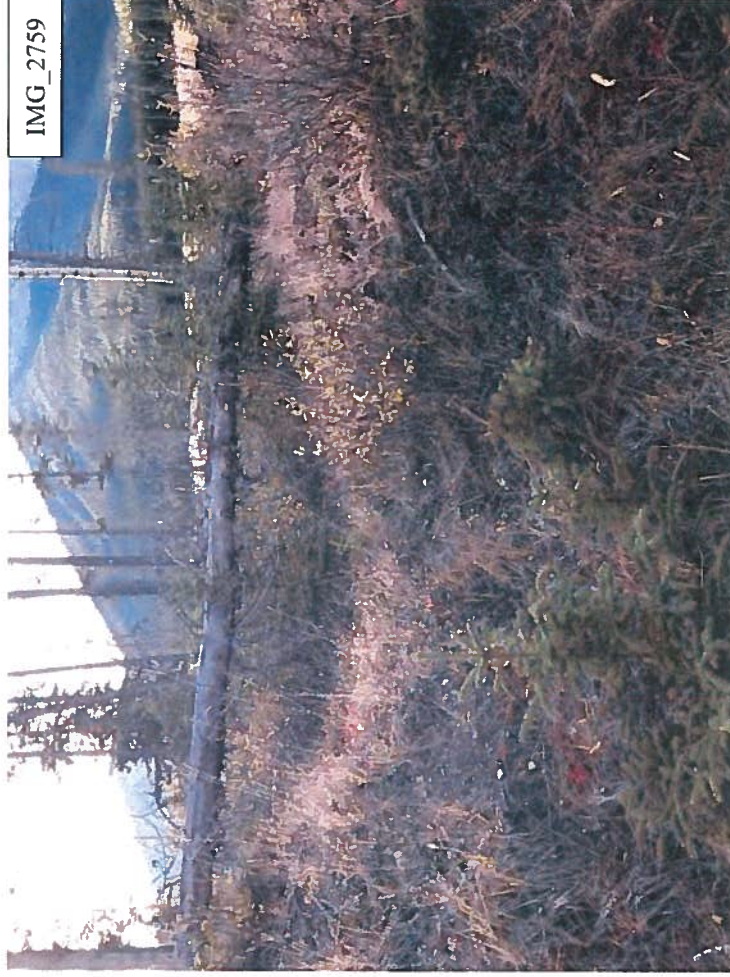
Photograph 30: Depression at Waypoint 134, September 2020

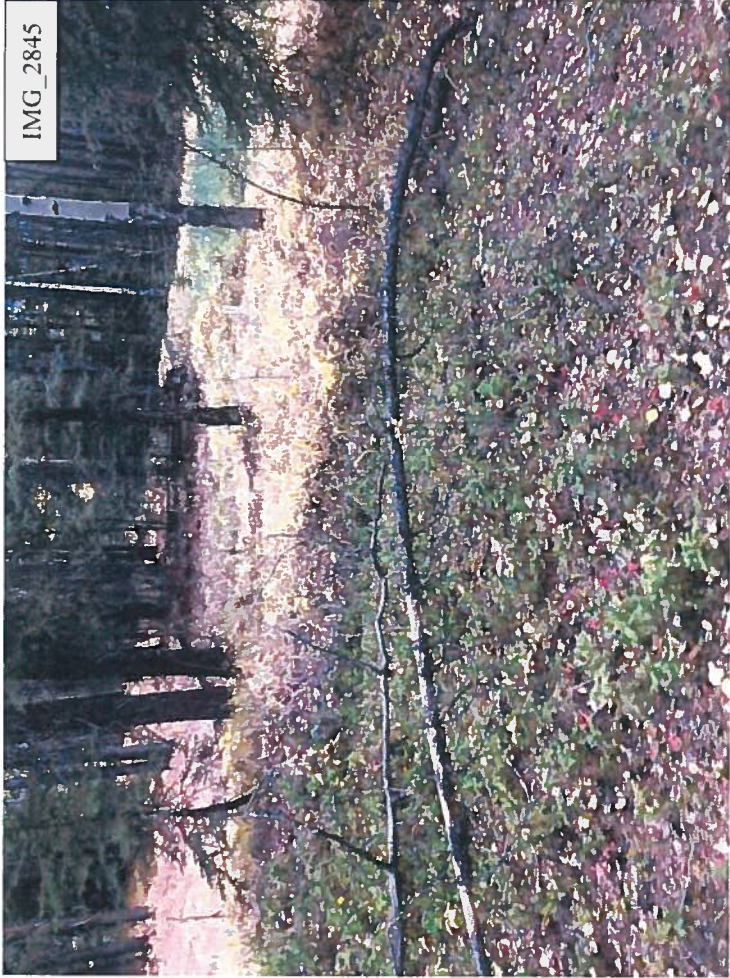
Photograph 39: Known shaft location with settlement at Waypoint 144, September 2020

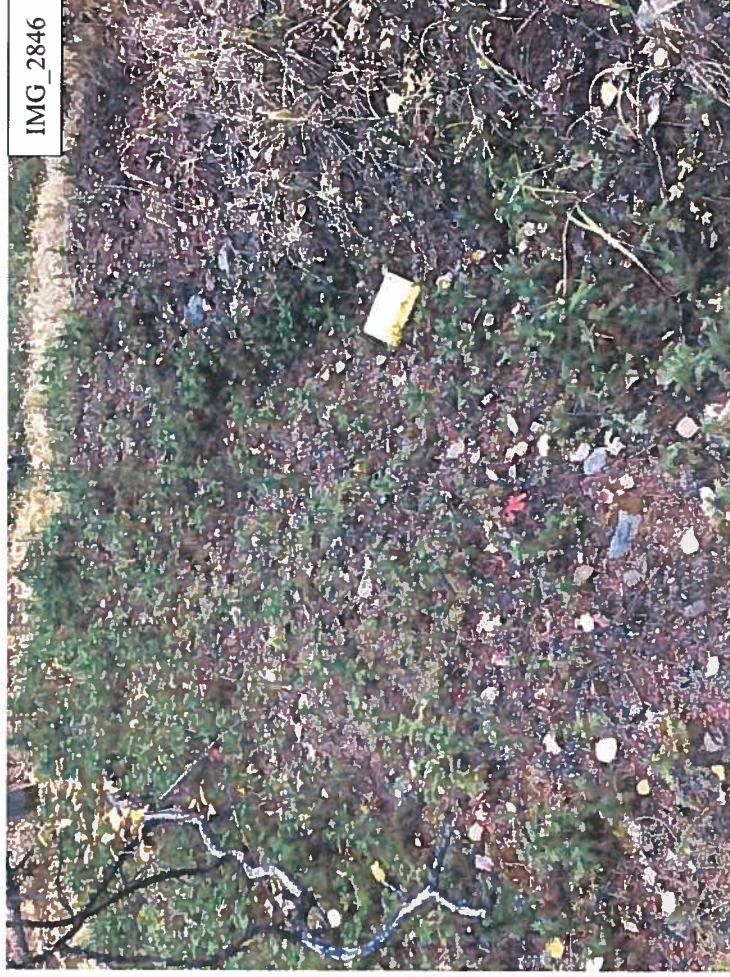
Photograph 40: Known shaft location with settlement at Waypoint 144, September 2020
