## Canmore Bow River Pathway Geotechnical Investigation

24 June 2022

**ISL Engineering & Land Services Ltd.**  
Canmore Bow River Pathway  
Geotechnical Investigation  
Canmore, AB

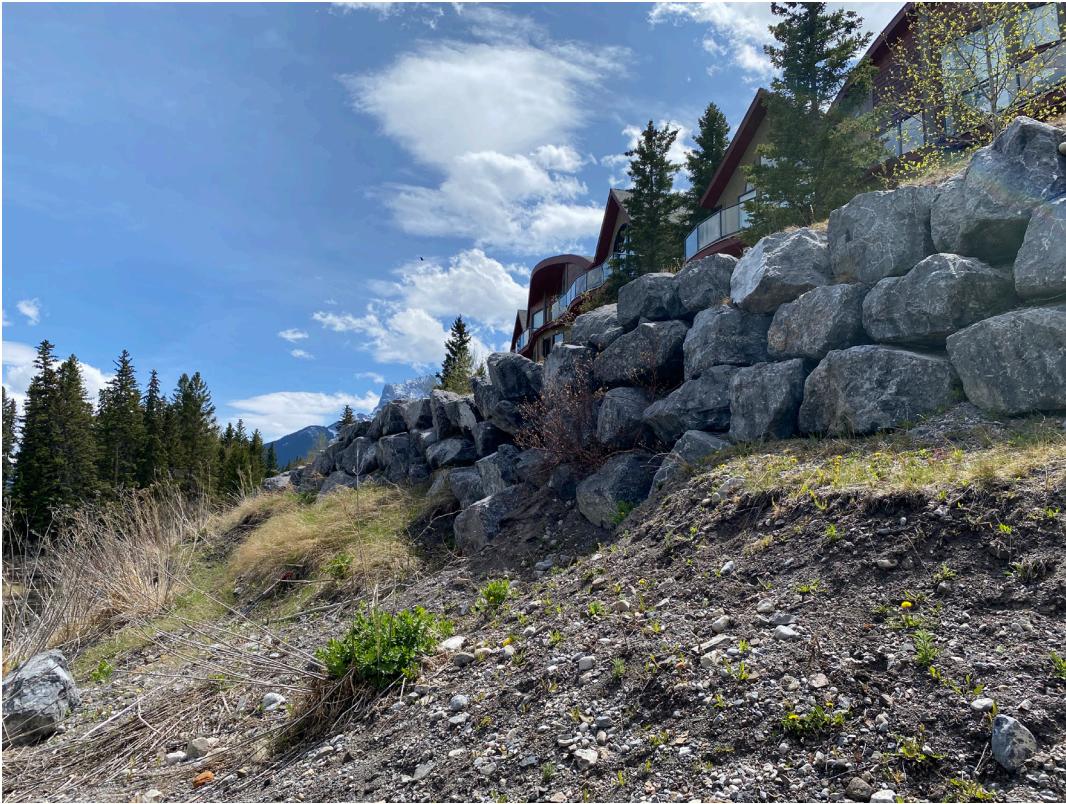
The base of the retaining wall was easily hand augered to 0.5 m, indicating the soil was very loose. This could lead to excessive movements of the boulders due to settlement or frost action. As well, it could make the subgrade susceptible to erosion. A competent base should be prepared to have long term performance

of the retaining wall. The Photograph 1 and Photograph 2 shows the base of the retaining wall where erosion and seepage have caused the movement of the base.

**Photograph 1**  
Base of retaining wall facing East

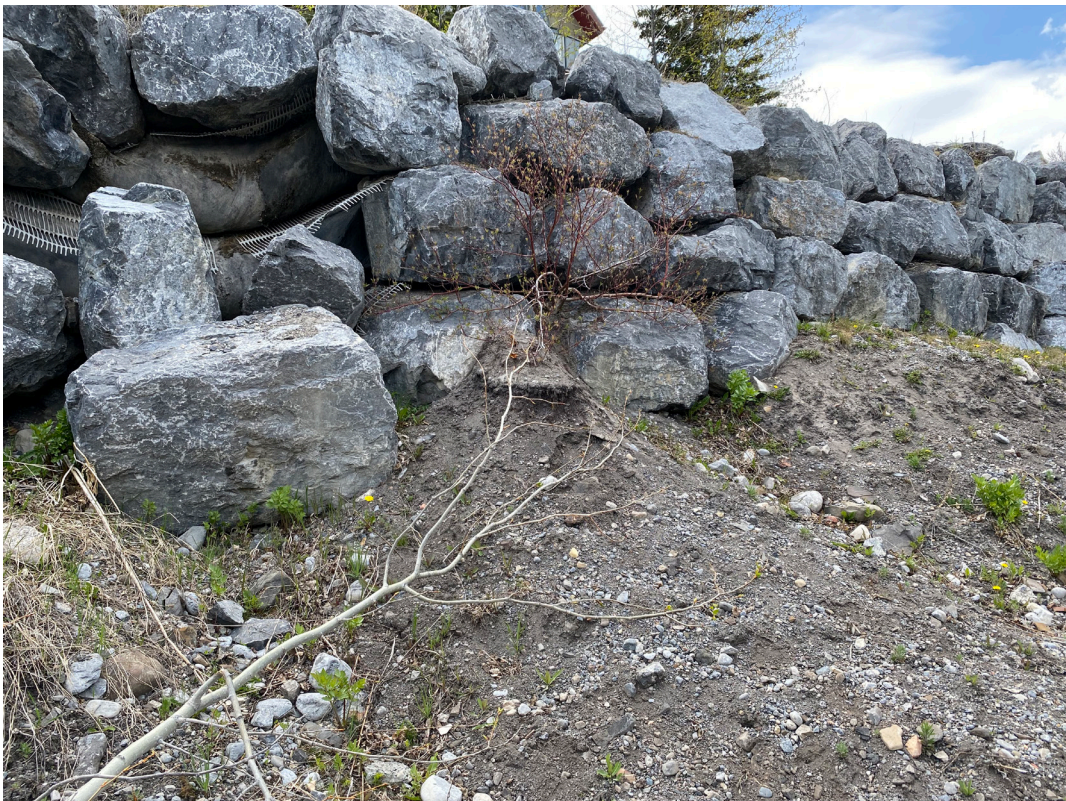
**Photograph 2**  
Base of retaining wall facing at the failed section

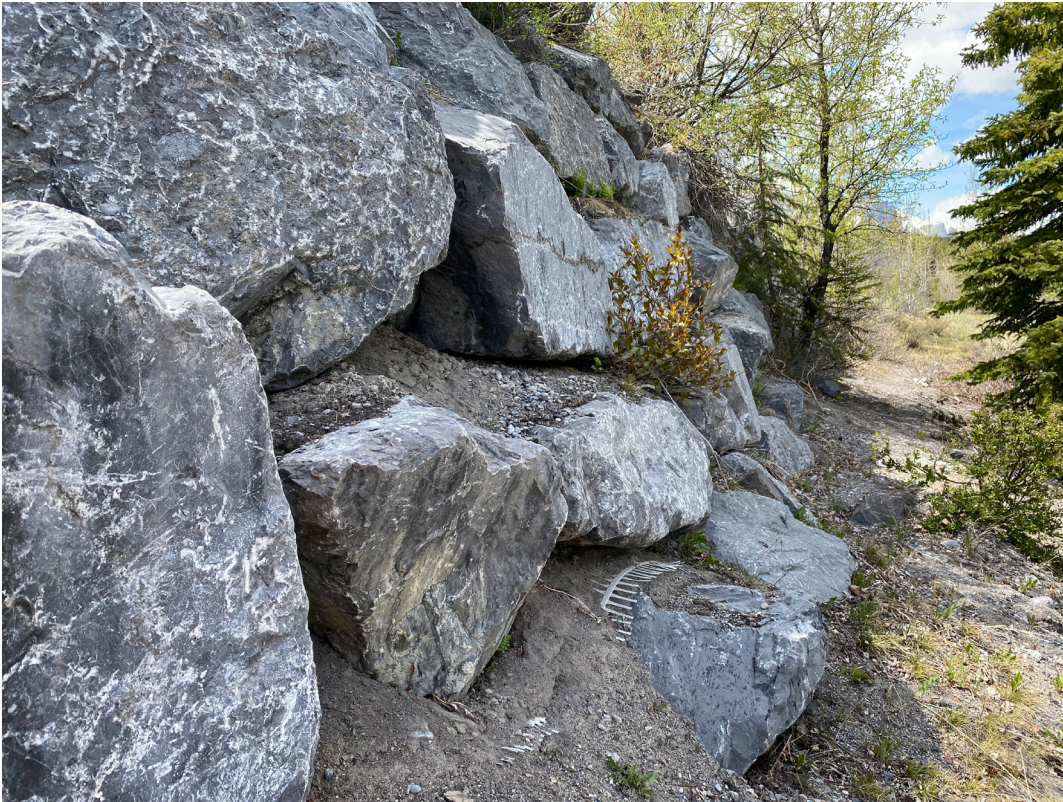
**Photograph 3**  
Washed out fines from the retaining wall

For both systems, proper drainage through the wall is essential. This will reduce the hydrostatic pressure behind the wall and will reduce the potential for erosion of the backfill.

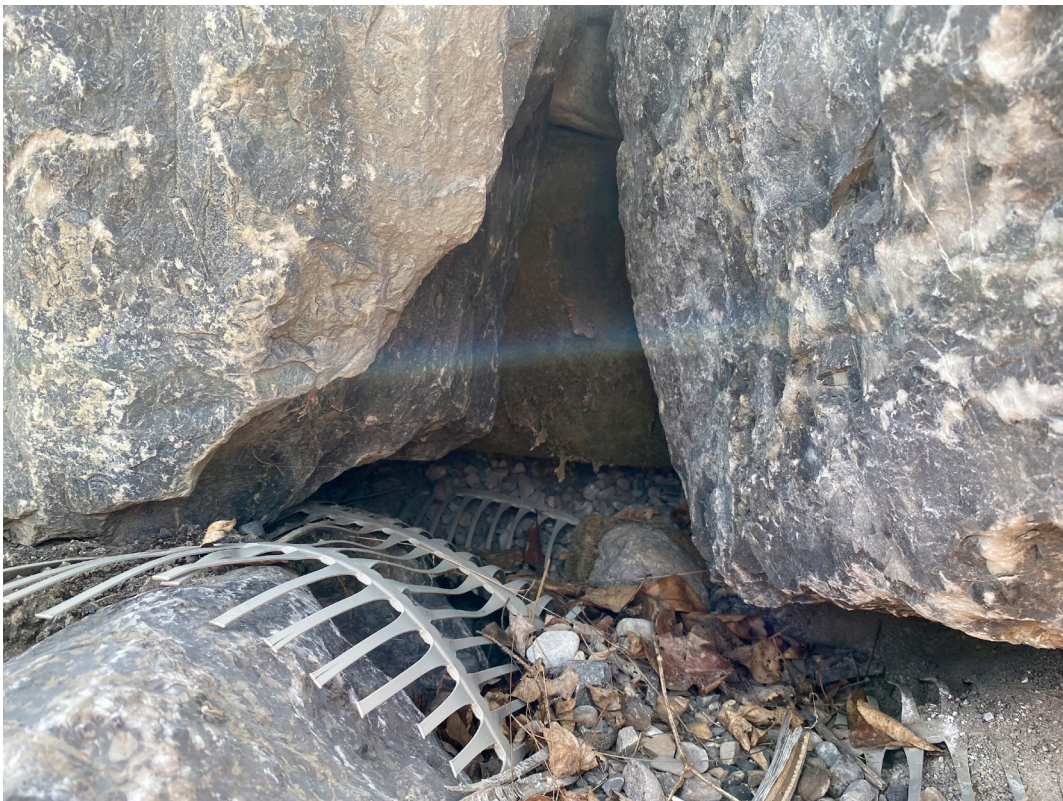
**Photograph 4**  
Close up of the retaining wall

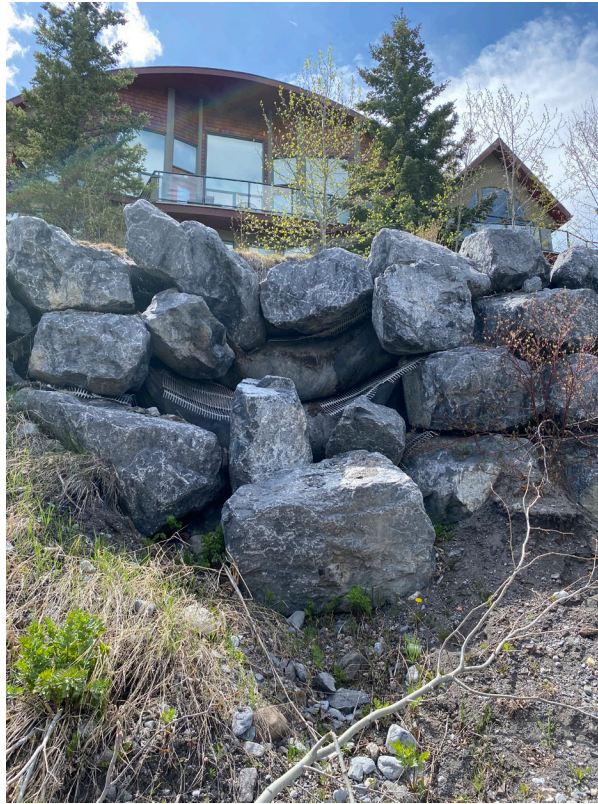
**Photograph 5**  
Failed retaining wall section

The site is very limited due to the river to the north and the residential houses to the south. A cantilever wall may provide better stability as the retaining wall foundation base can be designed to have an extension or to be buried deeper to provide additional support. If an MSE wall is proposed, a detailed analysis of the retaining wall is recommended prior to the design to see if the site has enough space for the reinforced soil mass.

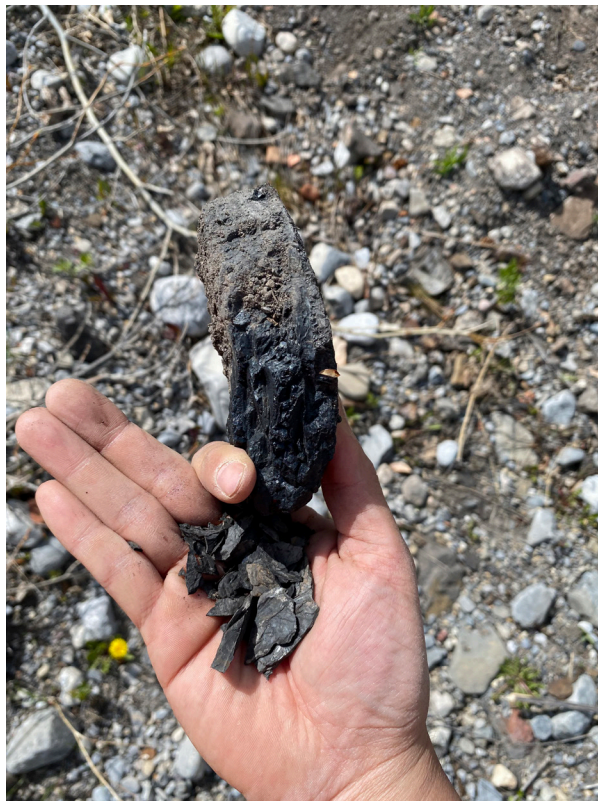
In BH22-05, 0.3 m and 1.4 m thick coal layer was encountered. Coal fragments were found at the base of the retaining wall during the site visit. The coal layer is compressible and can easily decompose. Therefore, if the retaining wall was founded in the coal layer, this may have further reduced the stability of the retaining wall over time.

**Photograph 6**  
Coal fragment at the base
