February 3, 2022

Project Number: 2021-133

**RE: Retaining Wall Condition Assessment
Below Prospect Heights in Canmore AB**

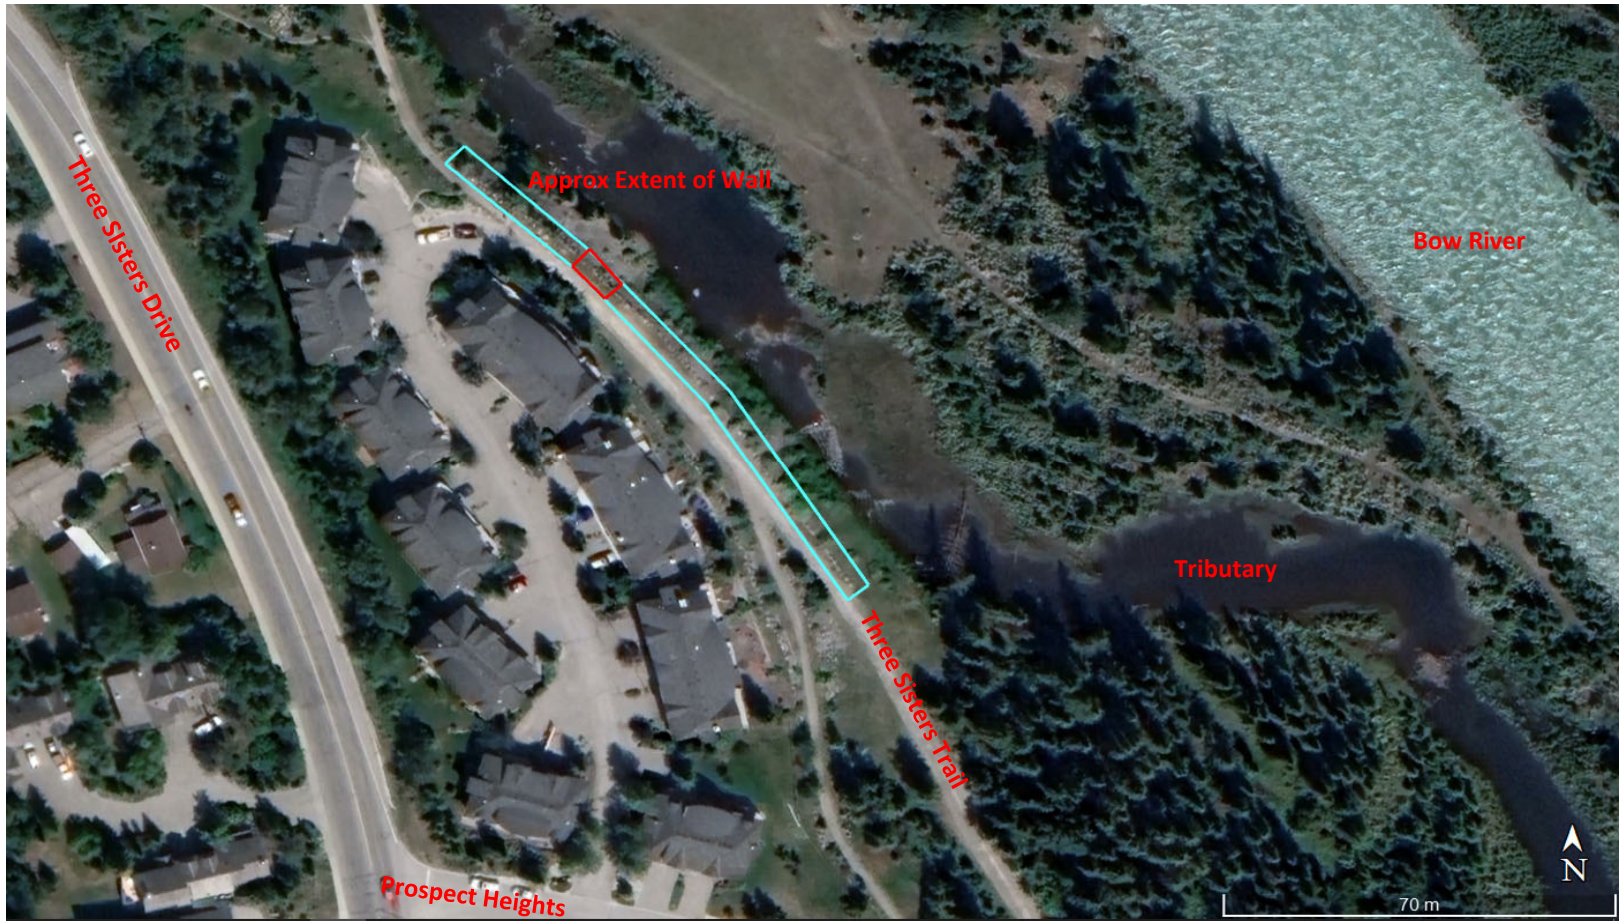
PROJECT:		
Prospect Heights Retaining Wall		
TITLE:		
Location Plan		
PROJECT #:	2021-133	FIGURE:
		2
REV.:	0

ToC has identified one section of the wall that has failed and is of main concern. The identified failure is outline in red in Figure 2. It is understood that the ToC requires a detailed assessment of the retaining wall to determine the likely failure mechanism and to recommend a repair strategy. ToC would also like to understand the potential for further failure across the length of the wall.

- The area of failure identified by ToC, as highlighted in Figure 2, has experienced loss of at least one rock unit from the middle of the wall.
 - A boulder of approximately 1.5 m by 0.7 m has fallen out of the wall, coming to rest approximately 2 m down slope of the wall. See Photo 5 for reference. The loss of the unit has caused the overlying units to shift and rotate inward. See Photo 6 for reference.

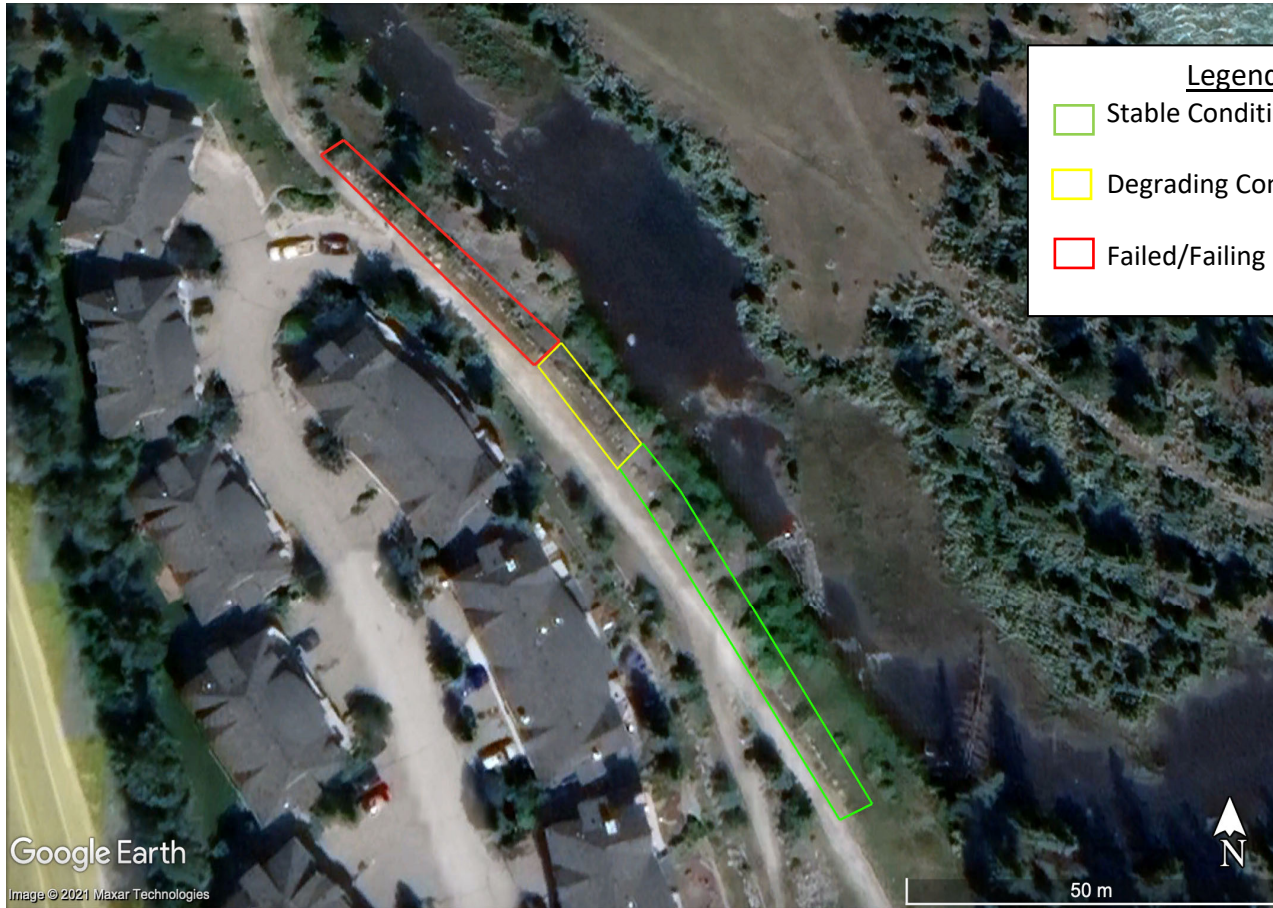
PROJECT:	Prospect Heights Retaining Wall		
TITLE:	Zones Identification Based on Stability		
PROJECT #:	2021-133	FIGURE:	3
			REV.: 0

The retaining wall can be divided into three zones: failed or expected to fail in the short term, experiencing distress or degradation (i.e., material migration), and generally stable. An approximation of the three zones can be seen in Figure 3, identified in red, yellow, and green respectively.

The northern segment of the retaining wall, including the existing failed area, is experiencing movement. It is expected that active earth pressure acting on the back of retaining wall has exceeded the capacity of the wall. The excess earth pressure is causing the lower boulder units to shift forward, and subsequent movement of the above boulders. As larger void space develops between the rock units, the geofabric material containing the backfill soil experiences loss of support and is more exposed to environmental factors which cause accelerated degradation to the geofabric. As such, migration of the backfill material occurs. On-going migration of the backfill results in further movement of the boulder facing units.

The southern half of the wall is in a more stable condition. This is likely attributed to its lower height, as it's therefor retaining a lesser volume of soil. Correspondingly, lower active earth pressures are applied to the structure.

Based on the results of the investigation, it is Taylor's opinion that the retaining wall has failed and will continue to experience movement including failure within the identified red and yellow zones along the length of structure if remedial measures are not implemented. The segment of structure in the "red zone" identified in Figure 3 is considered unstable in its current configuration. Replacement of the structure is required for the overlying pathway to remain in use. Within the "yellow zone", it is expected that failure will continue to accelerate through in a short time period (i.e., around 5 years). ToC can consider staging the replacement of the retaining wall. This would include replacement in the red zone and ongoing monitoring of the yellow zone with time until replacement is required. Replacement of the "green" zone isn't anticipated. However, periodic monitoring of the structure should continue.

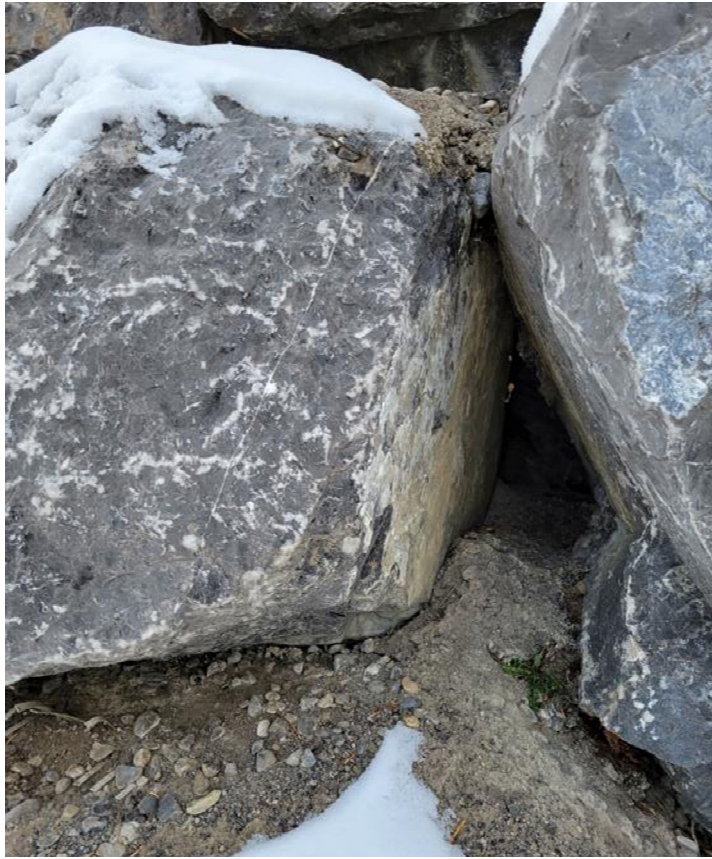
- The northern segment of the retaining wall, north of the identified failure location as outlined in red in Figure 2, is showing signs of movement.
 - Sand and gravel material was observed to have migrated through various voids in the wall and at the toe of the wall. See Photo 1 for reference.

- The geofabric within the retaining wall appears to have reached or exceeded its capacity and is bulging, allowing material to mobilize from behind the wall. Localized tears in the geofabric were observed.

Photo 1: Material deposition between rock units on north segment of wall.

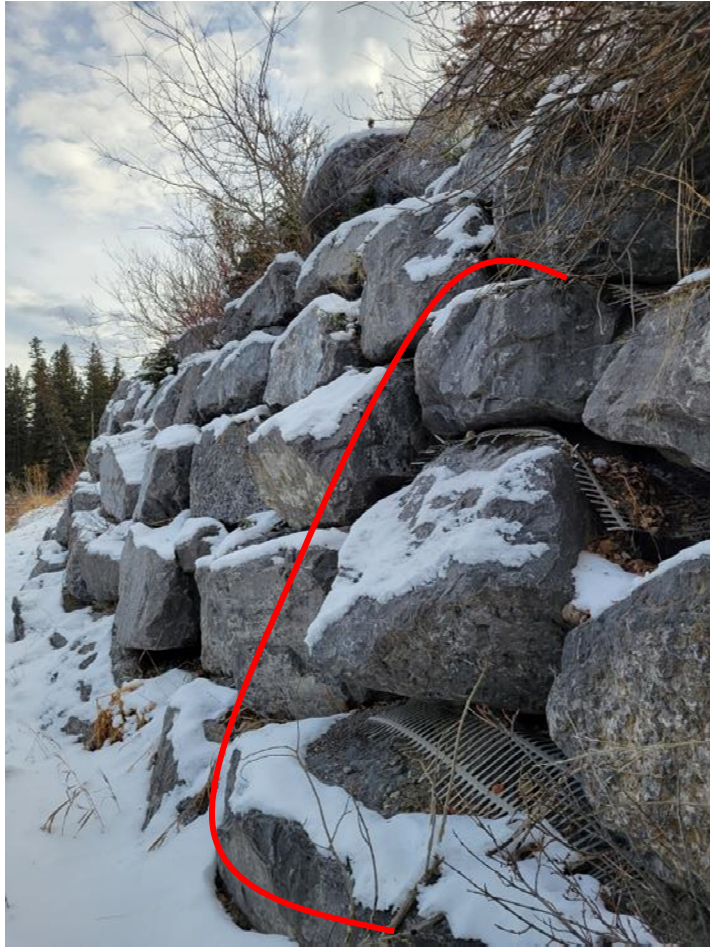
- Rocks within the wall appear to have shifted, creating a bulge-like feature as identified in Photo 2.
 - Various boulder sized rocks are present on the slope and in the tributary, which are believed to be sourced from within the wall. See Photo 3 for reference.

Photo 2: Shifting of rock units creating bulge-like feature in wall

Notes: Photo taken near north end of retaining wall, looking approximately southeast down the wall.

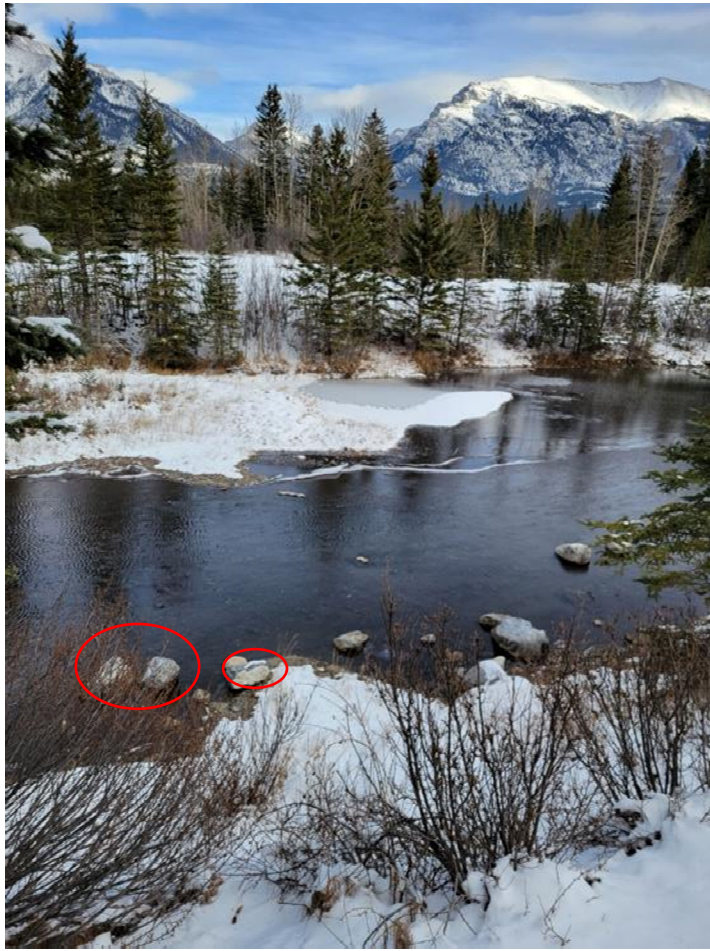
Photo 3: Select boulder sized rocks in tributary, as highlighted in red, appear to be sourced from within wall

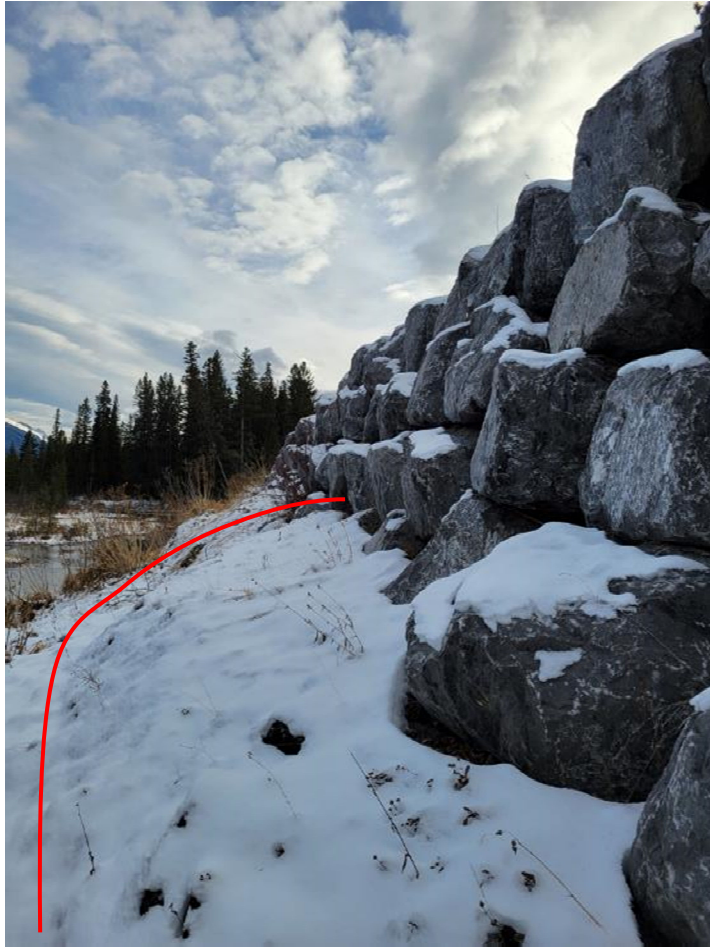
- The slope at the toe of the wall appears to have sediment build up; however, snow cover made it difficult to identify the material type and source. See Photo 4 for reference.

Photo 4: Sediment build-up at toe of wall

Notes: Sediment potentially sourced from behind wall. Photo taken near north end of wall, looking approximately southeast down the wall.

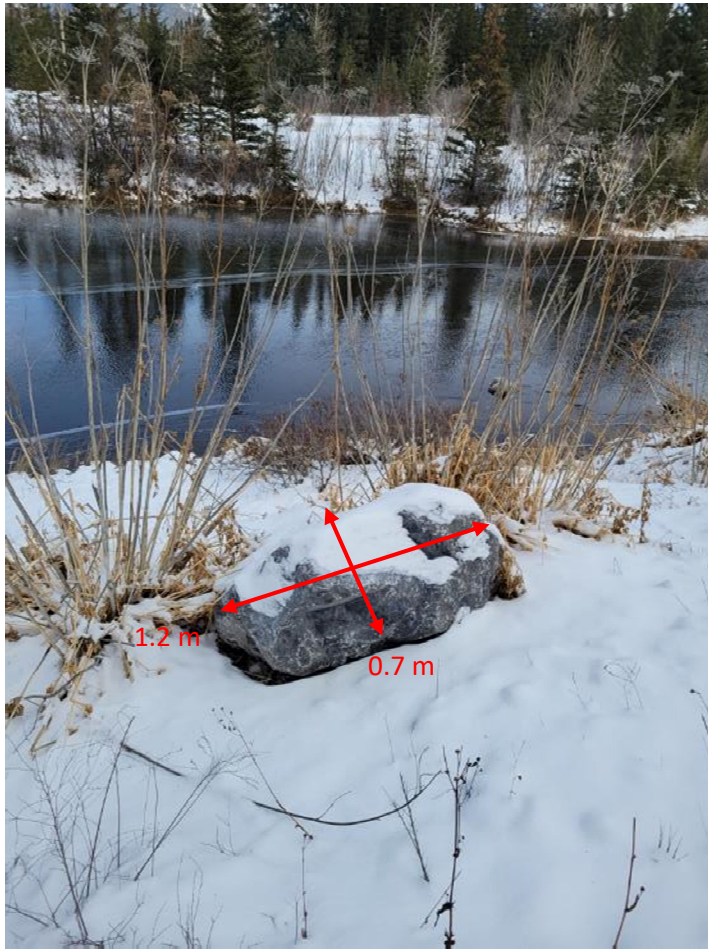
Photo 5: Boulder that fell out of wall in failure location.

Notes:
Approximately 1.2 m by 0.7 m.

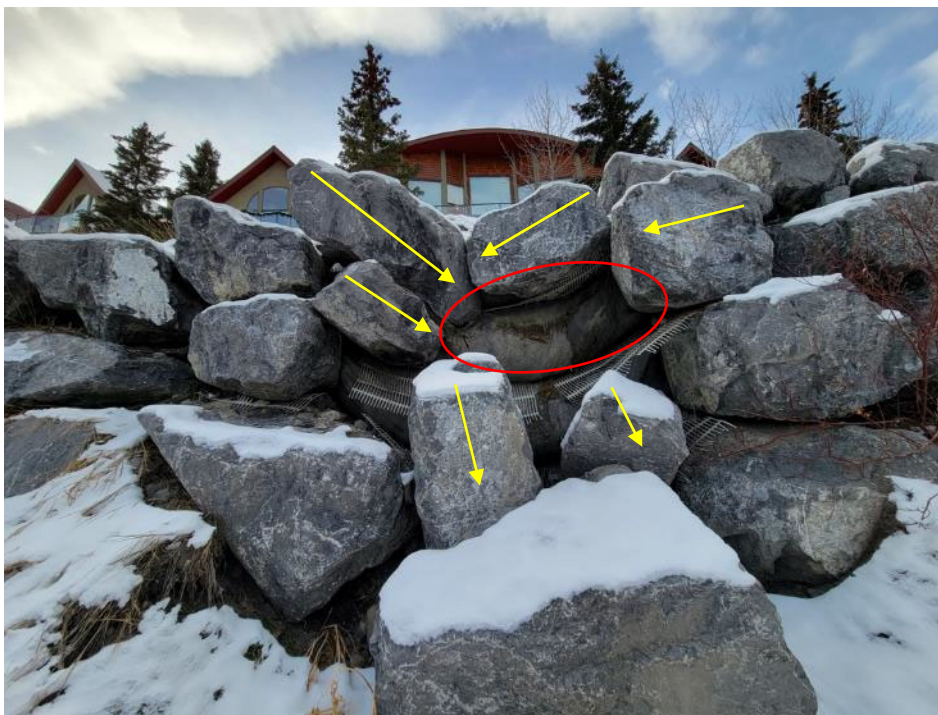
- The geofabric from behind the unit is now exposed and is the main source of support for the underlying material. The geofabric appears to be degrading.

- The loss of the unit has allowed the overlying geogrid to slump (assuming the geogrid was originally placed near horizontal).

This is apparent in the existing failed area where the earth pressures forced the lower units forward, which led to the middle unit falling out of the wall entirely. The displaced unit left a large void space in the wall, causing the overlying and adjacent units to shift and begin to overturn. Shifting of the units comprises their ability to interlock, ultimately impacting their ability to support the soil slope. The soil slope behind the void is now being supported solely by the geofabric, which is not an effective means of stabilization considering the near-vertical slope.

Photo 6: Retaining wall failure.

Notes: Large void created by boulder falling out of wall (red). Soil now being held back by existing filter fabric. Adjacent and overlying units shifting (yellow arrows showing suspected direction of movement, assuming units were placed horizontal)

It is Taylor's opinion that repair of the structure is not a feasible option. Instead, Taylor recommends the disassembly of wall followed by the construction of a new retaining wall structure. Two replacement options are recommended and are summarized below.

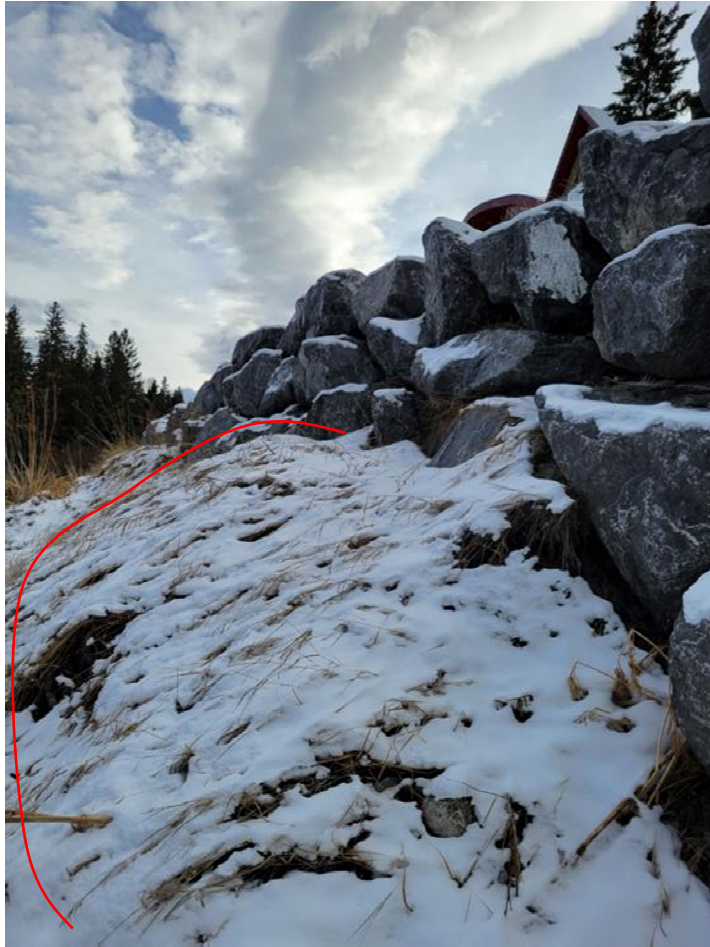
- A build-up of sediment at the toe of the wall has created a mound-like feature adjacent to the failure location. It is suspected that this material was sourced from behind or beneath the wall. See Photo 7 for reference.

Photo 7: Build-up of material at toe of wall, adjacent to failure.

Notes: Photo taken at failure location, looking approximately southeast down the wall.

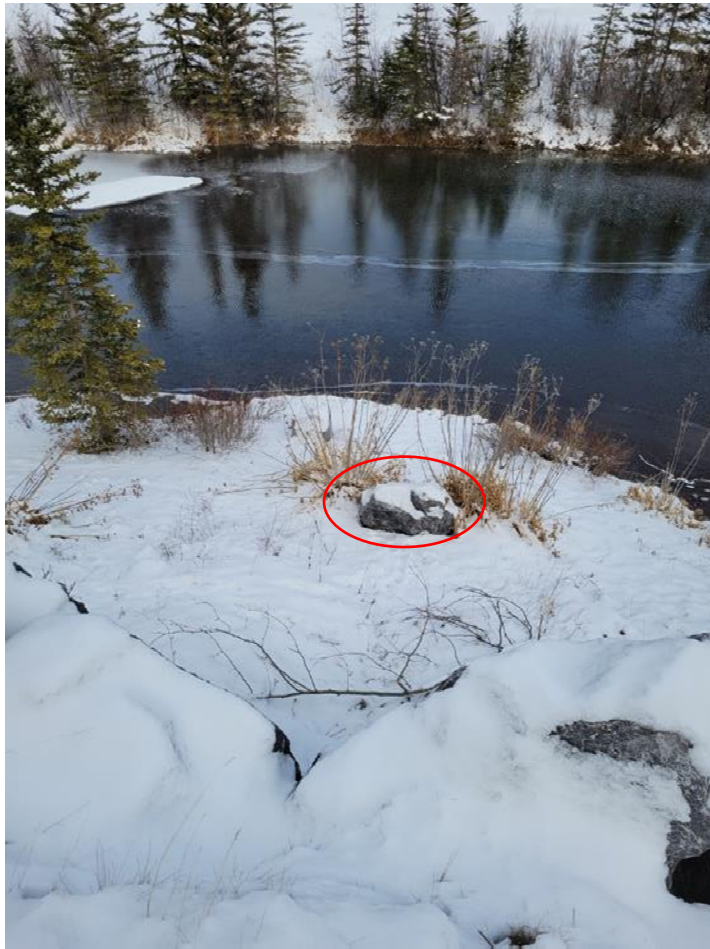
Photo 8: Location of fallen boulder relative to wall.

Notes: Photo taken standing above wall looking down.

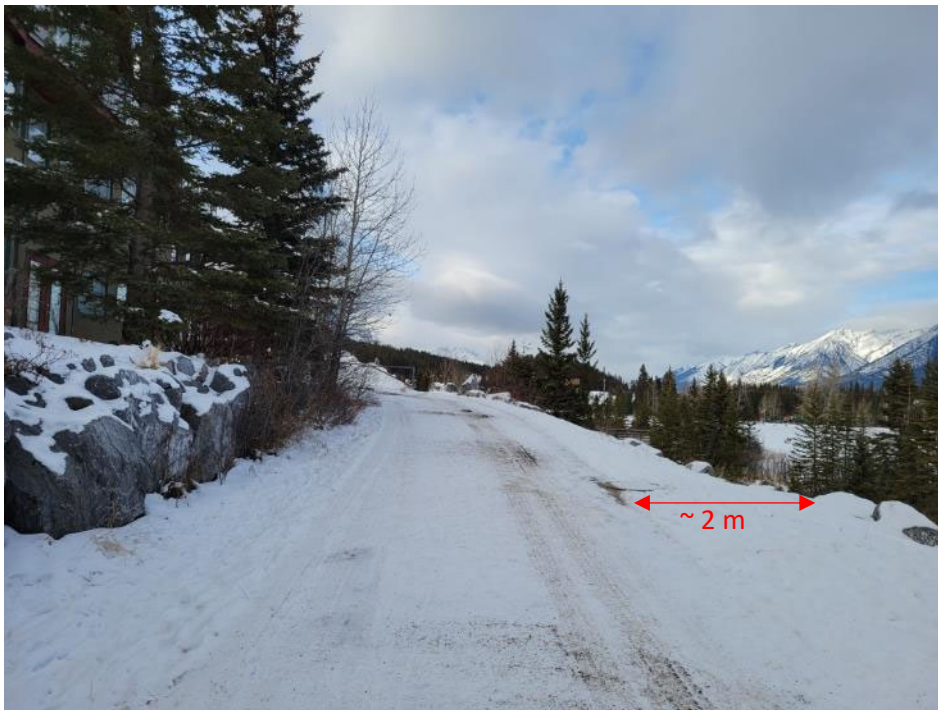
- It appears that the overlying pathway has not yet been affected by the underlying retaining wall failure. Snow cover on the pathway prevented a detailed assessment; however, no major signs of distress were observed on the pathway.

Photo 9: Location of wall relative to overlying pathway and upper retaining wall.

Notes: Pathway edge approximately 2 m to back of wall units.
