June 5, 2024

Project Number: 2024-055

**RE: Geotechnical Services for Construction Phase of Retaining Wall Replacement
Prospect Heights, Canmore, AB**

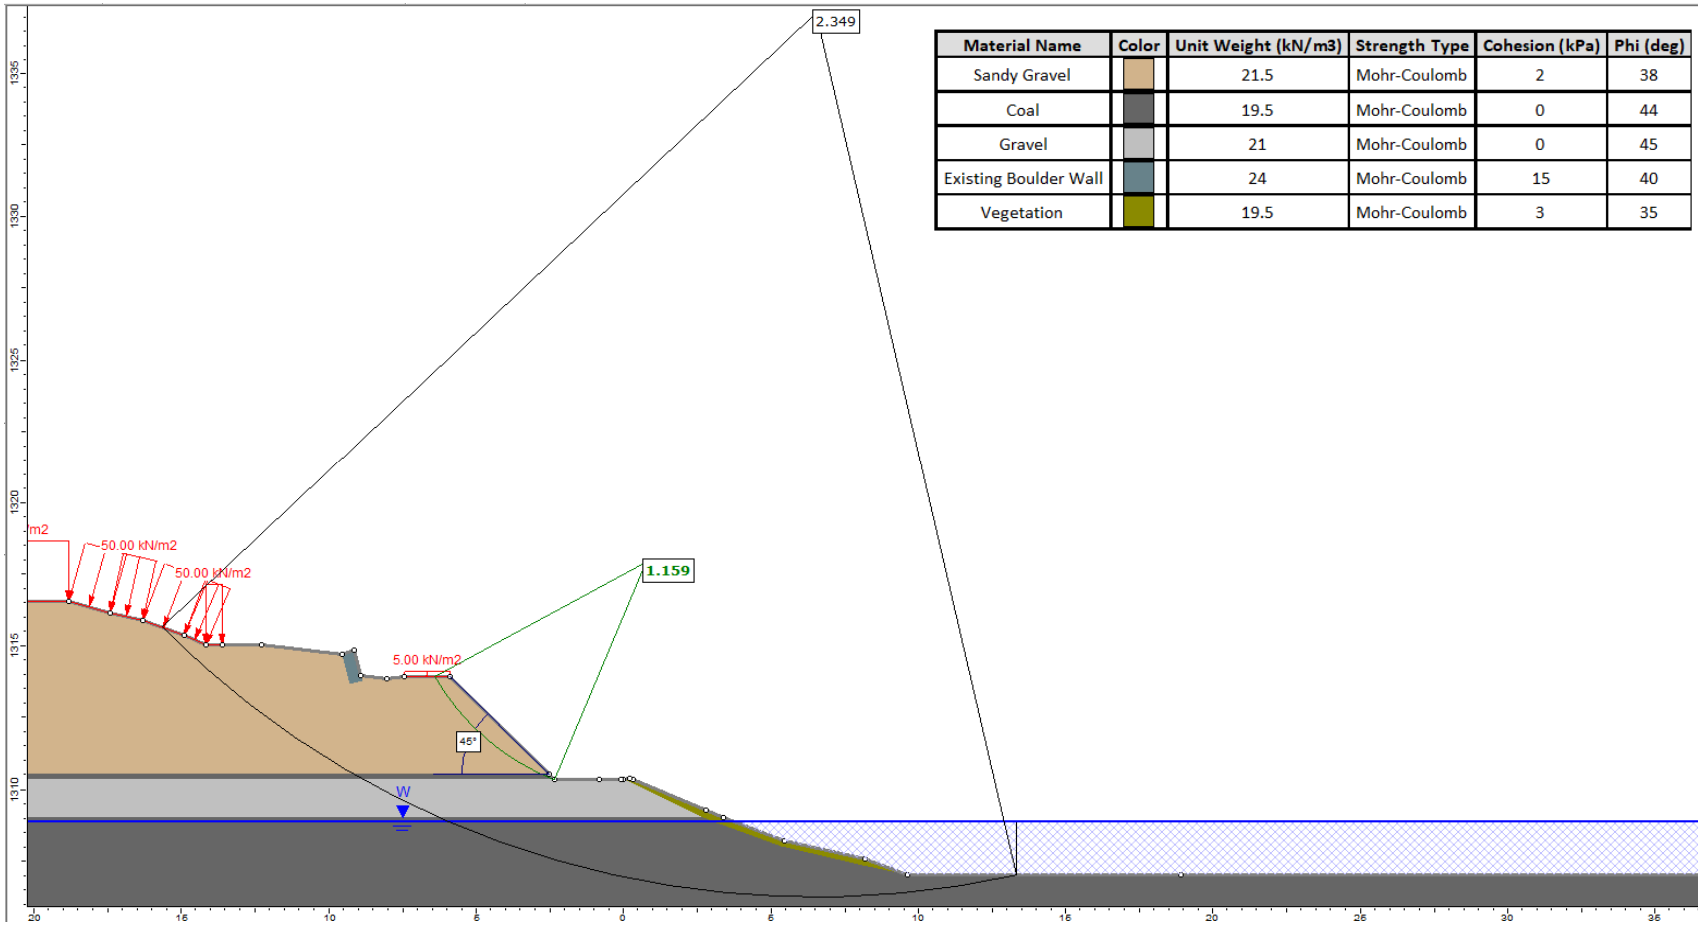
TITLE: Construction Case at Sta 30+024

Section 3, located at Station 30+024, was deemed the critical section for the construction case as the retaining wall is tallest in this location. It is understood that a construction cut of 1 horizontal to 1 vertical (1H:1V) is to be used, which was assessed in this analysis. It was assumed that the overlying pathway will remain closed throughout the duration of construction and therefore no loading was considered at the pathway location.

Section	Local FOS	Global FOS
3 (Sta 30+024)	1.16	2.35

Based on the slope stability analysis, a construction cut slope of 1H:1V is considered stable in terms of short-term performance and is therefore appropriate for construction. The cut slope does not influence the overall global stability of the slope, and the overlying infrastructure, inclusive of the condominium, is unaffected.

- A construction cut slope of 1H:1V is permitted. The pathway should remain closed throughout the duration of construction.
 - If steeper temporary excavation side slopes are required, additional geotechnical review is required.
 - Should sloughing soils or shallow groundwater be encountered during construction, excavations will need to be flattened. Additional geotechnical review is required to provide specific input on these requirements.
 - If excavations extend below the groundwater table, dewatering should be in place immediately after excavation. Dewatering should work continuously while constructing below the groundwater level. Dewatering is typically the responsibility of the contractor.

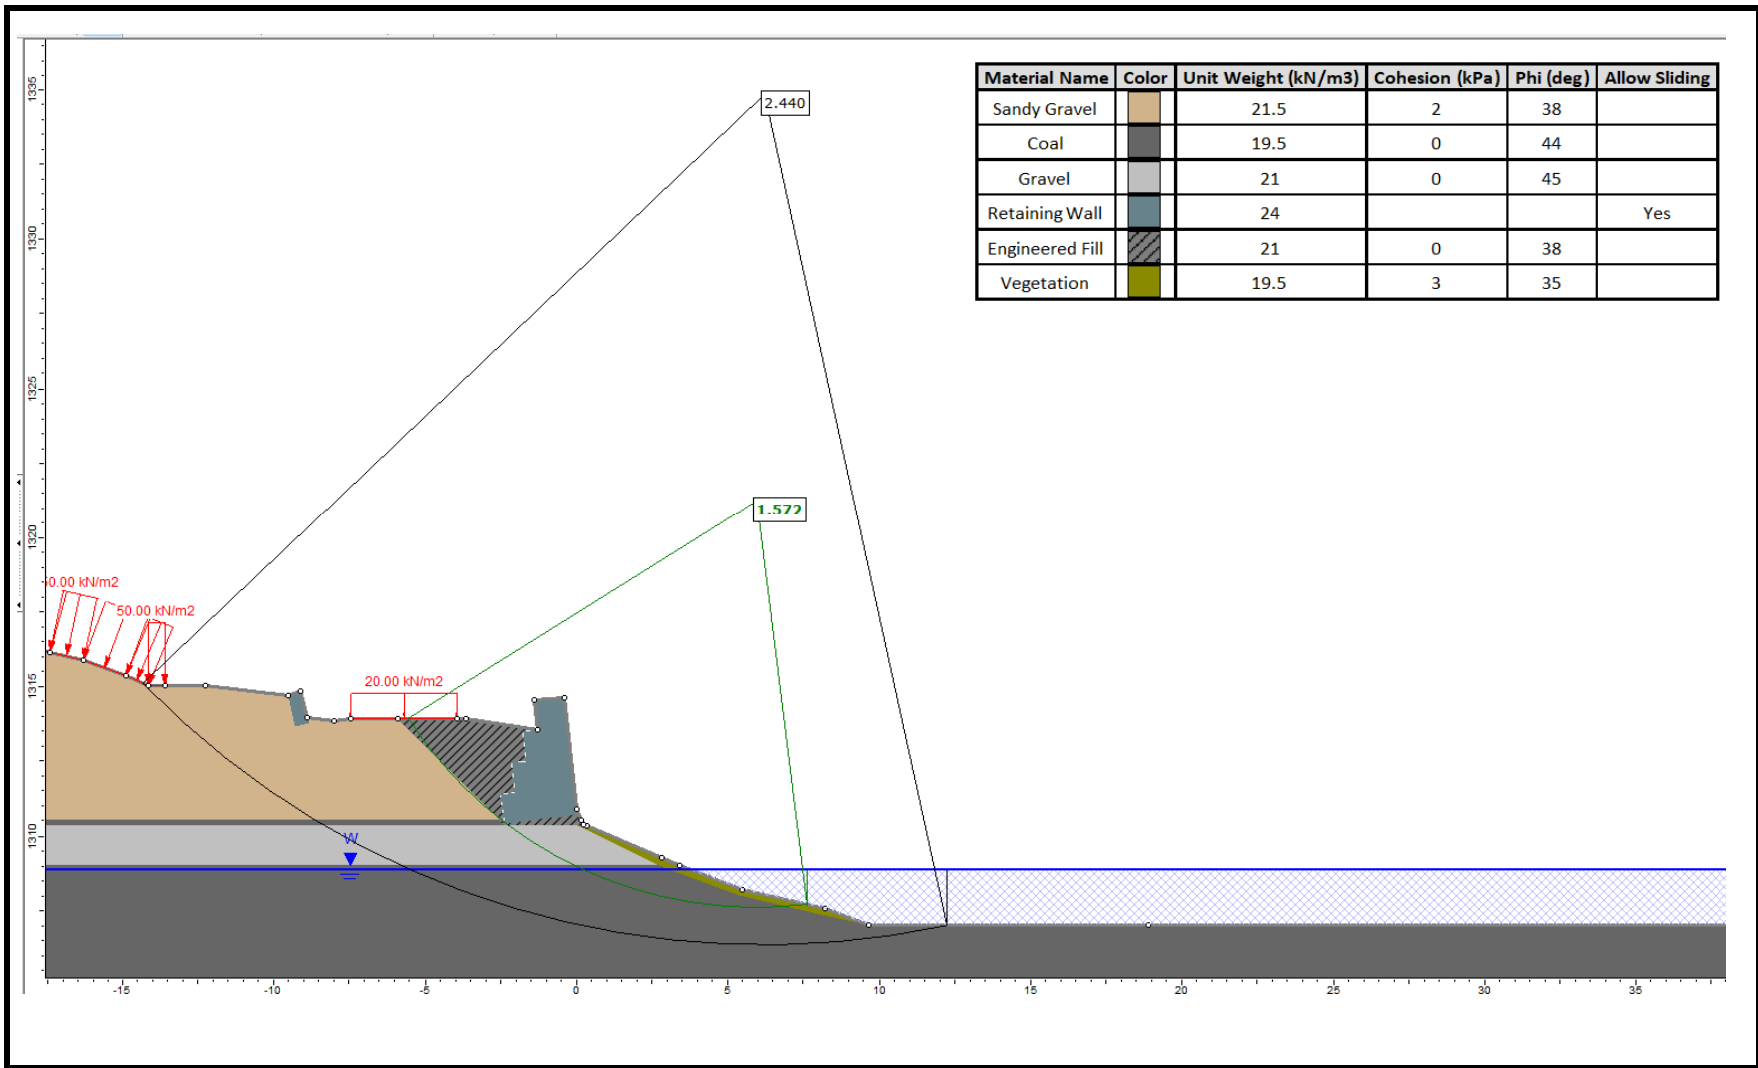
Section	Local FOS	Global FOS
3 (Sta 30+024)	1.57	2.44
1 (Sta 30+005)	1.37	2.35

Based on the slope stability analysis, the retaining wall at Station 30+024 is stable in terms of long-term performance. Additionally, the entire slope remains stable in terms of global stability at both section locations. However, the local FOS at Station 30+005 does not meet the minimum FOS criteria, with a FOS less than 1.5.

- The proposed retaining wall design located at Station 30+024 is considered acceptable in terms of local global stability.
- The proposed retaining wall design located at Station 30+005 does not meet the FOS criteria, with local global FOS less than 1.5. It is anticipated that the low FOS in this area can be attributed to the over-steepened slope located beneath the retaining wall.
- TGL recommends adjusting the retaining wall design at Station 30+005 to allow for greater embedment.
 - A revised design should consider a deeper embedment vertically into the ground surface, and/or horizontally into the sloping terrain.
 - An additional slope stability analysis should be undertaken to determine the revised design. TGL can complete this upon request.
