SUBDIVISION MINING IMPACT REPORT

THREE SISTERS VILLAGE - PHASE 1

THREE SISTERS VILLAGE – PHASE 1

PROJECT NO.: CG09140
DATE: NOVEMBER 2023

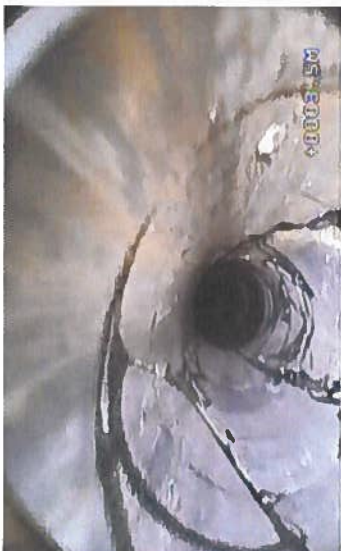
End of PVC at 3.0 m

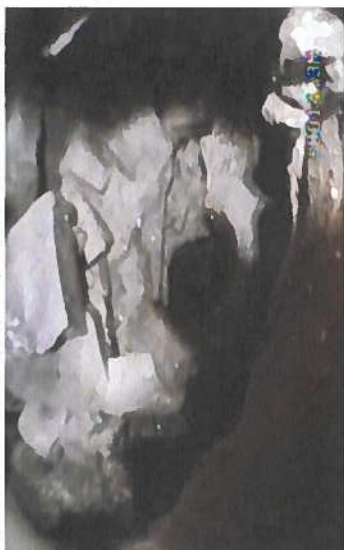
Void at 14.2 to 14.4 m

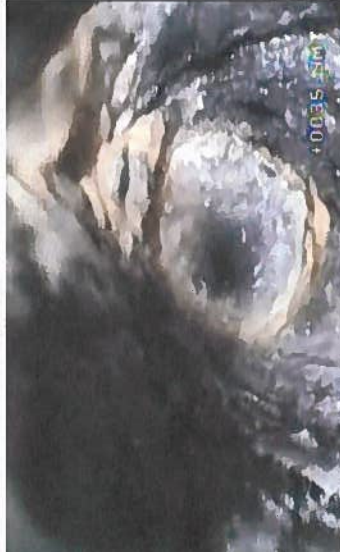
Rough borehole wall from 30.0 to 33.0 m

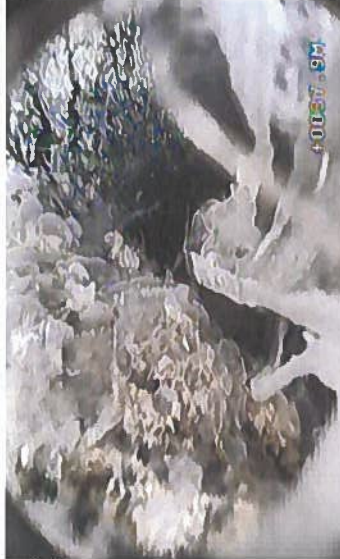
Water noted at 36.0 m

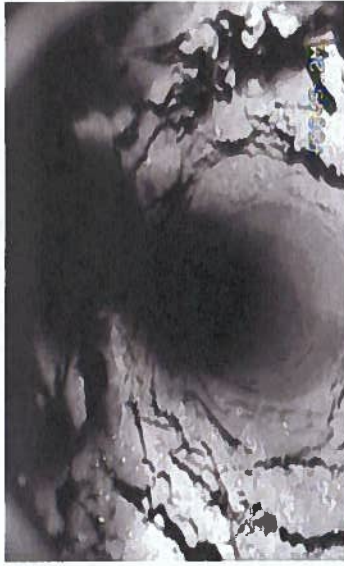
Water noted at 40.0 m

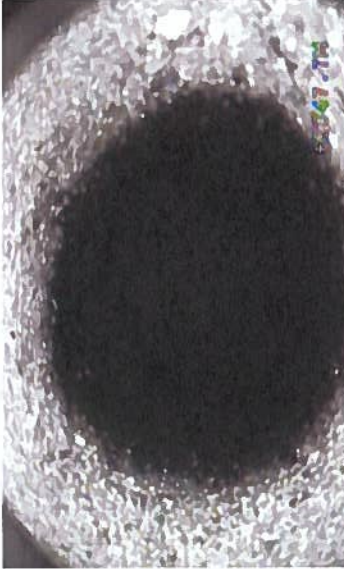
Fractured borehole wall from 45.0 to 47.7 m

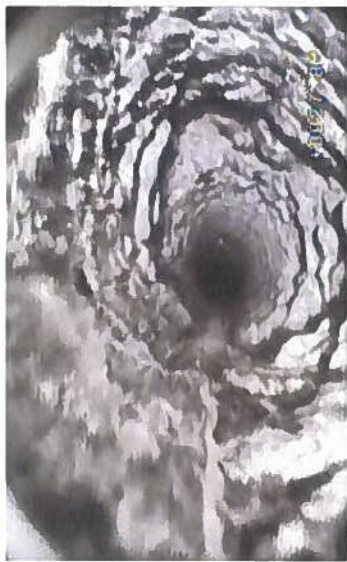
End of PVC at 16.7 m

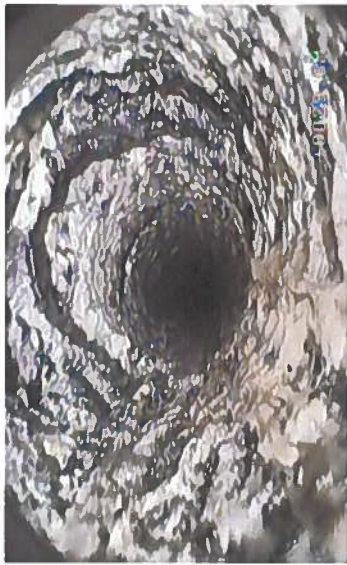
Start of void noted at 27.9 m extending to 29.0 m

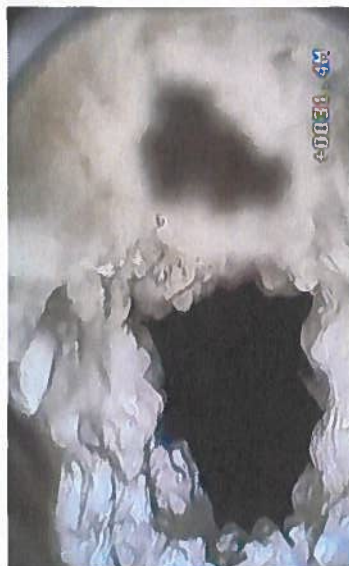
Fractures noted at 29.6 m

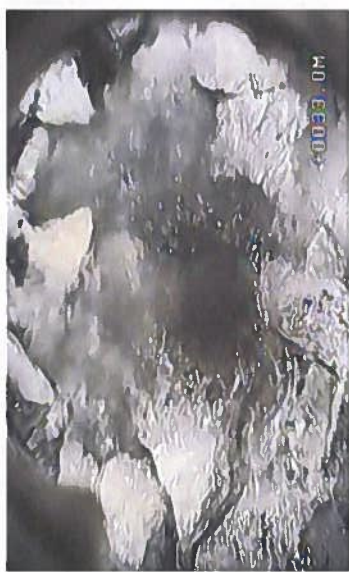
Start of void at 31.7 m

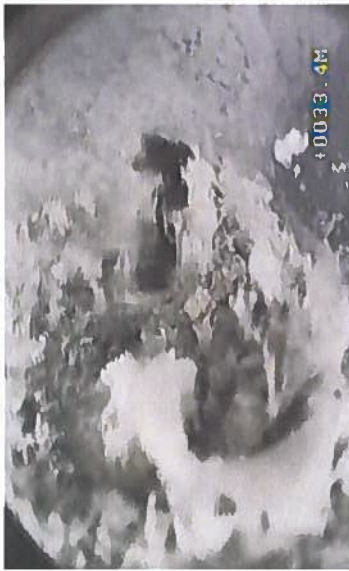
End of void and water noted at 33.1 m

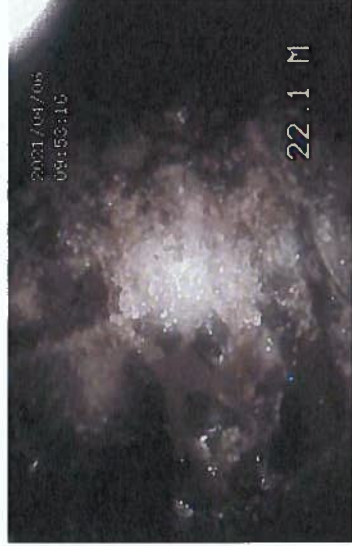
Start of void at 21.1 m

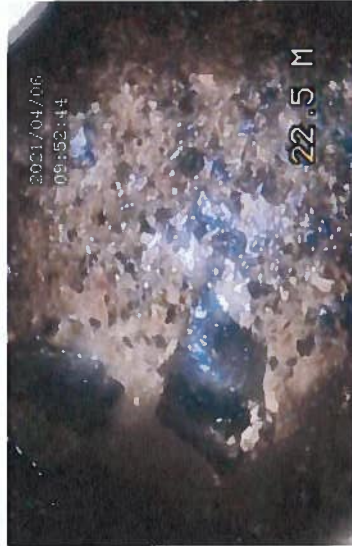
Rubble noted on the floor

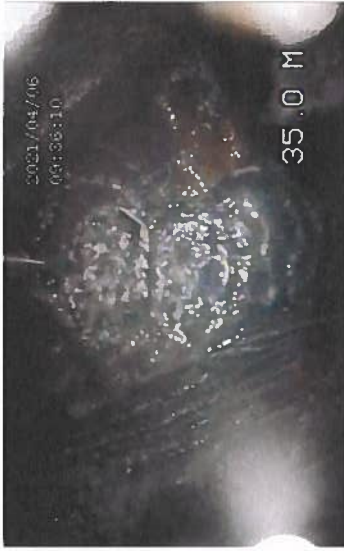
Timber logs noted at the bottom around 35.0 m
