PIGEON CREEK HAZARD ASSESSMENT

PRESENTED TO
TOWN OF CANMORE

NOVEMBER 2016
ISSUED FOR USE
FILE: 704-V13203145-01

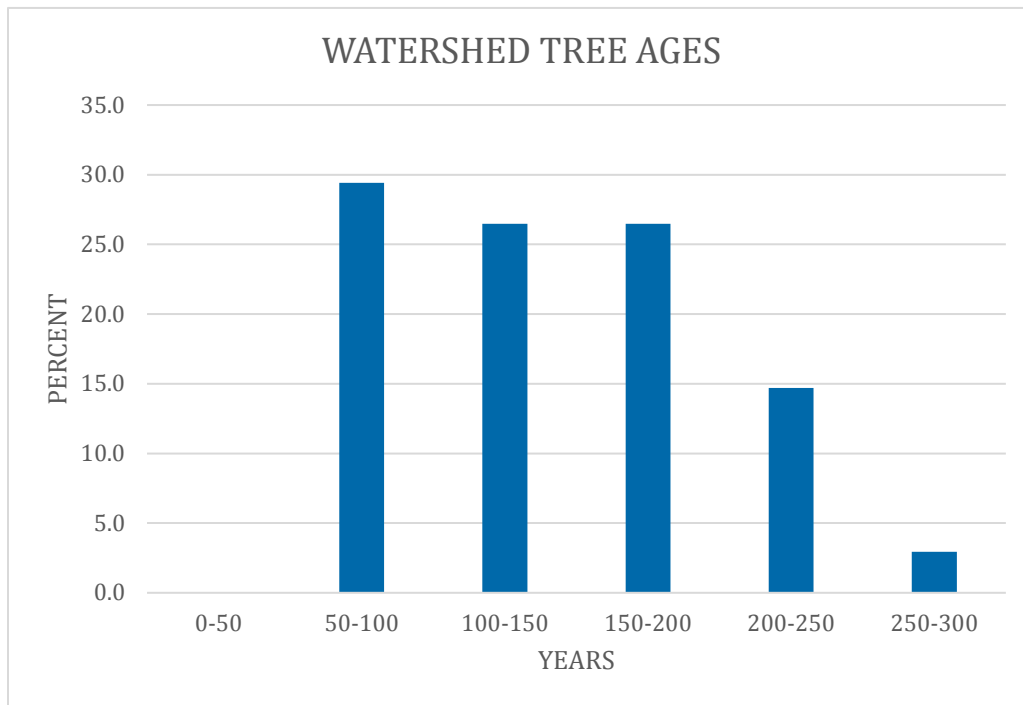
Figure 4.9. Age Classes of Sampled Trees in the Pigeon Creek Watershed.

The age distribution of the cored trees in the watershed indicates that 29 percent are in the 50-100 year class, 26 percent are in the 100-150 year class, 26 percent are in the 150-200 year class and 19 percent are older than 200 years (Figure 4.9). In fact, about 46 percent of the aged trees along the channels within the watershed are older than 150 years which suggests they may have become established after the major regional fires in the 1860's. Field evidence of channel avulsions very similar to that observed upstream of large woody debris jams after the 2013 event, suggests that there was a morphologically significant flood event about 63 to 64 years ago (early 1950's), based on the ages of trees growing on the bed of the abandoned channel. A number of other trees in this general age range were also located along Pigeon Creek. Inferred and reported flood events were identified on nearby watersheds between 1948 and 1956 by BGC (2014a), so it is likely that there was an event of unknown magnitude on Pigeon Creek in that time frame. The aerial photographic analysis of the Pigeon Creek fan identified that there was a significant change in the lower creek alignment between 1950 and 1962 (Figure 4.6).

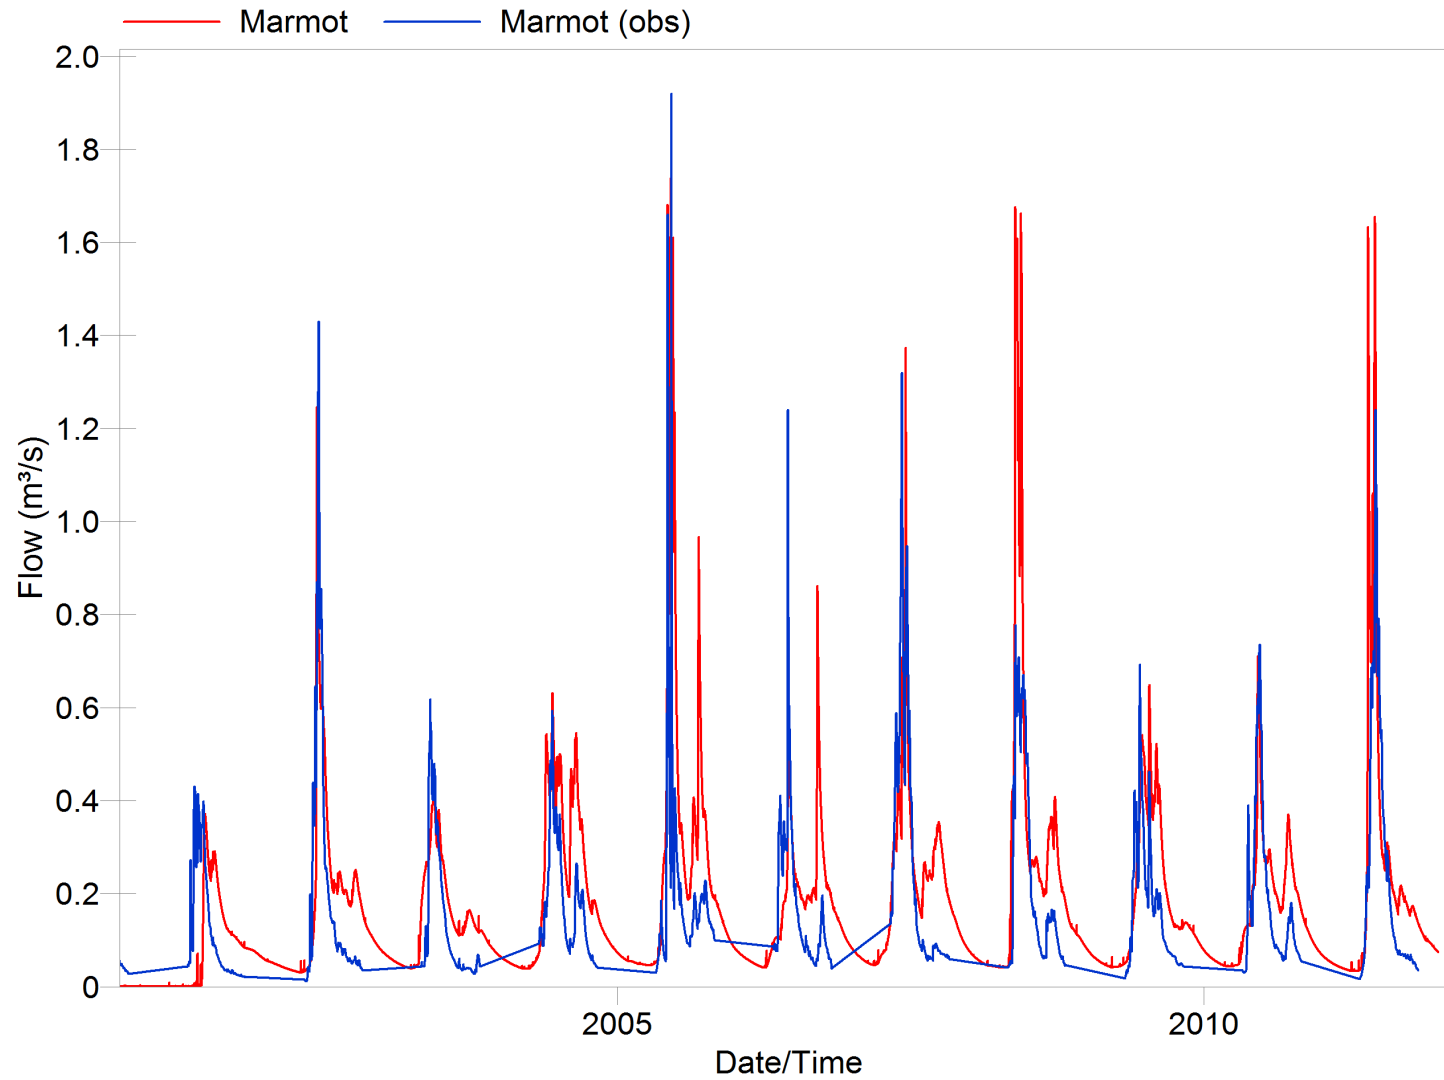
Figure 5.4. Marmot Creek Hydrograph: Observed vs. Computed Flows

The outcome of the calibration is considered acceptable for the purposes of this project: the model is able to properly simulate key hydrologic watershed processes, including snow accumulation, snowmelt, infiltration, soil moisture, depression storage, runoff generation, and streamflow routing.

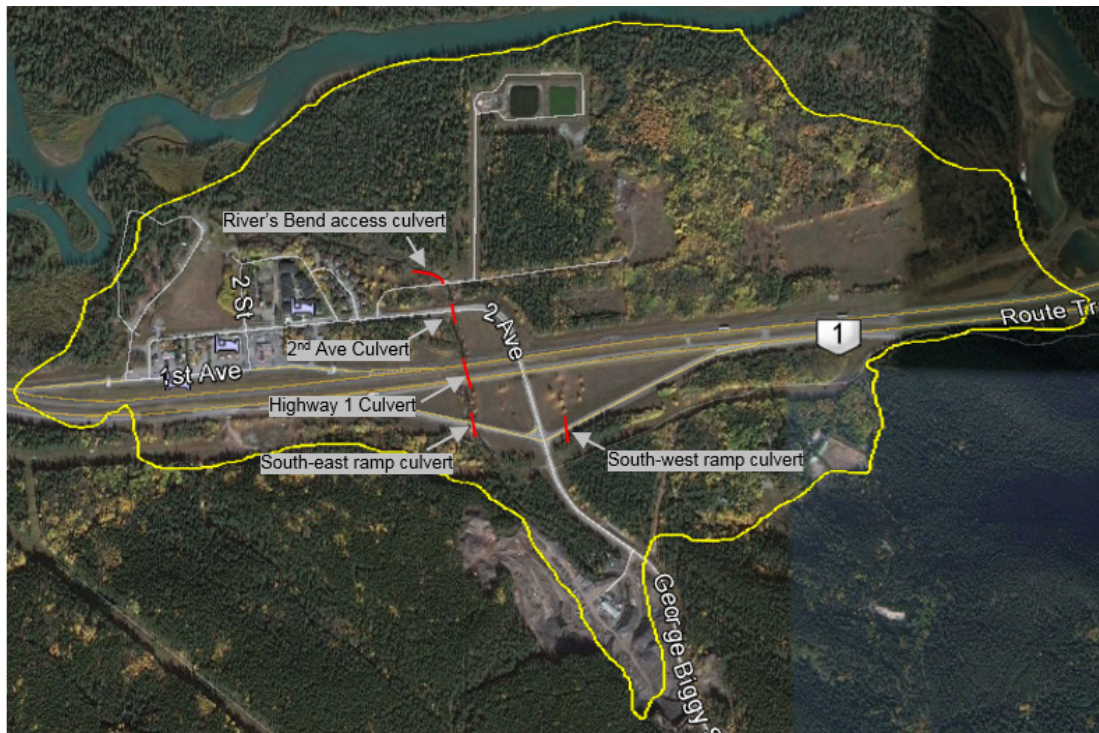
Figure 9.9. Critical culverts in the Pigeon Creek Fan

Figure 9.9 shows the location of critical culverts within the Pigeon Creek Fan. Different culvert blockage combinations are considered in Scenarios 1, 2a, and 2b; as described below.

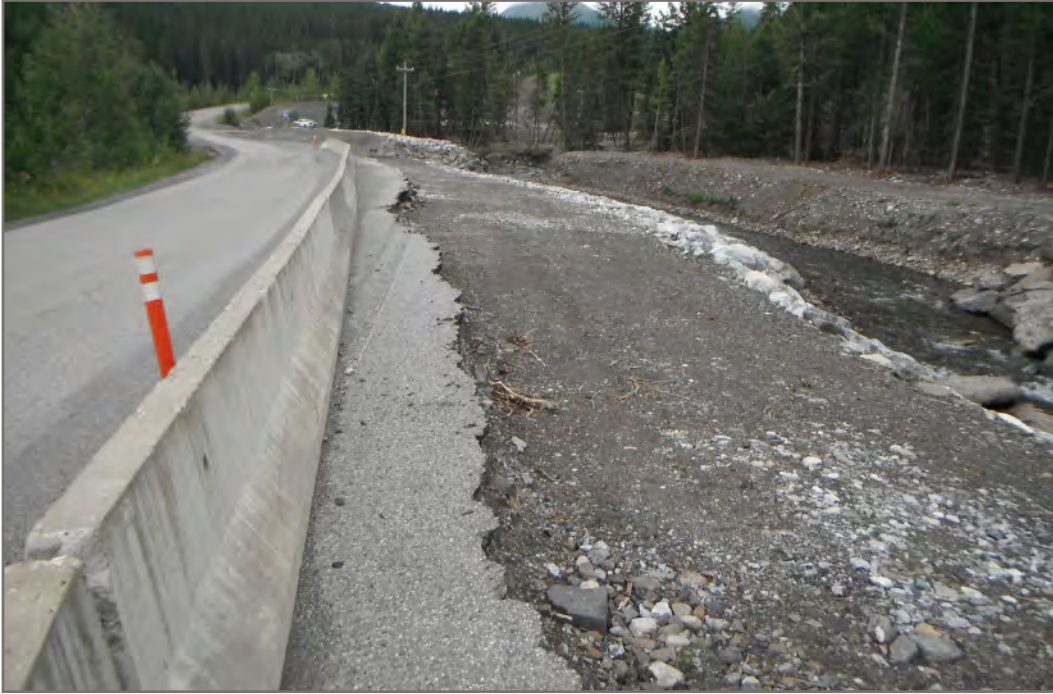
Photo 7137: Damage to George Biggy Senior Road.

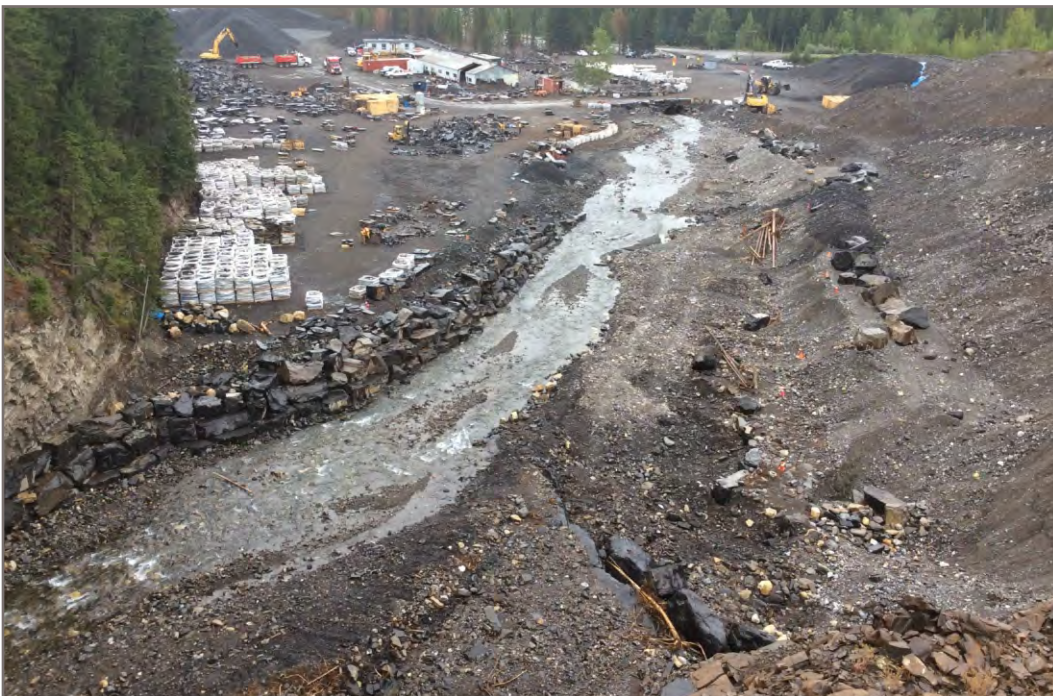
Photo 43(1): New position of Pigeon Creek in Thunderstone Quarry, near apex waterfall, looking north. Note limestone block riprap placed on west bank by Thunderstone Quarry operator.

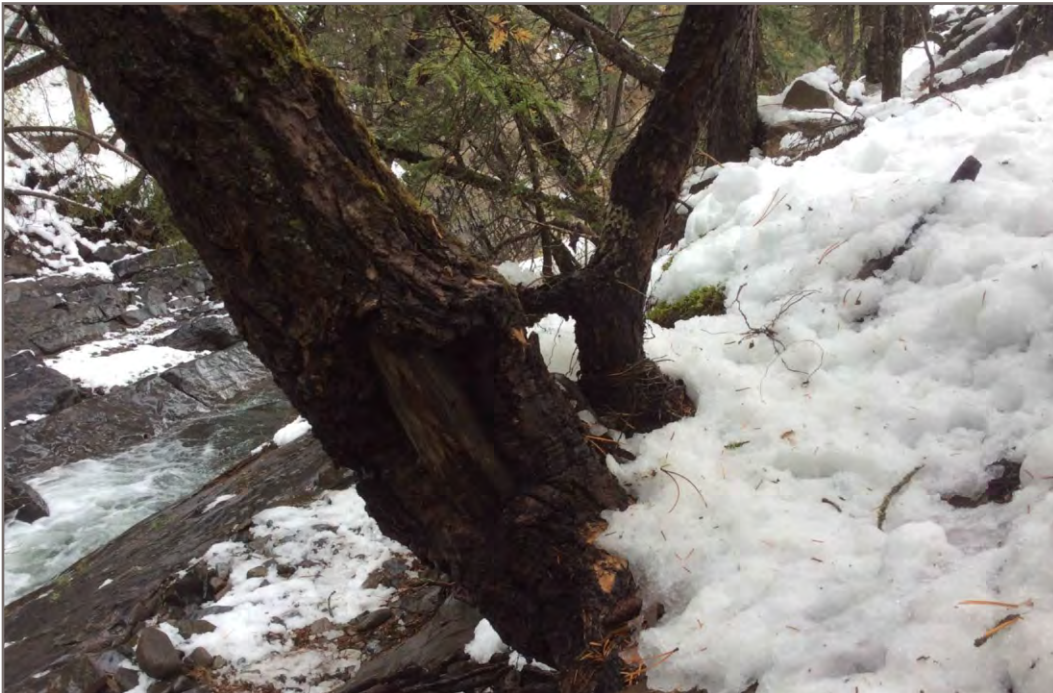
Photo 45(3): Flood damage to older tree, just south of location above. This damage is older than the 2013 event.

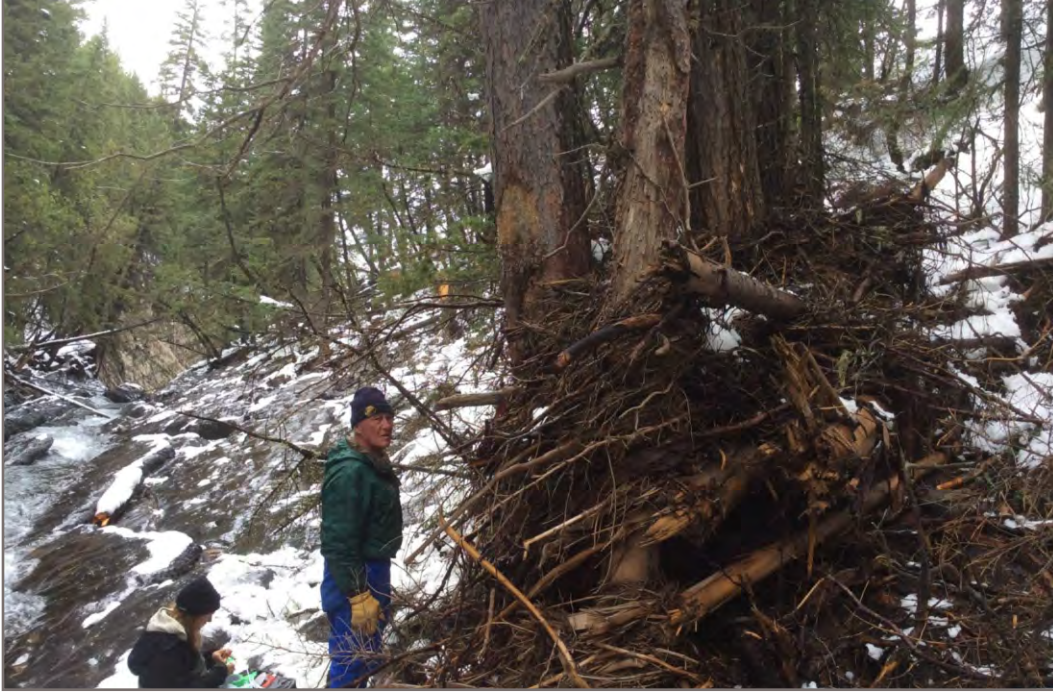
Photo 213(2): Log jam against trees and flood damage on trees above jam. The logs and damage are from the 2013 event and show the minimum flood level above the current creek surface. Looking north with waterfall drop off in background.

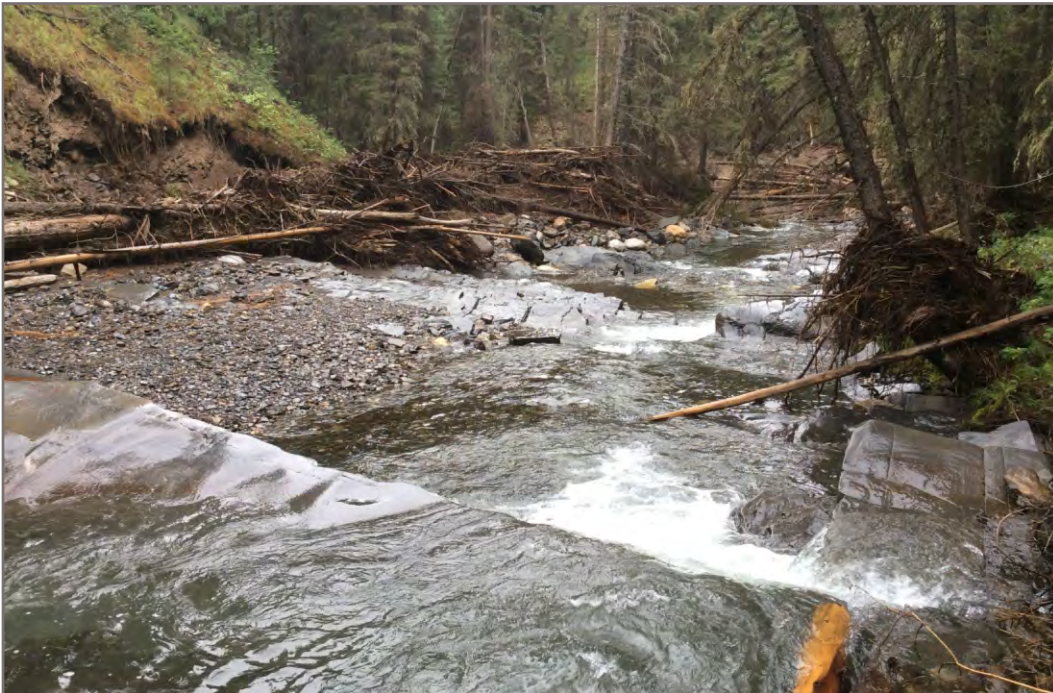
Photo 56(1): Looking downstream showing debris on banks.

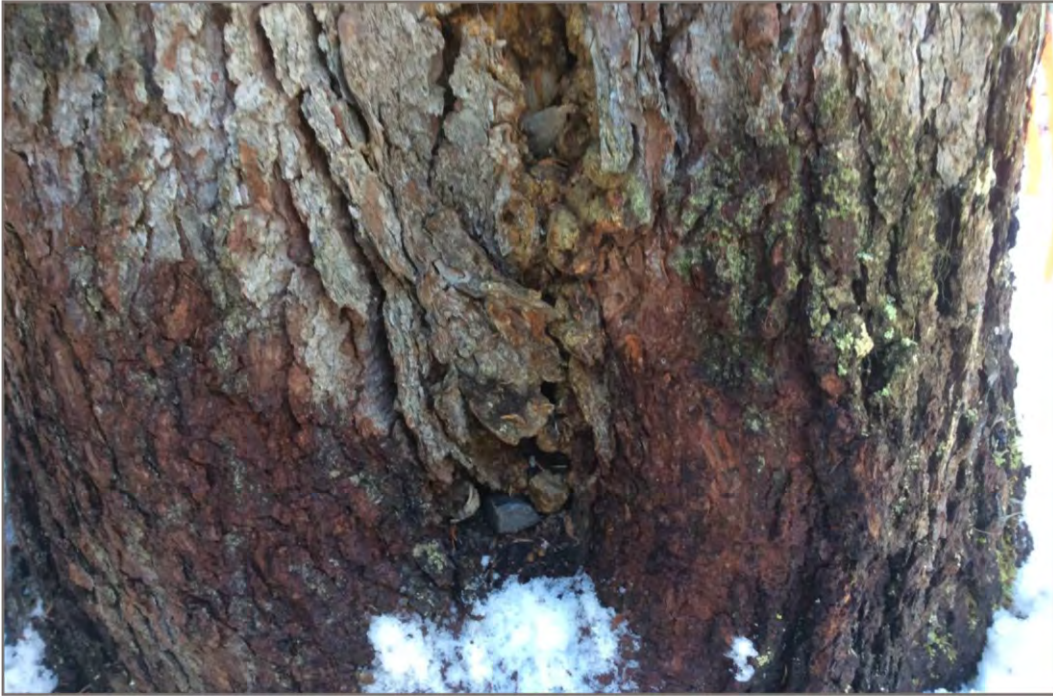
Photo 117(1): Older flood damage in upper Pigeon Creek area. Note pebbles held in place by healed bark.

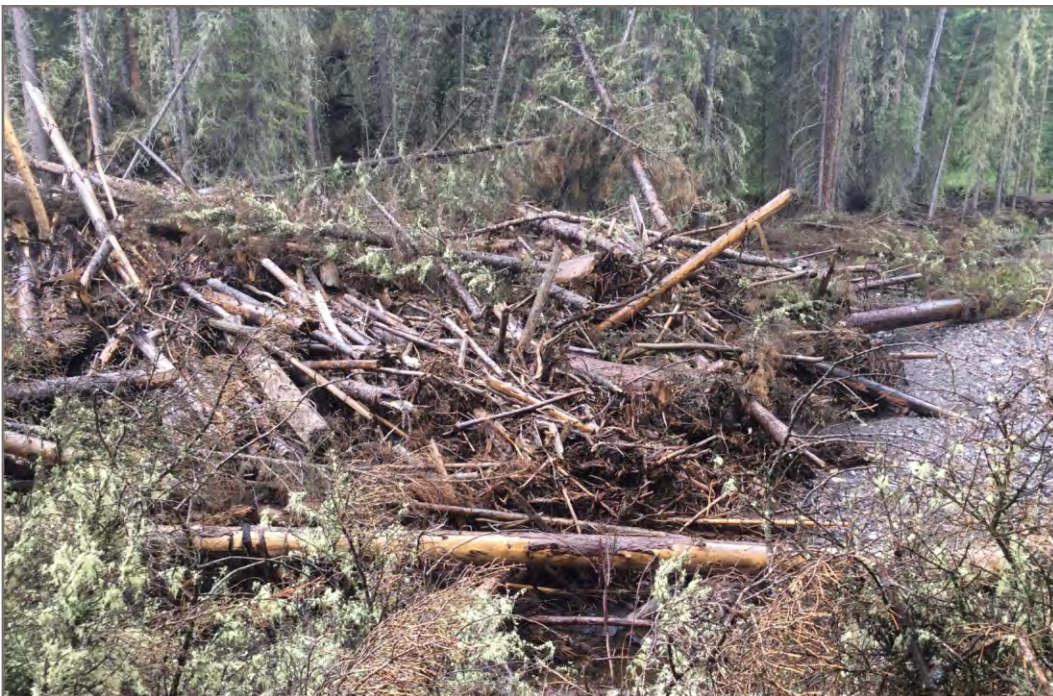
Photo 71(1): Large log jam on Pigeon Creek floodplain, southeast of confluence of Pigeon and West Wind creeks.

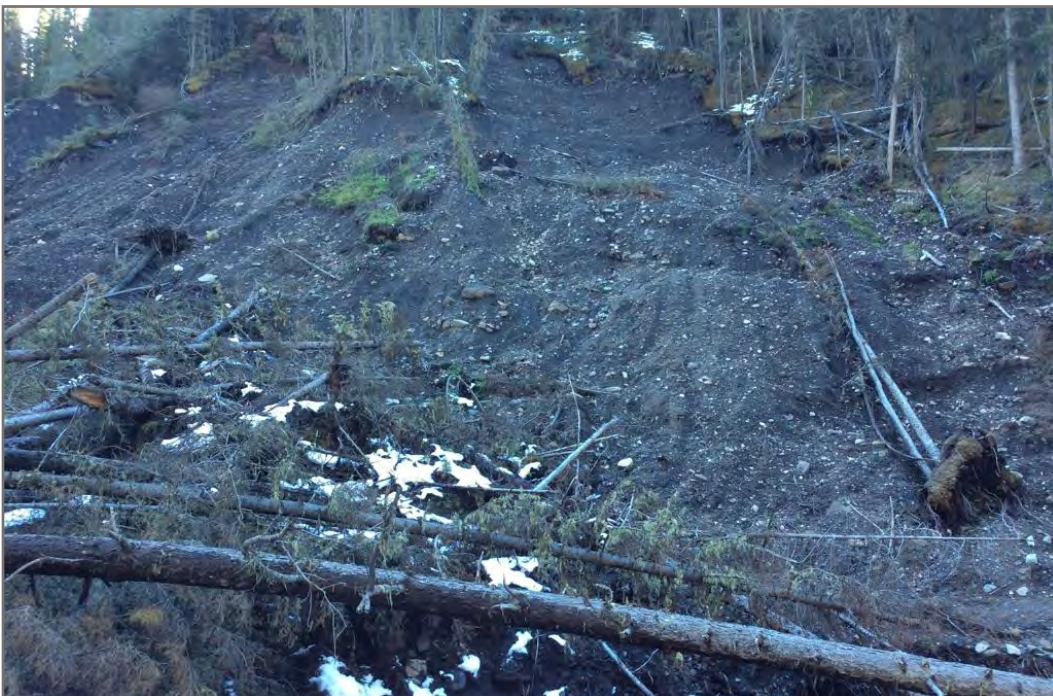
Photo 179(1):Failed slope in creek.

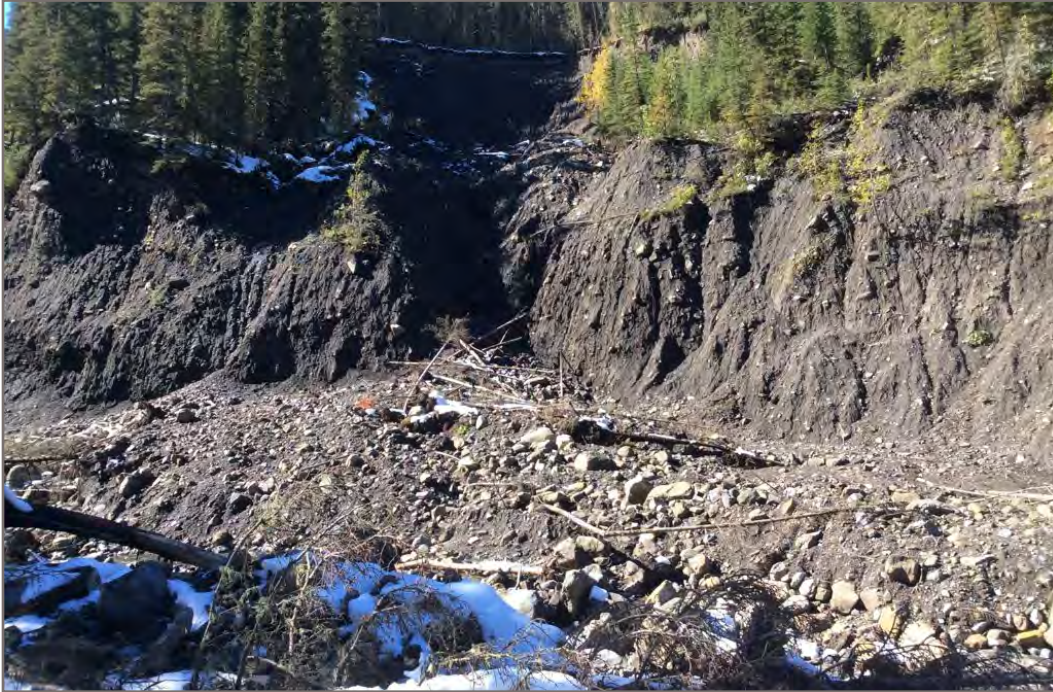
Photo 157(1):Slope failure.

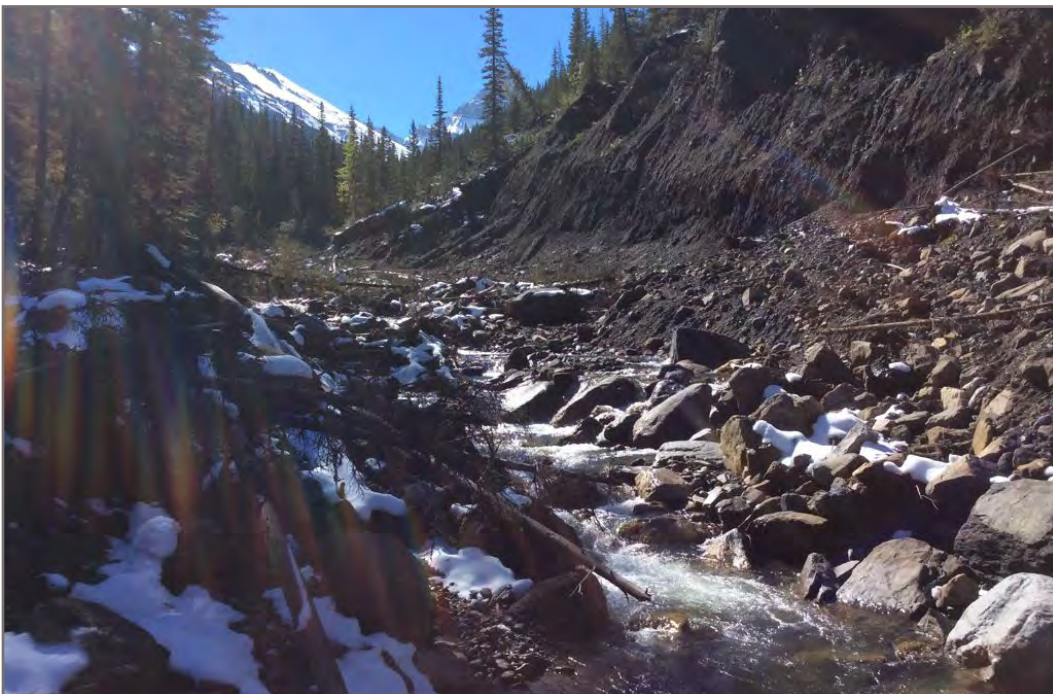
Photo 157(3):Slope failure.

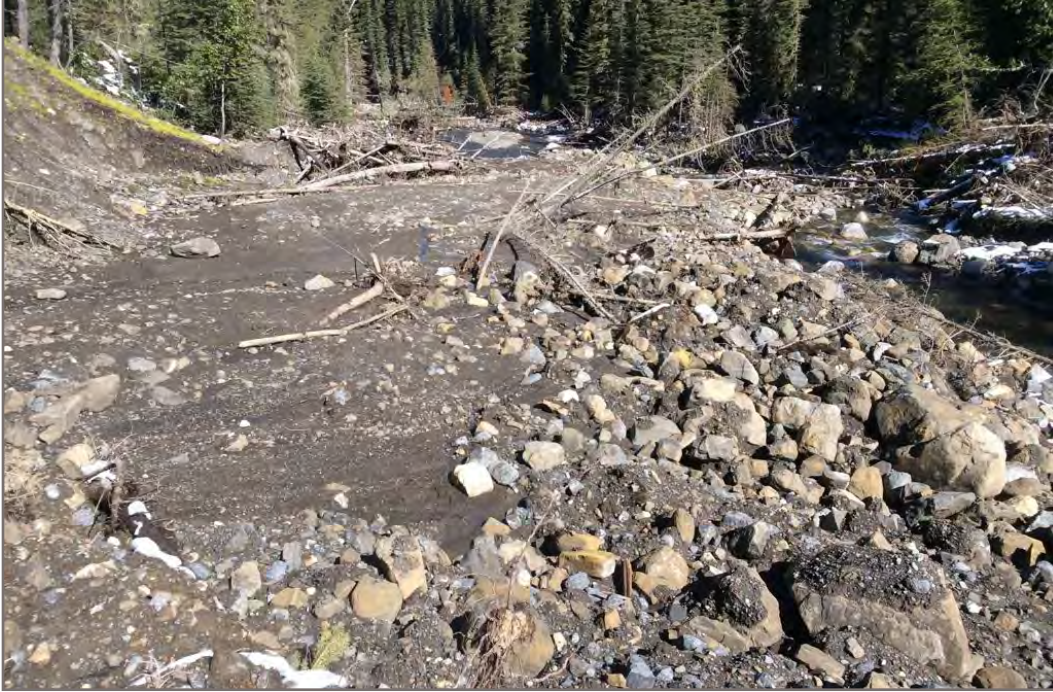
Photo 157(6): Aggraded channel.
