BOW RIVER PATHWAY CANMORE

LEGAL BANK SURVEY OF BOW RIVER TRIBUTARY

PREPARED FOR:
ISL

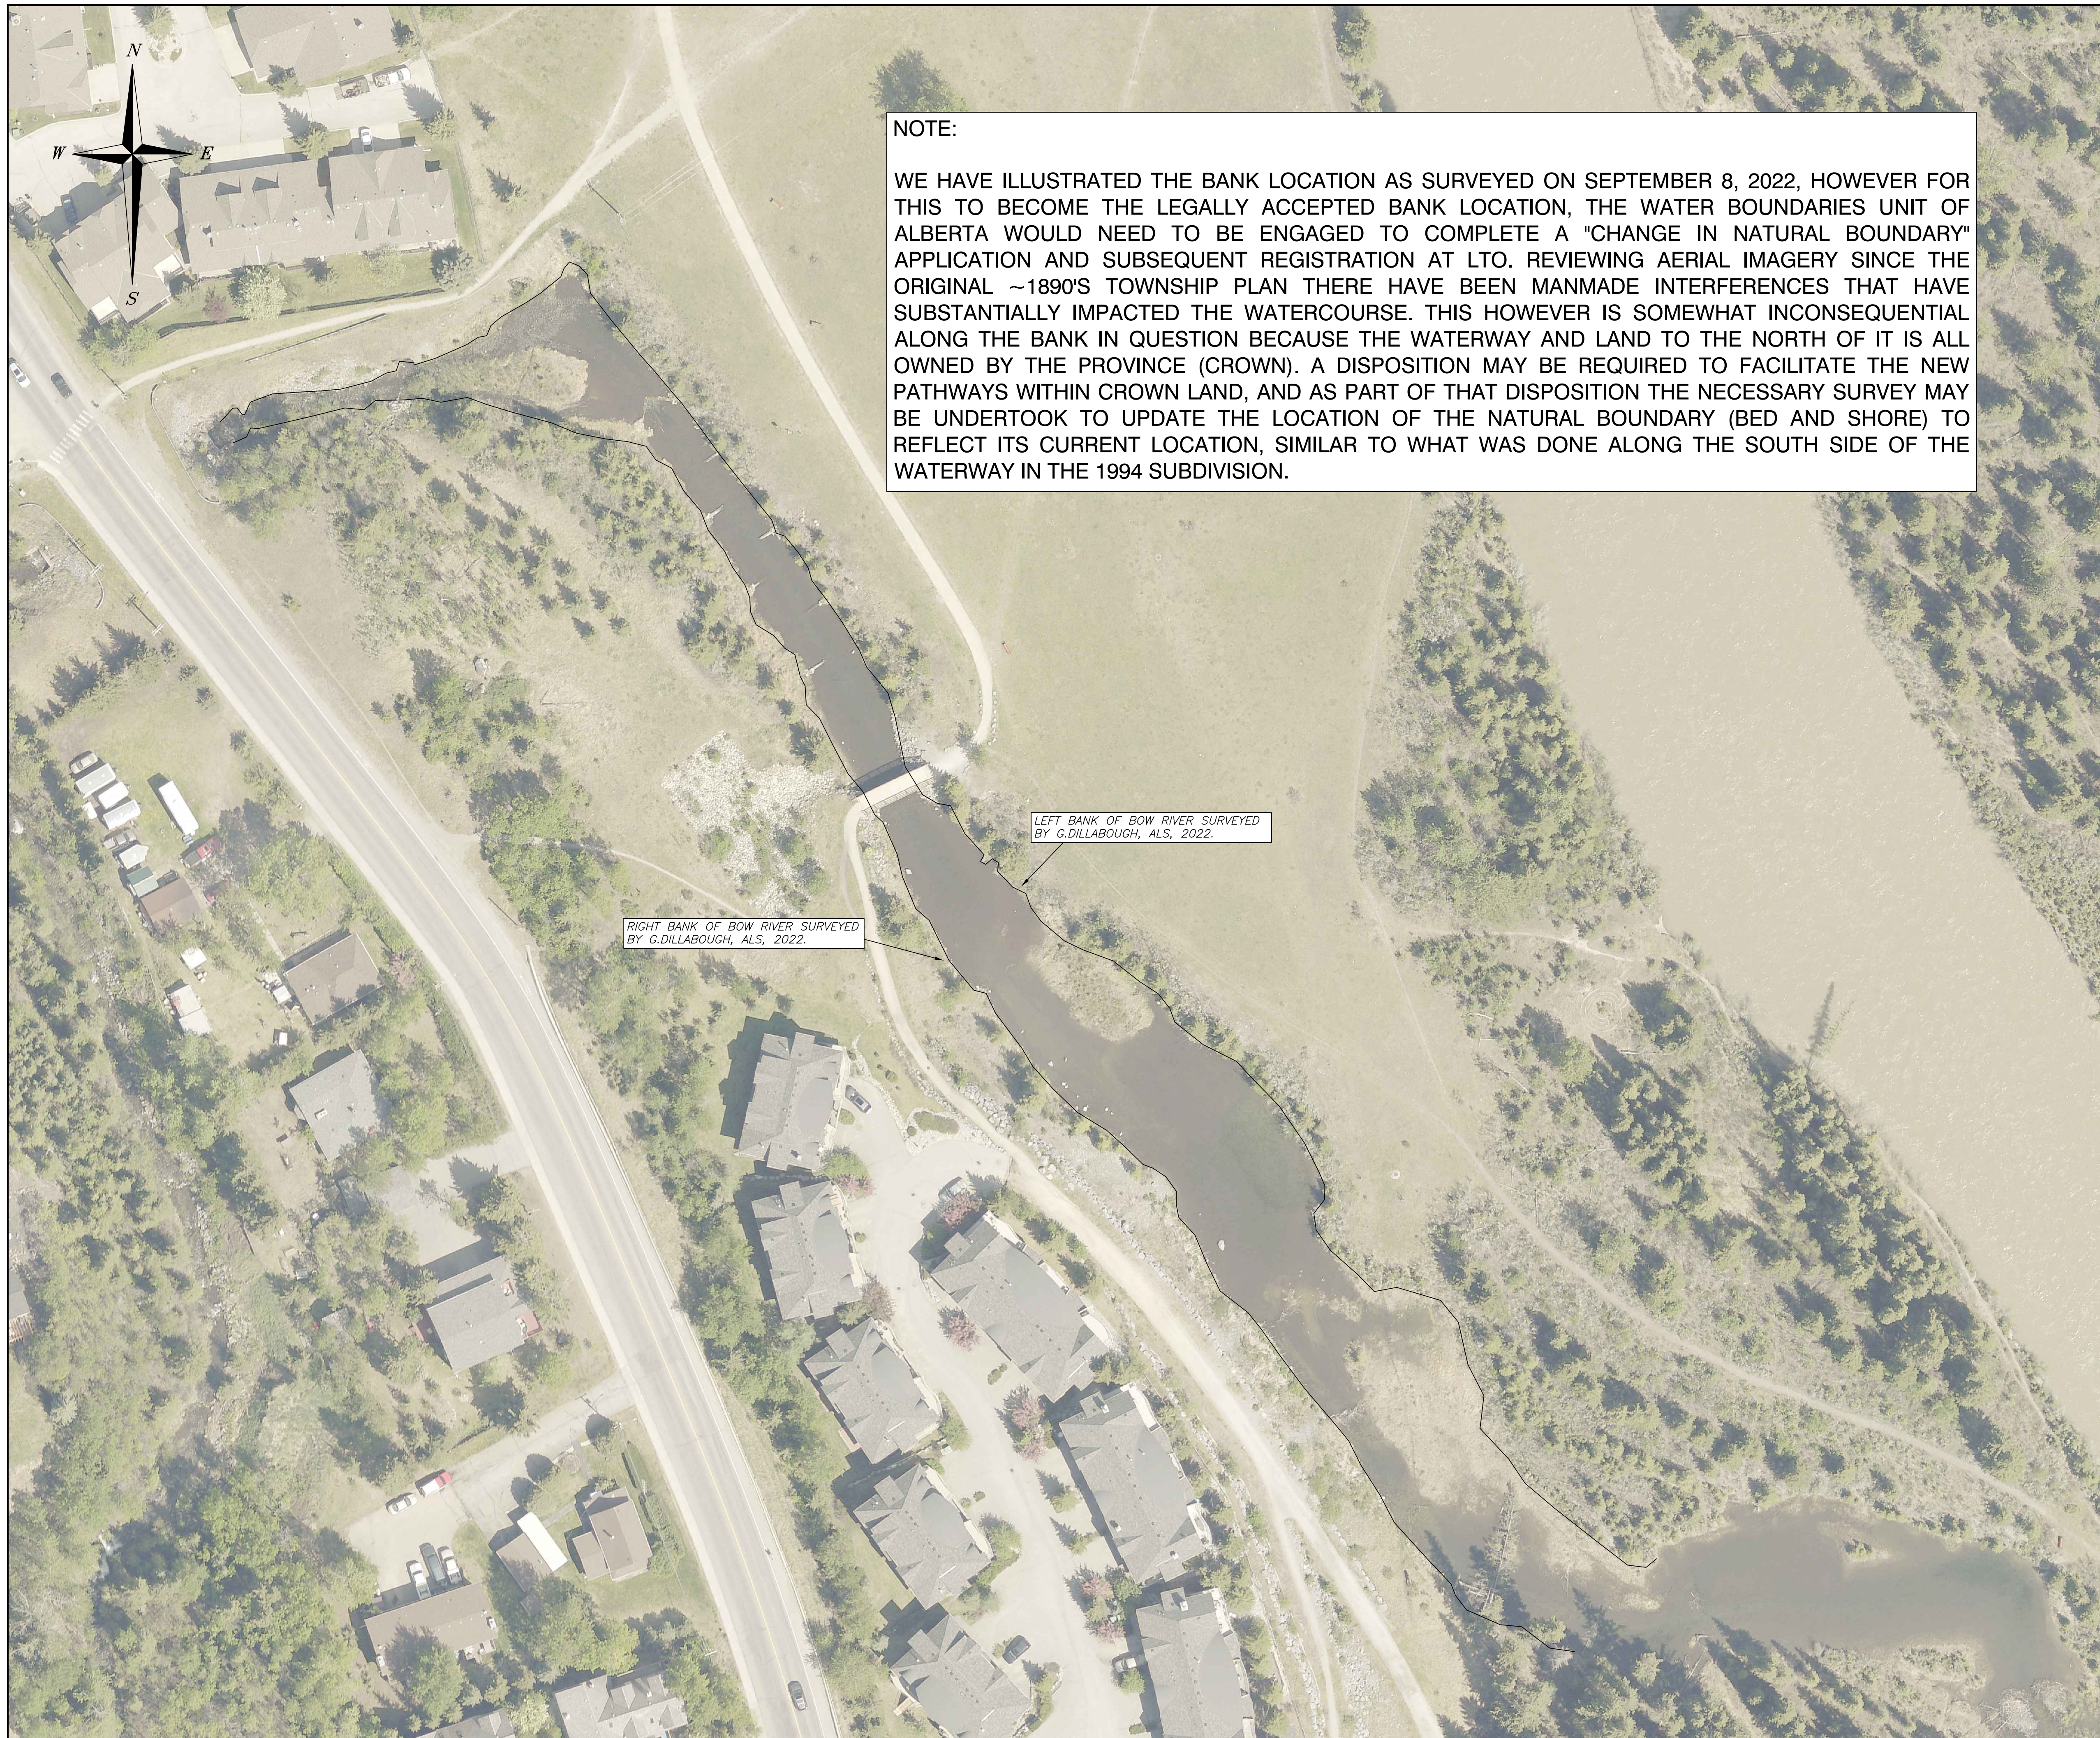
WE HAVE ILLUSTRATED THE BANK LOCATION AS SURVEYED ON SEPTEMBER 8, 2022, HOWEVER FOR THIS TO BECOME THE LEGALLY ACCEPTED BANK LOCATION, THE WATER BOUNDARIES UNIT OF ALBERTA WOULD NEED TO BE ENGAGED TO COMPLETE A "CHANGE IN NATURAL BOUNDARY" APPLICATION AND SUBSEQUENT REGISTRATION AT LTO. REVIEWING AERIAL IMAGERY SINCE THE ORIGINAL ~1890'S TOWNSHIP PLAN THERE HAVE BEEN MANMADE INTERFERENCES THAT HAVE SUBSTANTIALLY IMPACTED THE WATERCOURSE. THIS HOWEVER IS SOMEWHAT INCONSEQUENTIAL ALONG THE BANK IN QUESTION BECAUSE THE WATERWAY AND LAND TO THE NORTH OF IT IS ALL OWNED BY THE PROVINCE (CROWN). A DISPOSITION MAY BE REQUIRED TO FACILITATE THE NEW PATHWAYS WITHIN CROWN LAND, AND AS PART OF THAT DISPOSITION THE NECESSARY SURVEY MAY BE UNDERTOOK TO UPDATE THE LOCATION OF THE NATURAL BOUNDARY (BED AND SHORE) TO REFLECT ITS CURRENT LOCATION, SIMILAR TO WHAT WAS DONE ALONG THE SOUTH SIDE OF THE WATERWAY IN THE 1994 SUBDIVISION.

RIGHT BANK OF BOW RIVER SURVEYED BY G.DILLABOUGH, ALS, 2022.

LEFT BANK OF BOW RIVER SURVEYED BY G.DILLABOUGH, ALS, 2022.
