Area Mining Impact Overview Report Resort Village Area Structure Plan_Rev2

Three Sisters Mountain Village
Canmore, AB
Wood File: CG09125

16-Nov-20

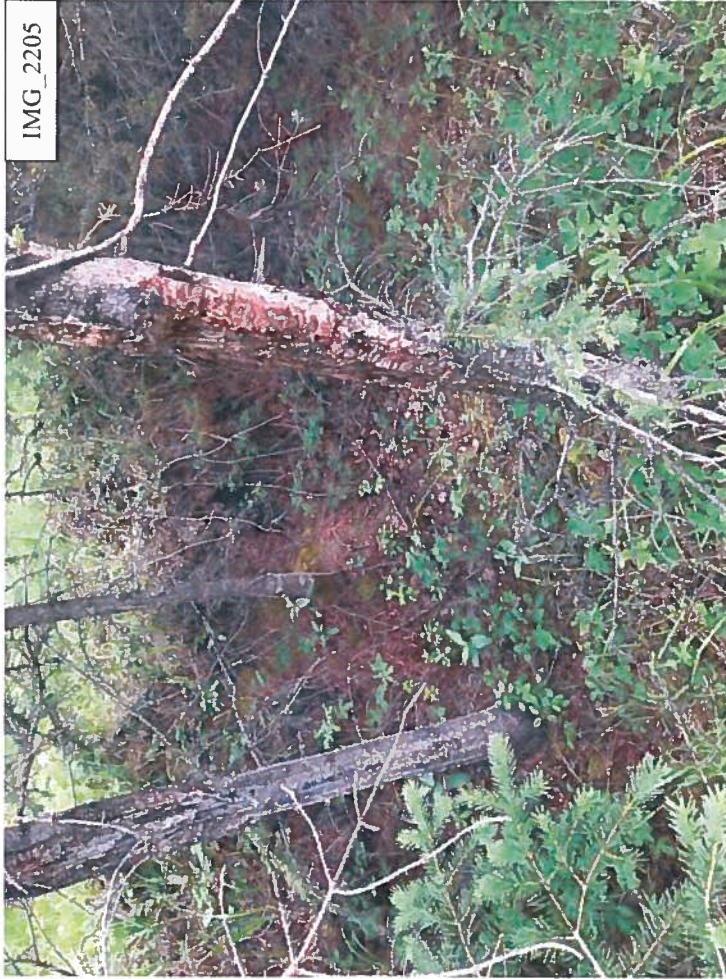
Photograph 21: Depression with 90° turn, less defined toward Waypoint 43, coincidence with mining limit, B113 feature in this area, feature bounds waypoint 043-047, photo at waypoint 045, July 2020

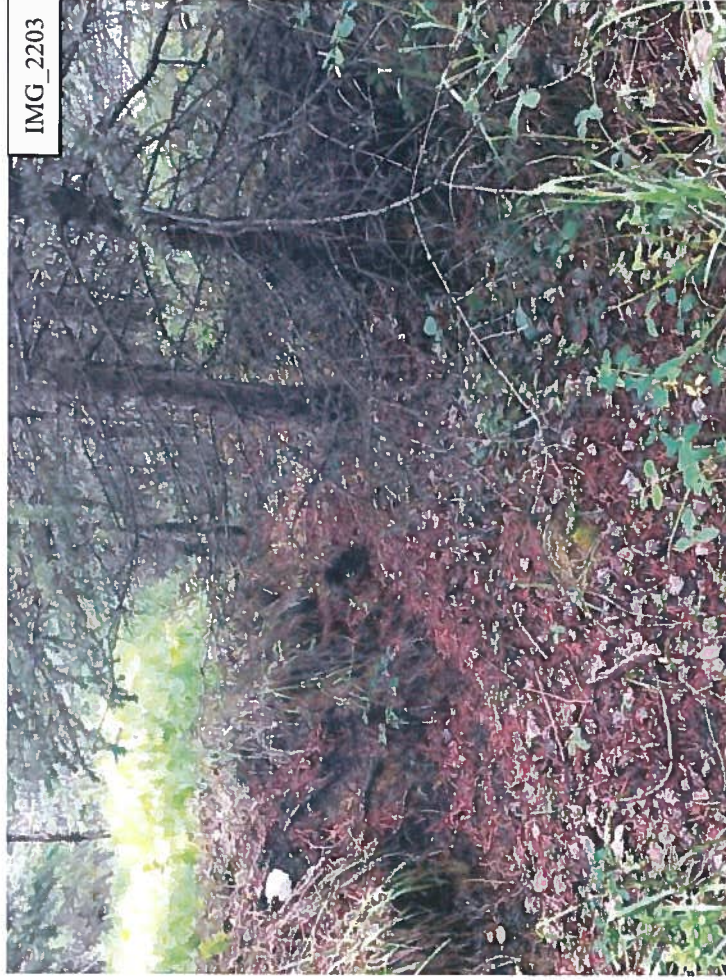
Photograph 22: Depression with 90° turn, less defined toward Waypoint 43, coincidence with mining limit, B113 feature in this area, feature bounds waypoint 043-047, photo at waypoint 046, July 2020

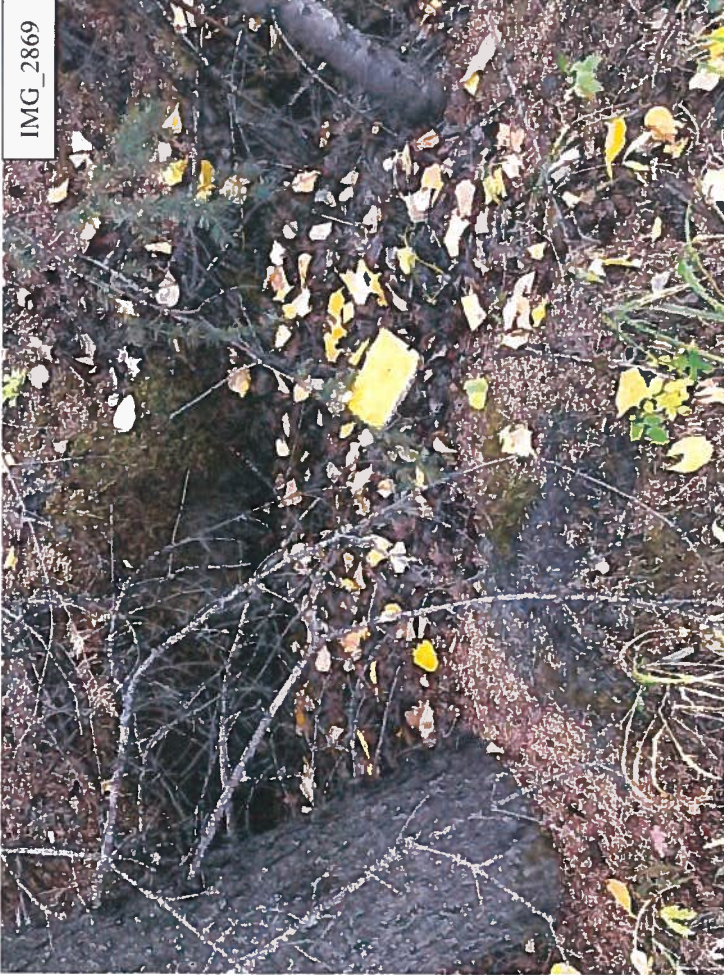
WPT 149	Bottom of ditch 0.8 x 0.8 m	29-Sep-20
WPT 150	Possible crack, 0.2m deep, 0.3m wide, 4m long. Orientated 132, could be TF17	29-Sep-20
WPT 151	Trench 3-4m wide, 2m deep orientated 102, continues to WPT 154 and WPT 155	29-Sep-20
WPT 152	Several voids over distance of 12m in alignment to 160. Largest hole is 1.5m long, 1.0m deep and 0.5m wide.	29-Sep-20
WPT 153	Portal where mitigation soil has collapsed leaving open access. Orange fencing surrounds.	29-Sep-20
WPT 154	Continuation of WPT 151, orientated 112, 1m wide 0.5m deep	29-Sep-20
WPT 155	End of trench marked by WPTs 151 and 154	29-Sep-20
WPT 156	Three concrete panels on golf cart track, approx 20m long. Believed to be mitigation.	29-Sep-20
WPT 157	Asphalt crack orientated 237, approx 20m long	29-Sep-20

Photograph 47: Possible subsidence area Waypoint 150, September 2020

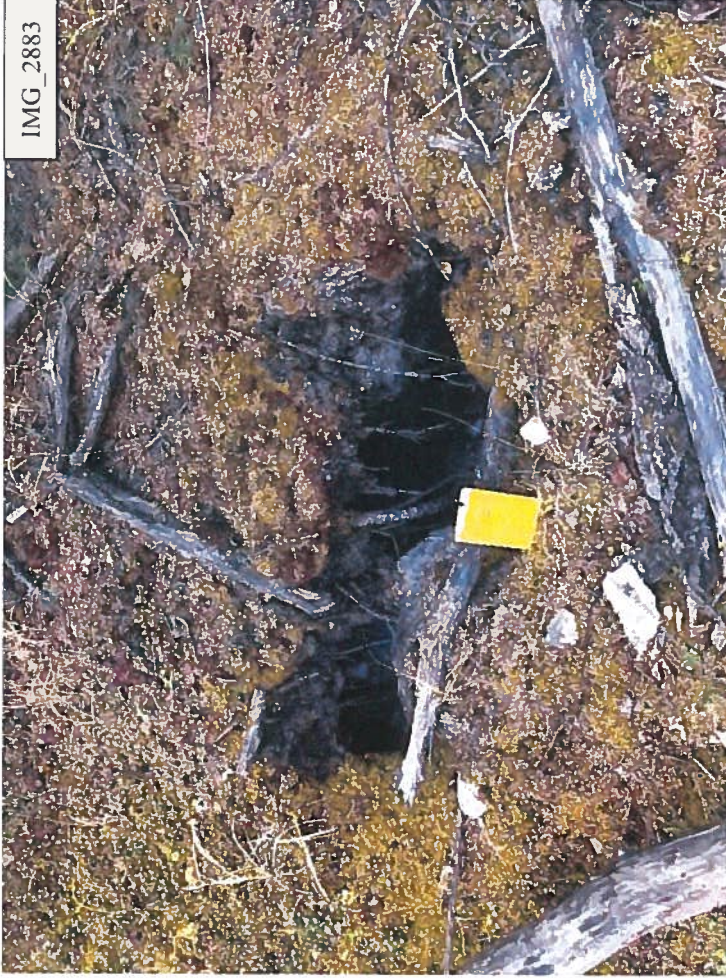
Photograph 51: Voids, Waypoint 152, September 2020 (outside ASP Area)

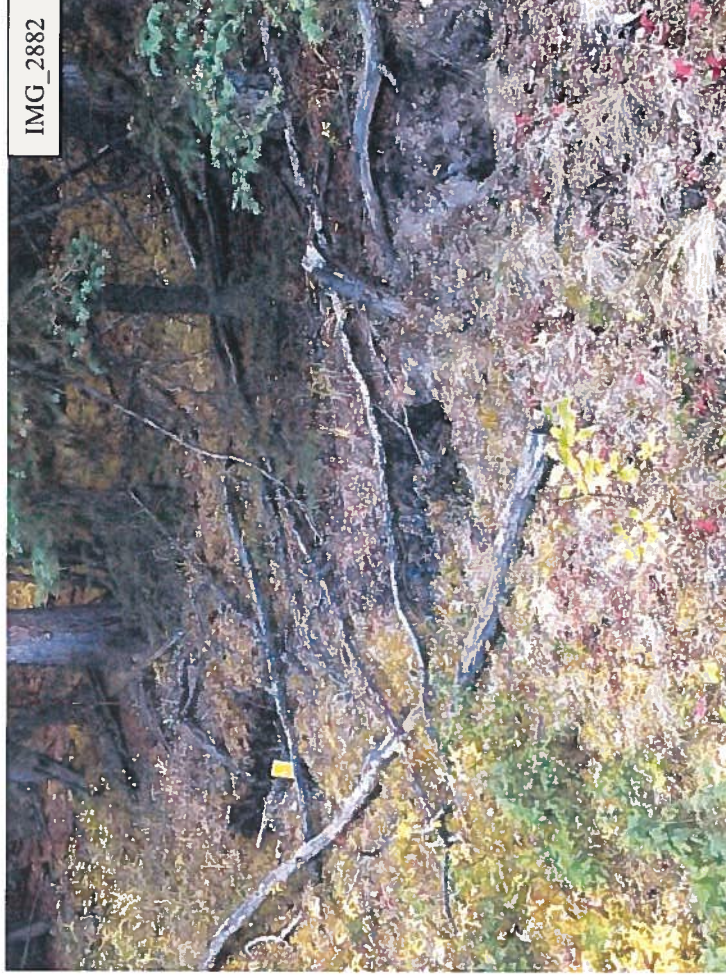
Photograph 52: Voids, Waypoint 152, September 2020 (outside ASP Area)
