SUBDIVISION MINING IMPACT REPORT

THREE SISTERS VILLAGE - PHASE 1

THREE SISTERS VILLAGE – PHASE 1

PROJECT NO.: CG09140
DATE: NOVEMBER 2023

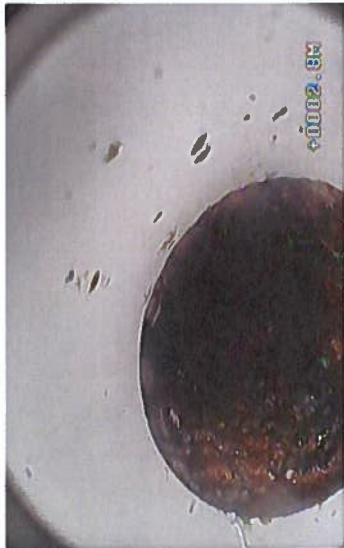
End of PVC at 2.9 m

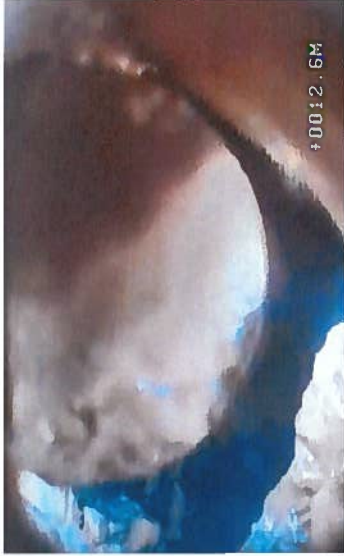
Top of void at 12.5 m

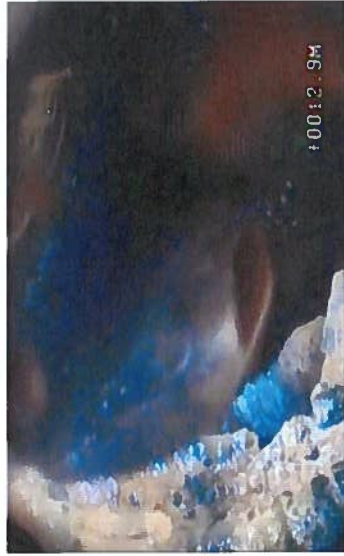
Side view of the void at 12.9 m

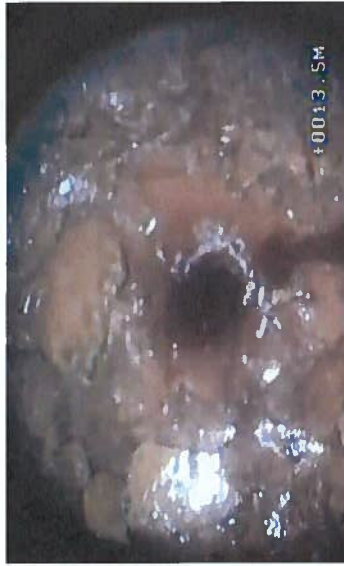
Rubble at the bottom of the borehole

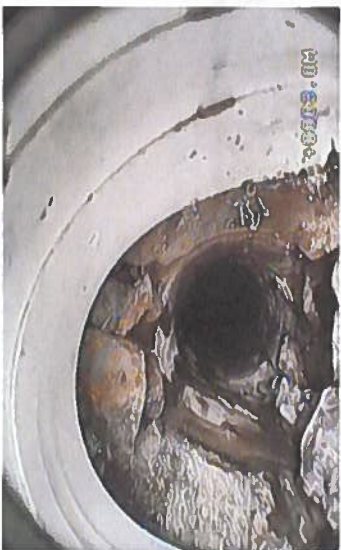
End of PVC at 3.0 m

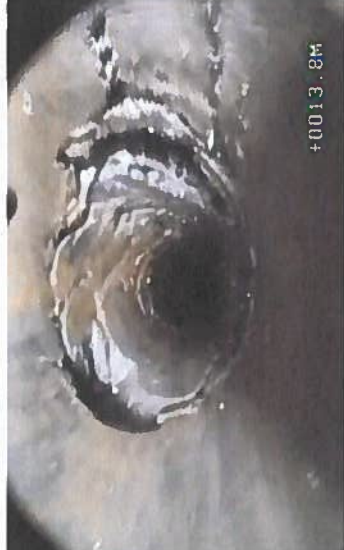
Void at 13.8 to 14.0 m

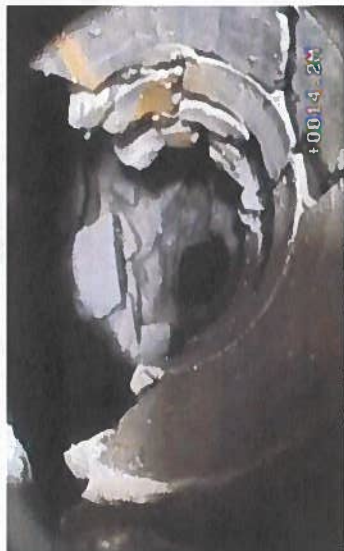
Void at 14.2 to 14.4 m

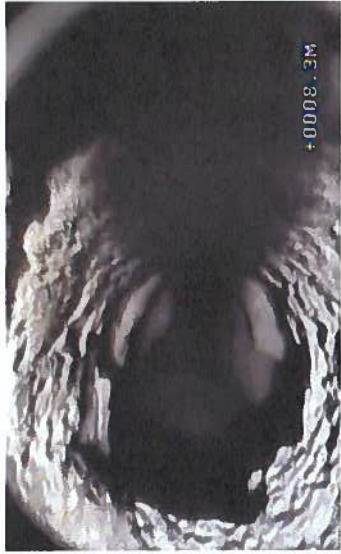
Start of void at 8.4 m

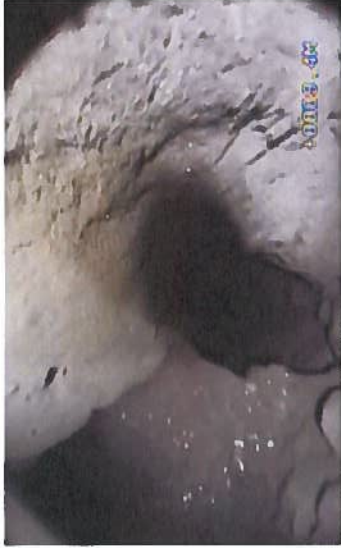
End of Void at 9.6

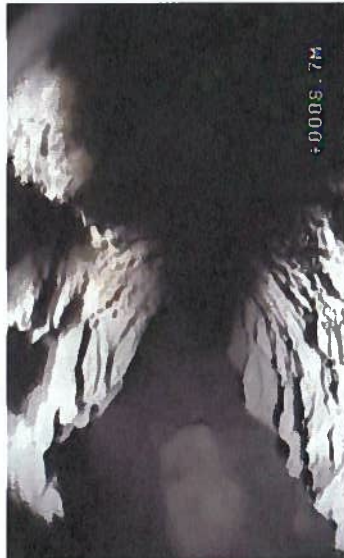
Side view of the void at 8.7 m

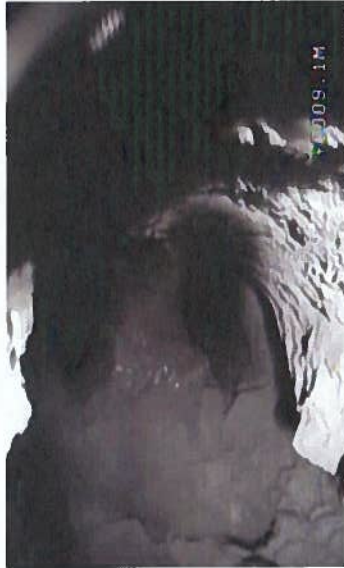
Widening of void at 9.1 m

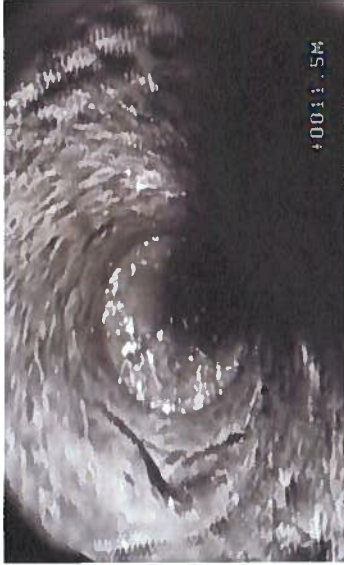
End of borehole at 11.7 m

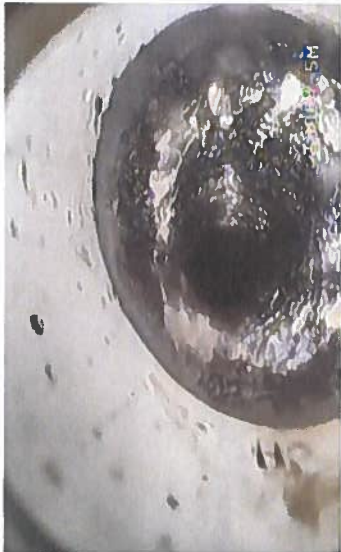
End of PVC at 4.6 m

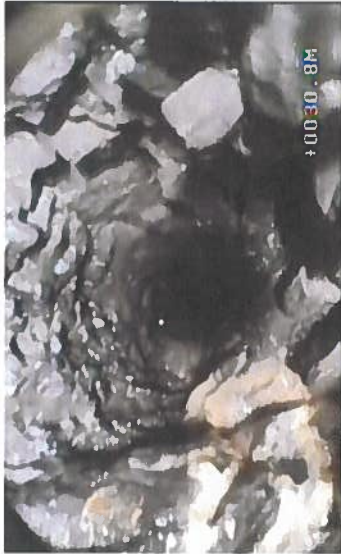
Rough borehole wall from 30.0 to 33.0 m

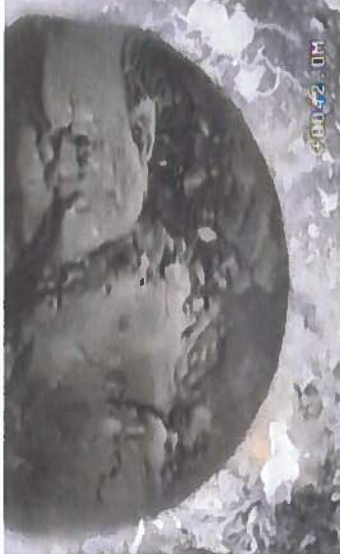
End of borehole at 42.1 m

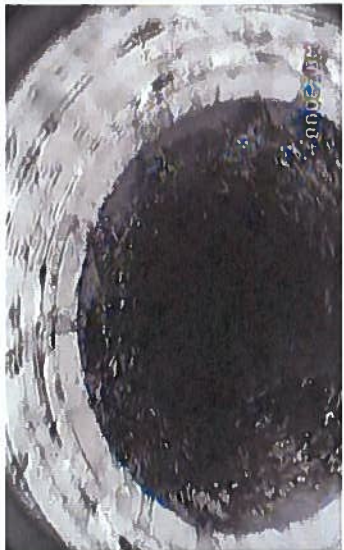
End of PVC at 6.0 m

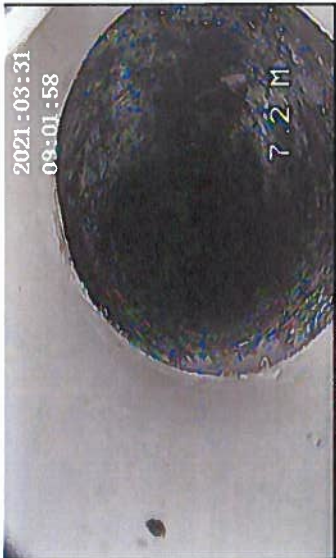
End of PVC at 7.2 m

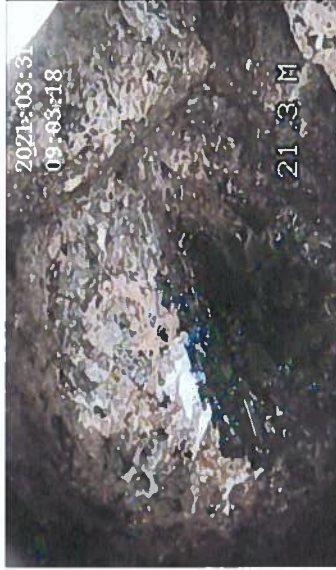
End of void at 21.5

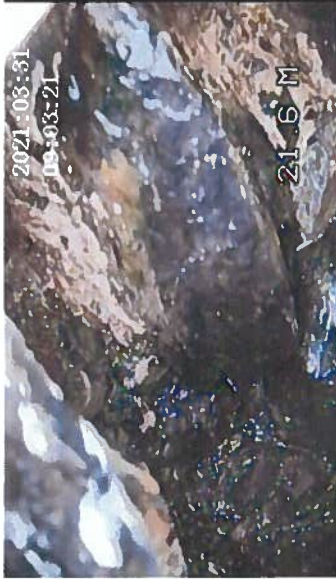
End of borehole at 21.8 m

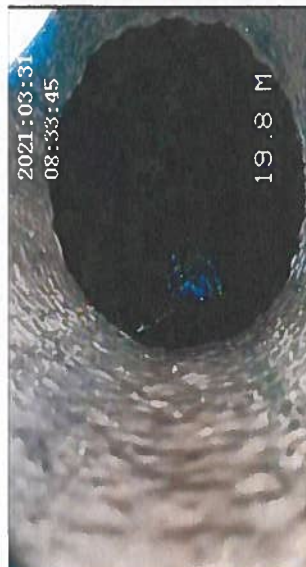
Start of void at 19.8 m

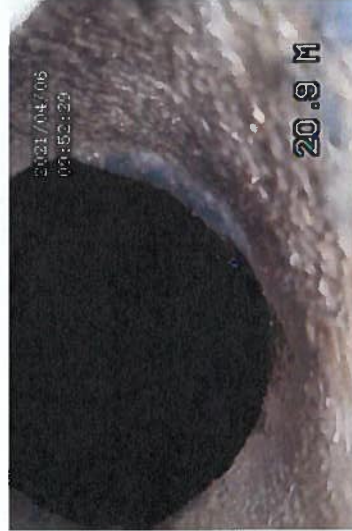
Start of void at 21.1 m

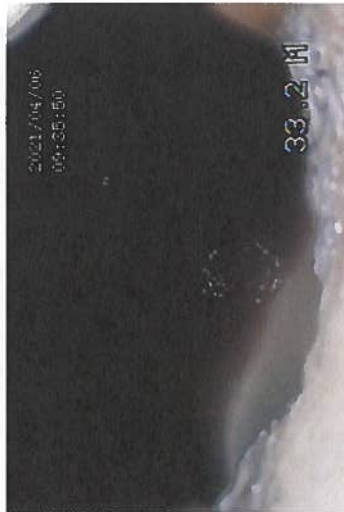
Void at 33.2 to 35.8 m
