Area Mining Impact Overview Report Resort Village Area Structure Plan_Rev2

Three Sisters Mountain Village
Canmore, AB
Wood File: CG09125

16-Nov-20

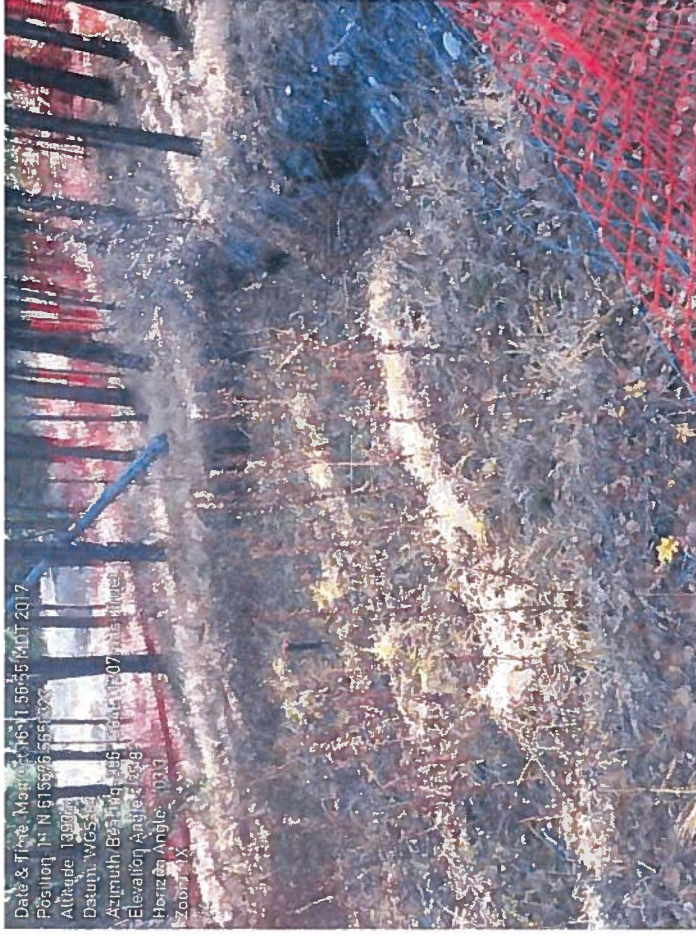
Photograph 1A: Feature #74, October 2017

#74	Cave Subsidence	Feature is approximately 6m in diameter and 4m deep. Cone shaped, instability around edges	6m diameter, 75 m deep, fence down needs to be fixed	N	High current hazard, may increase in future. Fence currently in place, recommend mitigation before opening of TSCGR.	Subsidence feature, 0.75 m deep, ~6 m diameter, circular / rectangular shape. Den noticed on SW side, ~0.5 m diameter, pm in center	25-Jun-20

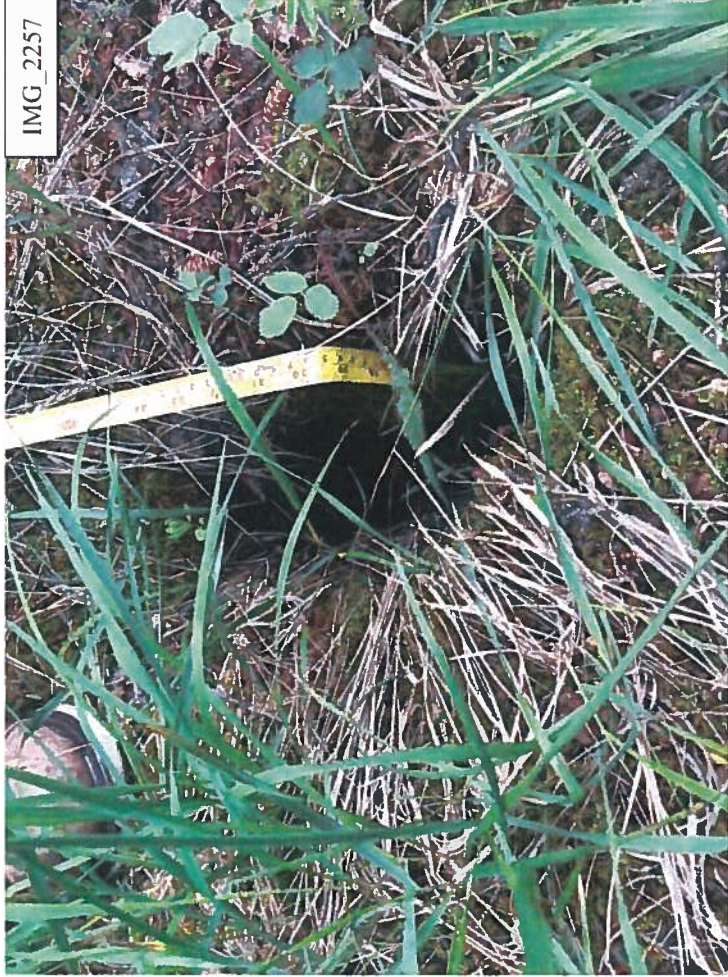
Photograph 13: Numerous small holes appear to be in line, Waypoints 076 – 081, near Features G165, G167, and G177, July 2020

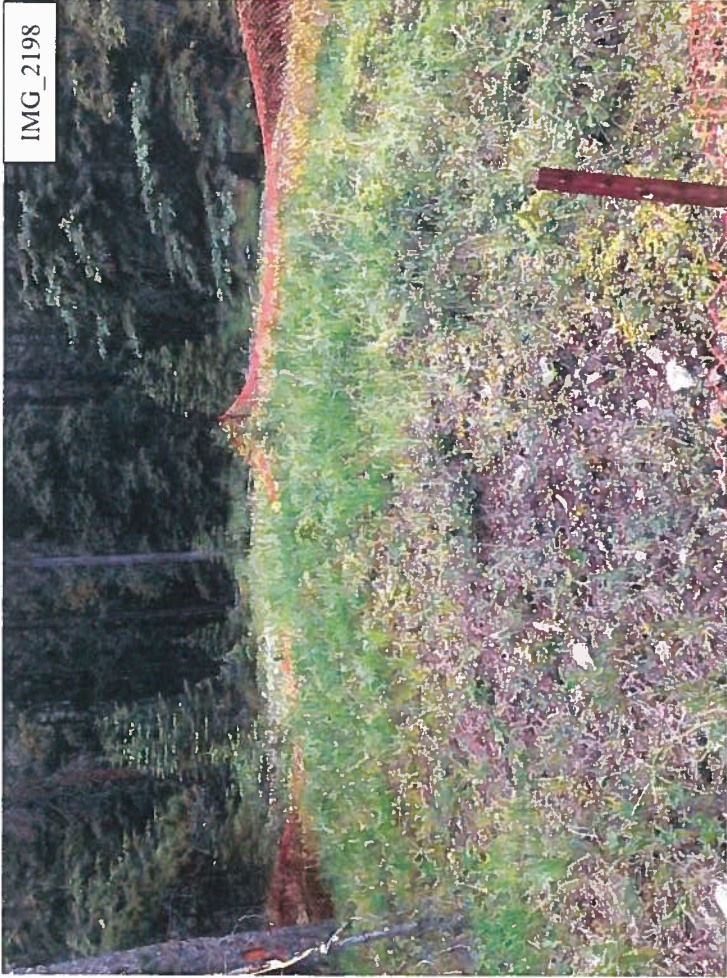
IMG_2198

Photograph 23: Feature S-15, July 2020

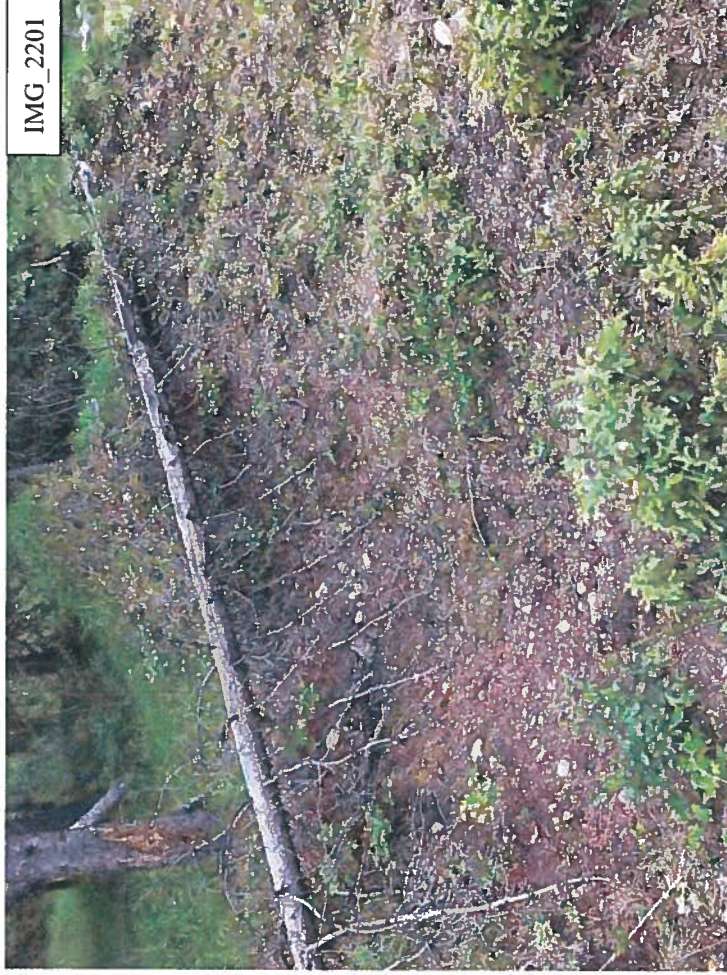
IMG_2201

Photograph 24: Depression with 90° turn, less defined toward Waypoint 43, coincidence with mining limit, B113 feature in this area, feature bounds waypoint 043-047, photo at waypoint 043, July 2020

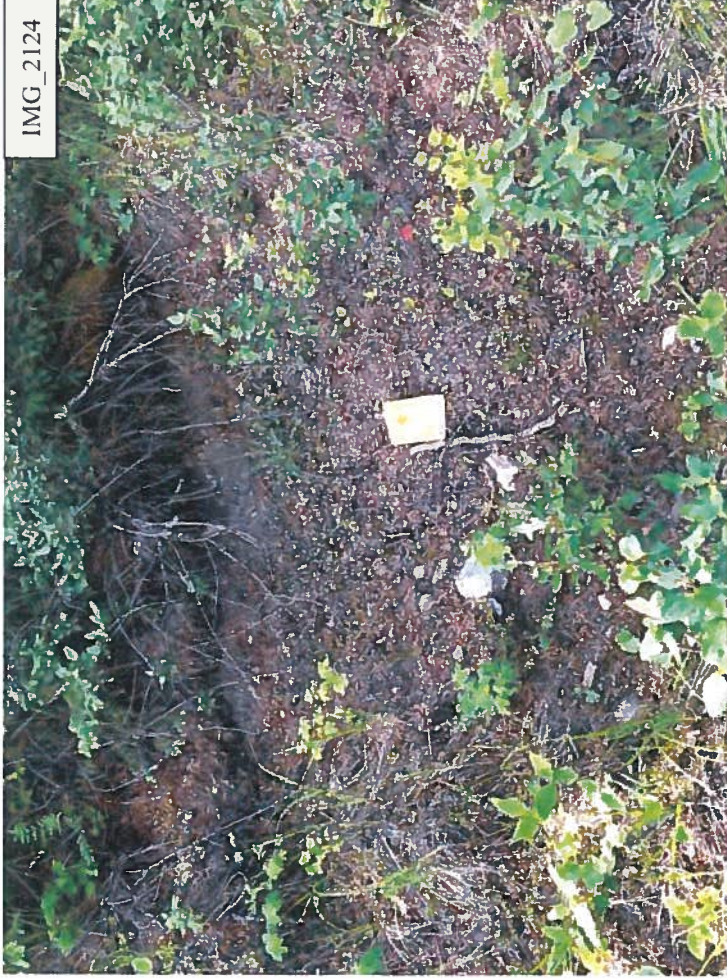
IMG_2124

Photograph 25: Linear scarp, relatively continuous, likely Feature G393, Waypoint 012, June 2020

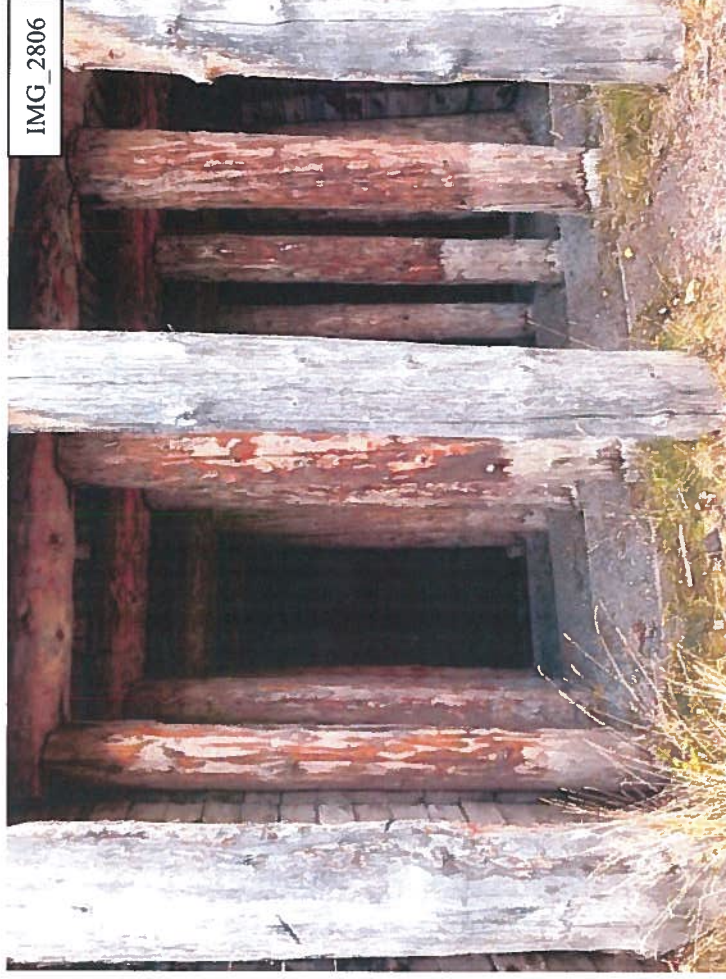
IMG_2806

Photograph 34: Sealed mine portal at Three Sisters Parkway,
September 2020

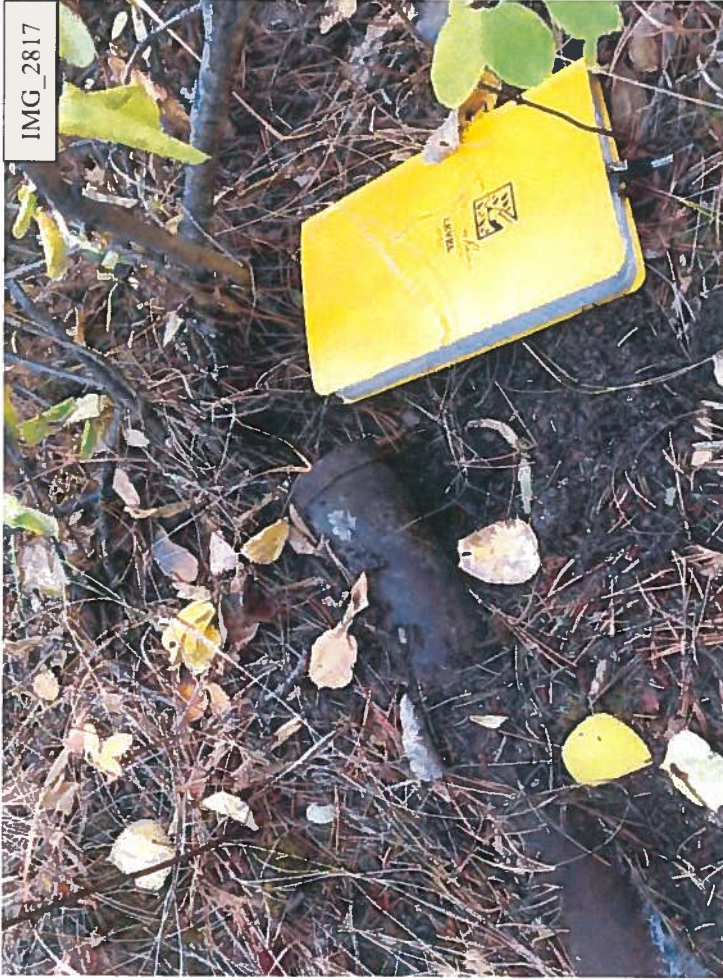
IMG_2817

Photograph 35: Steel pipe at Waypoint 140 and 141, September 2020

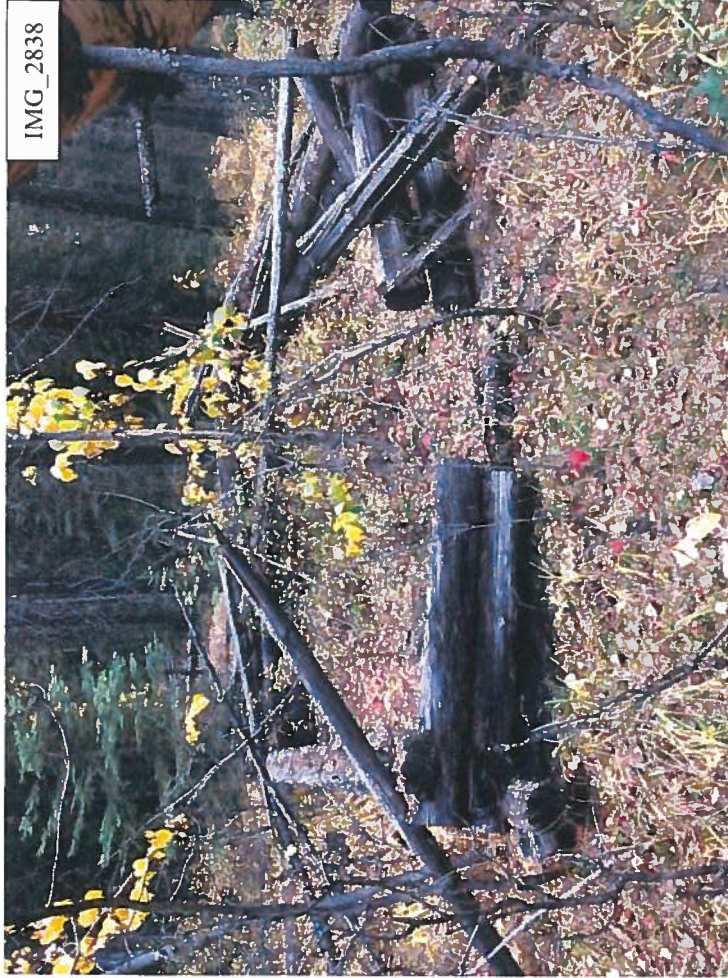
IMG_2838

Photograph 37: Square wooden crib structure at Waypoint 143, September 2020

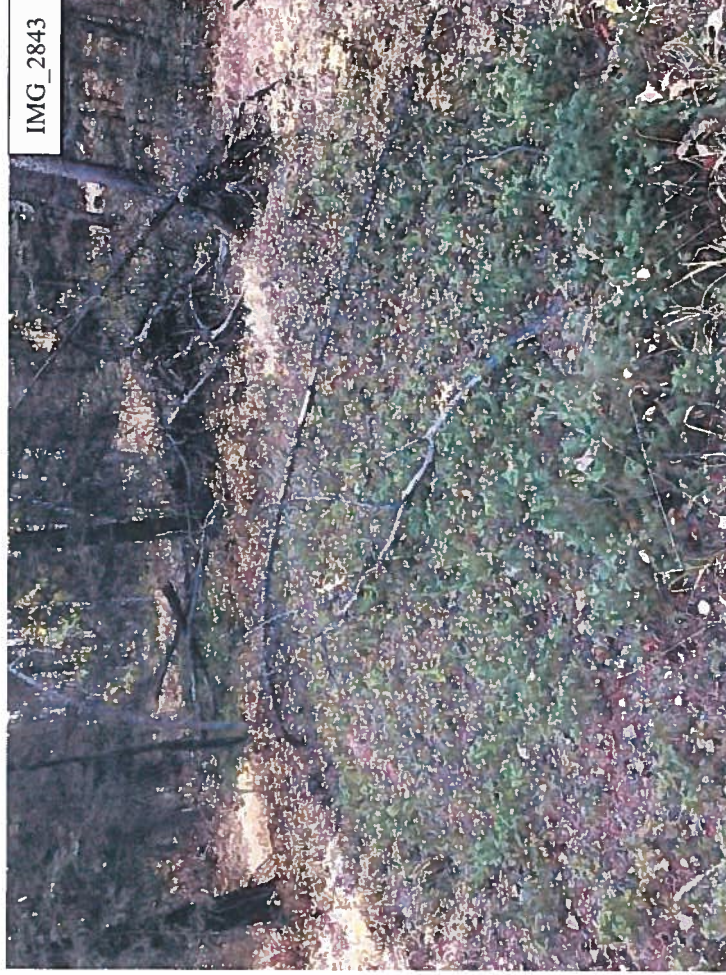
IMG_2843

Photograph 38: Known shaft location with settlement at Waypoint 144, September 2020

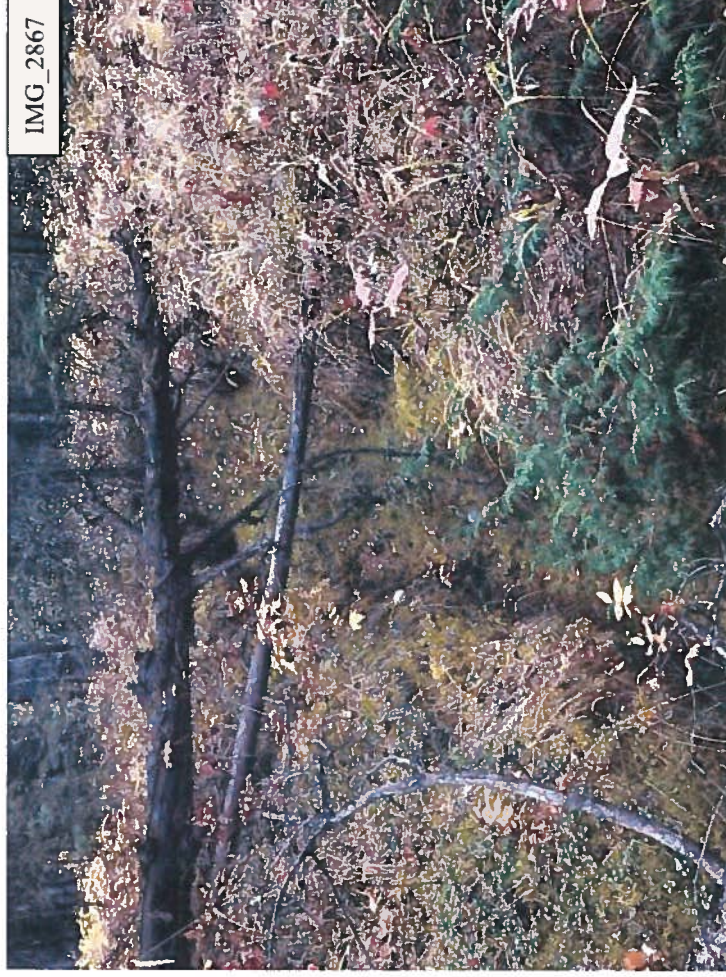
IMG_2867

Photograph 46: Ditch between Waypoint 148 and 149,
September 2020

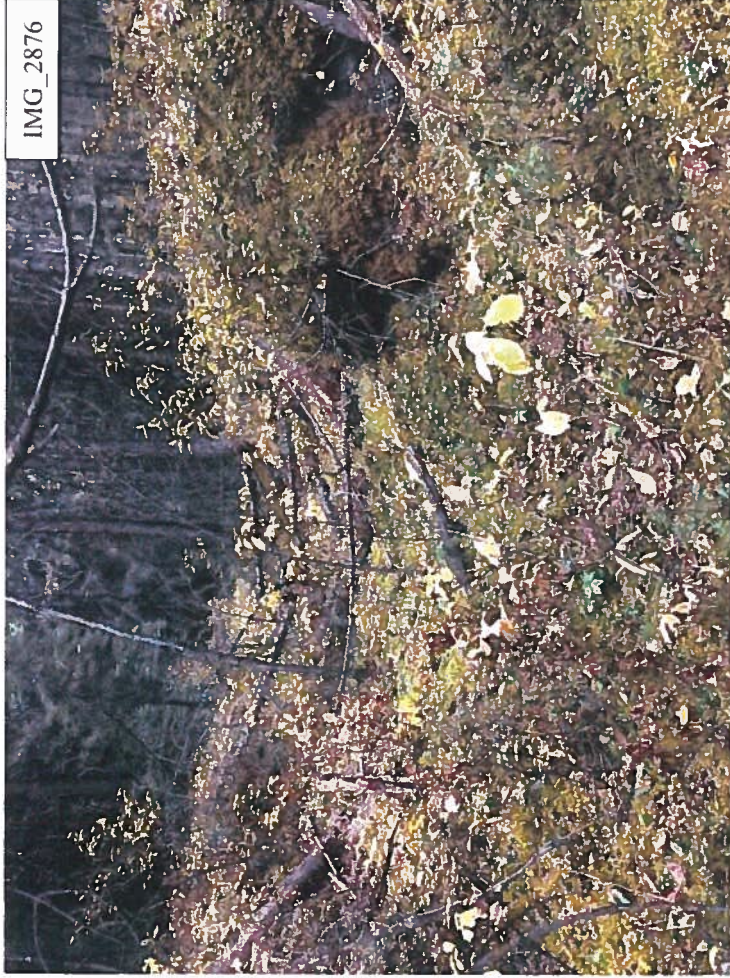
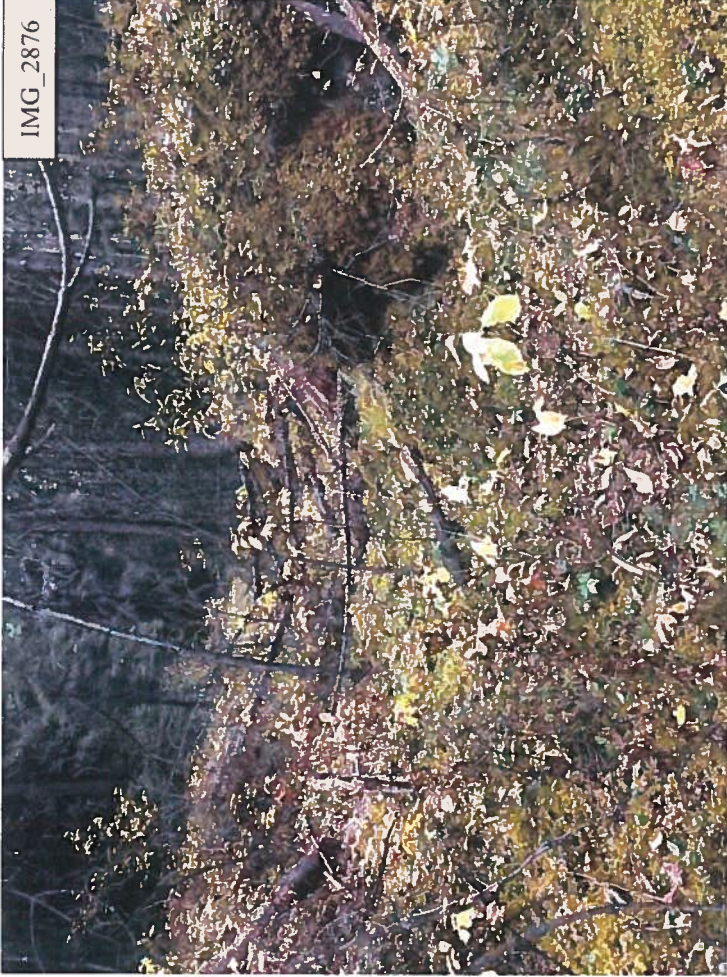
IMG_2876

Photograph 49: Trench, Waypoint 151, 154, 155,
September 2020

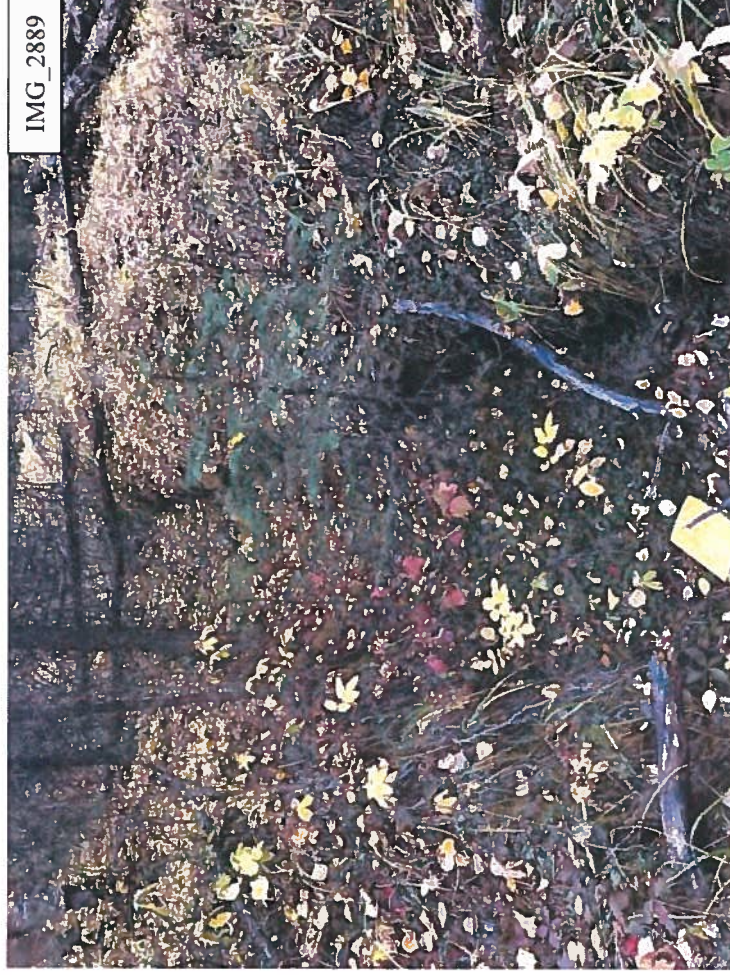
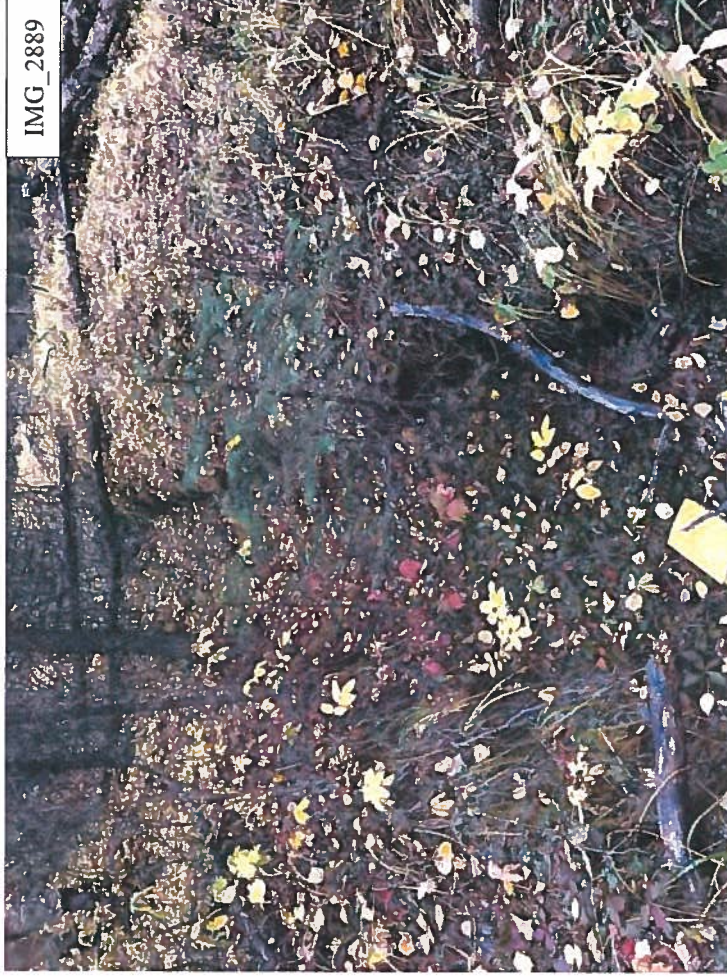
IMG_2889

Photograph 50: Trench, Waypoint 151, 154, 155,
September 2020

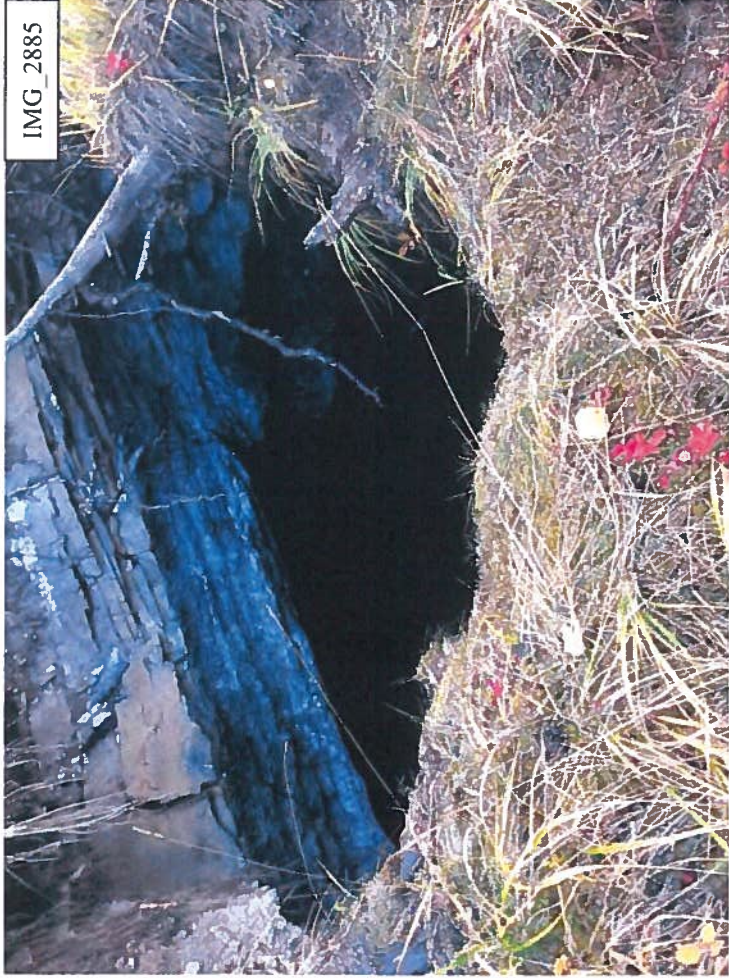
IMG_2885

Photograph 53: Former Mining Portal, Waypoint 153, September 2020 (outside ASP Area)

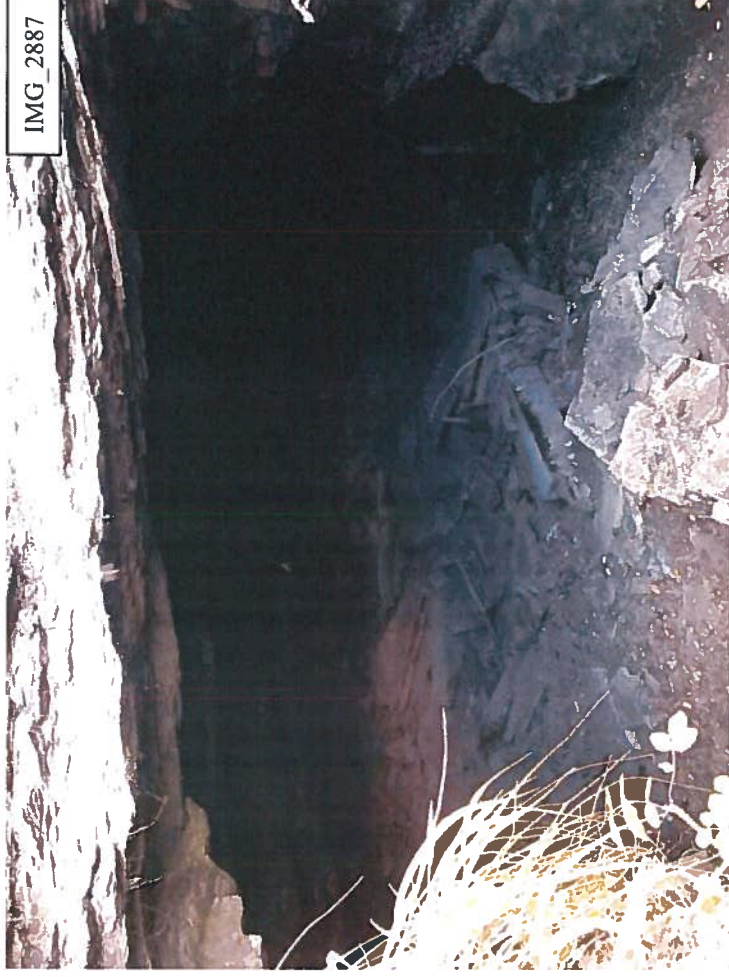
IMG_2887

Photograph 54: Former Mining Portal, Waypoint 153, September 2020 (outside ASP Area)
