SUBDIVISION MINING IMPACT REPORT

THREE SISTERS VILLAGE - PHASE 1

THREE SISTERS VILLAGE – PHASE 1

PROJECT NO.: CG09140
DATE: NOVEMBER 2023

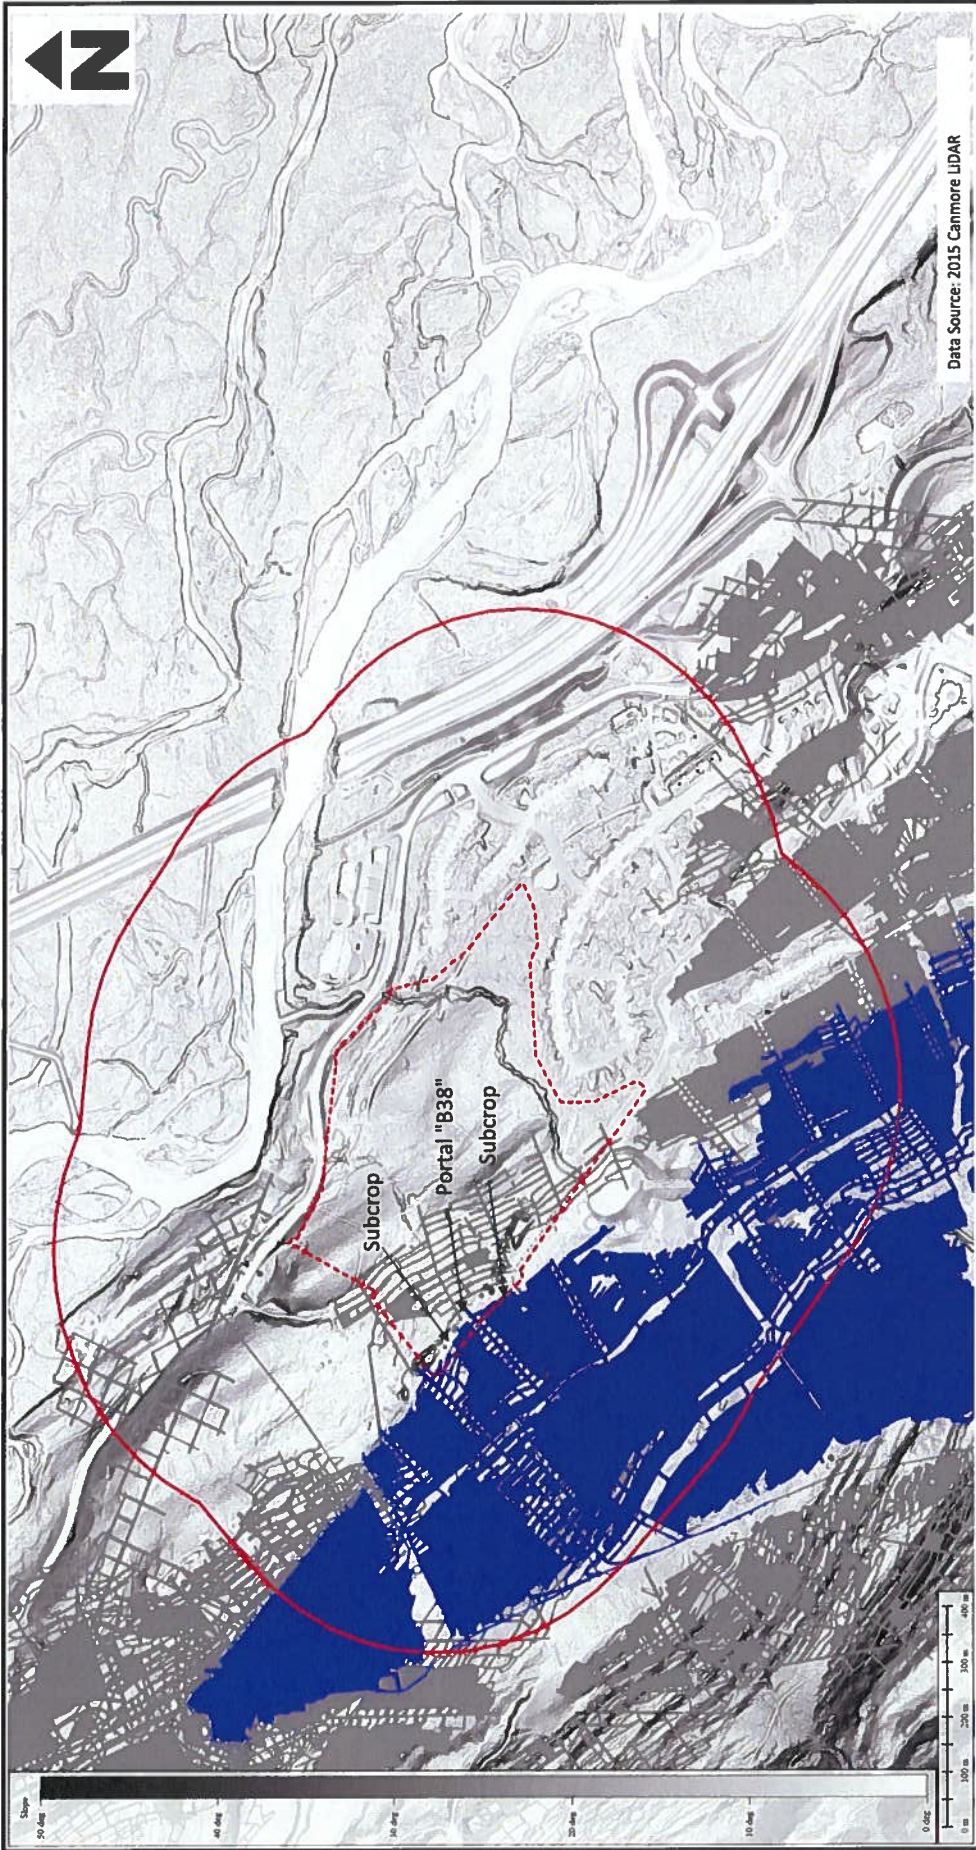
PROJECT NAME	Resort Village - Phase 1 Undermining
	SHEET TITLE	Stewart Mine
PROJECT NUMBER	CG09140	
FIGURE NUMBER	8	
ISSUE/REVISION	0

Within the project area limits there is one (1) known portal to this mine. This location is marked on **Figure 8**. In addition, there are shafts and portals present within the 500 m public safety assessment area. These have been mitigated for public safety as discussed within the Area Structure Plan report (Wood's Area Mining Impact Report: Resort Village Area Structure Plan_Rev2, dated 16 November 2020). Visual inspection during the site reconnaissance for the preparation of the Area Structure Plan report indicated no evidence of changed conditions for these areas. Periodic inspections of these areas (which could be completed as part of overall land reviews) should be undertaken to verify ongoing stability.

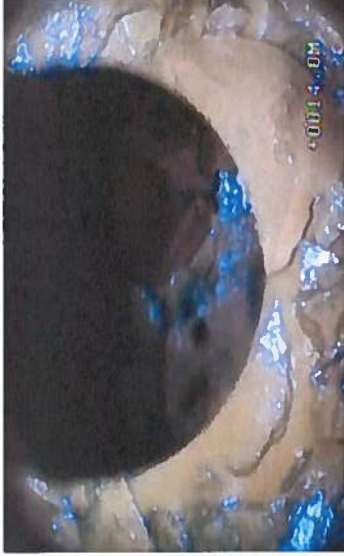
Maximum camera depth at 14.1 m

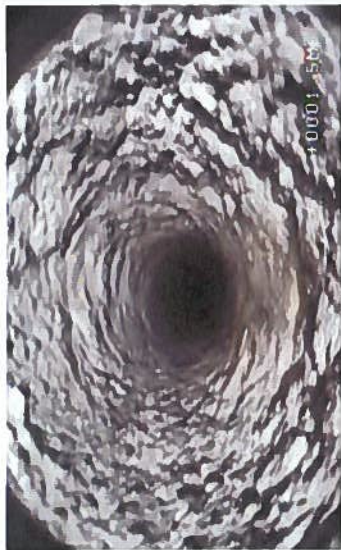
Typical borehole wall at 1.5 m

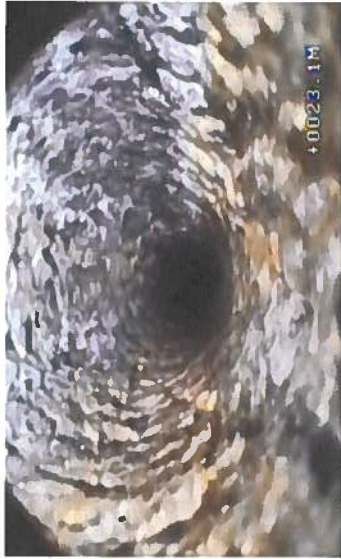
Typical borehole wall at 23.1 m

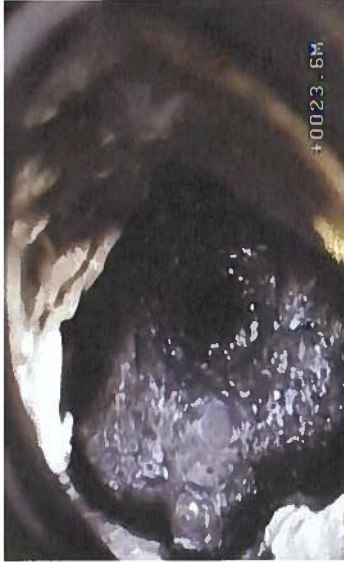
End of void at 23.6 m

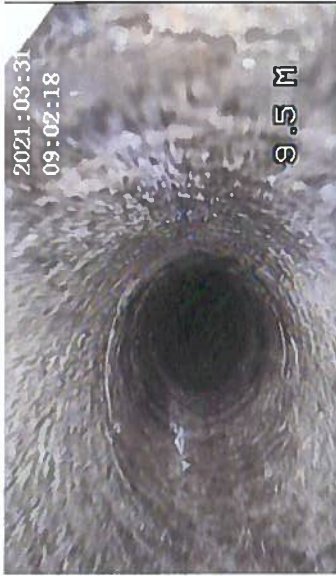
Typical borehole view at 9.5 m

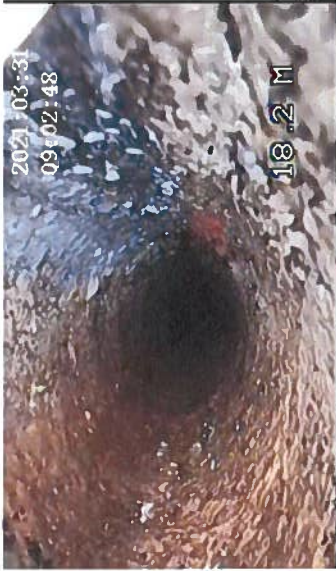
Typical borehole view at 18.2 m

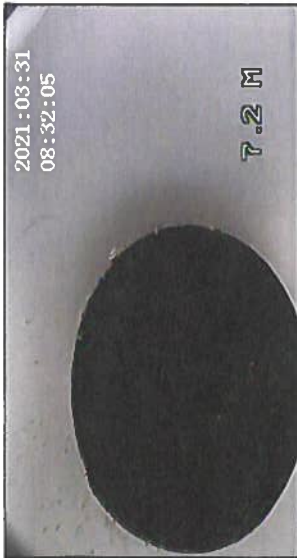
End of PVC at 7.2 m

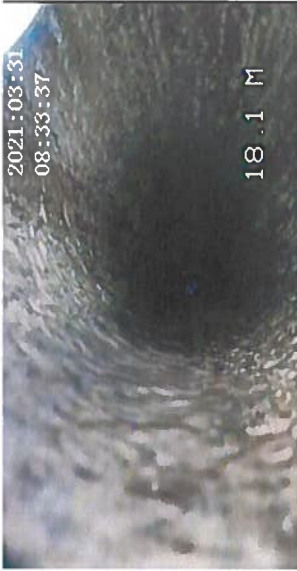
Typical borehole view at 18.1 m

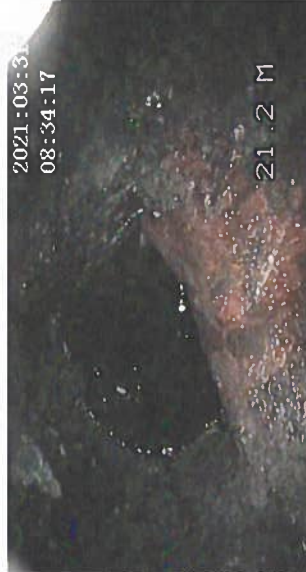
End of void at 21.4 m

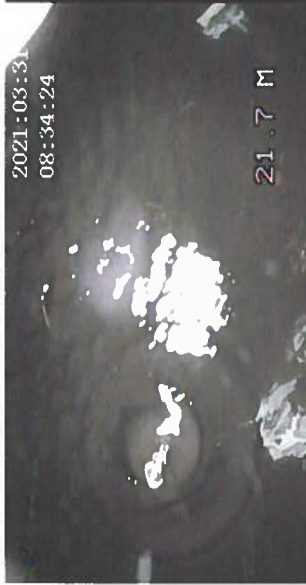
Water at 21.7 m

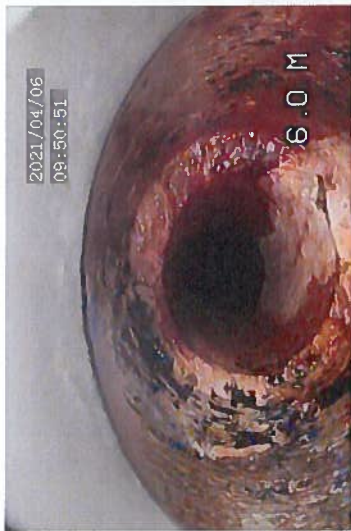
Bottom of PVC at 6.0 m

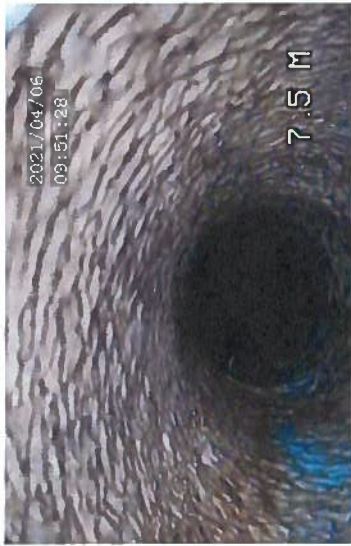
Typical borehole section at 7.5 m

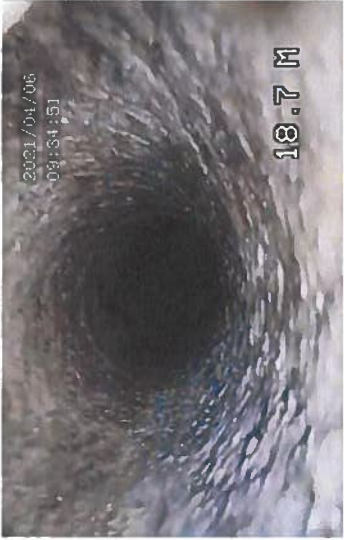
Typical borehole section at 18.7 m
